Aquatic Assessment
&
Habitat Enhancement Plan
Fountain Creek - Soda Springs Park
City of Manitou Springs
El Paso County - Colorado

FIN-UP Habitat Consultants, Inc.

In February 2007, FIN-UP Habitat Consultants, Inc. was contracted by the City of Manitou Springs to conduct an aquatic habitat analysis and habitat enhancement strategy for a segment of Fountain Creek within Soda Springs Park, immediately west of the downtown business district. The stream within the park is approximately 700 feet in length, and is mostly confined by concrete retaining walls and a moderately entrenched natural channel throughout its length. An aquatic assessment was conducted within the project area during the 2nd week of March, 2007, and the results of this work are summarized in this document.

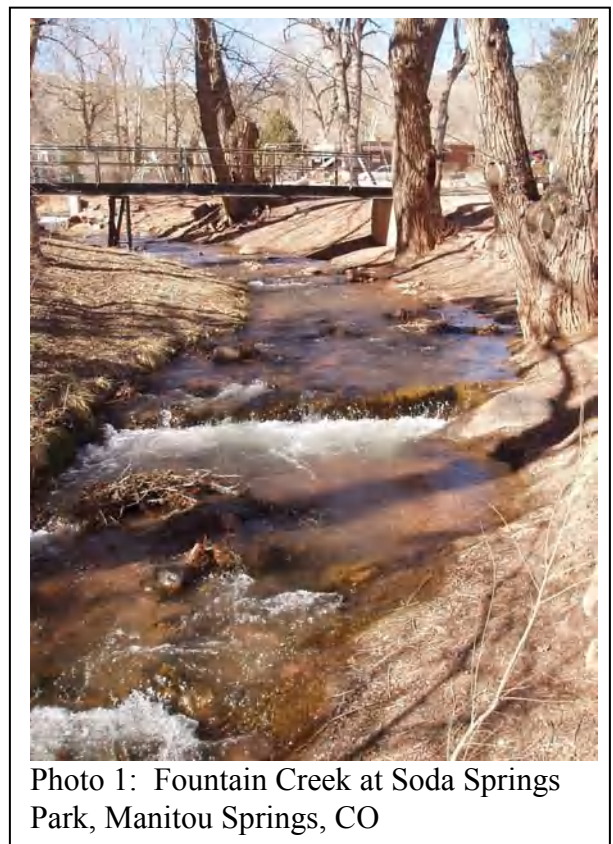
Photo 1: Fountain Creek at Soda Springs Park, Manitou Springs, CO

Reach 11 has been dramatically altered throughout much of its length through channelization and construction of concrete retaining walls on either bank. The middle portion of the reach is characterized by a deeply incised channel through relatively unstable depositional material composed mostly of smaller gravel. The stream exhibits a very narrow valley bottom with minimal riparian green-line, low sinuosity and moderate (2%) gradient, and is classified as a Rosgen G4c. G4 channels tend to be very unstable due to the very high sediment supply available from both upslope and channel derived sources. Several log drop structures are providing a degree of vertical channel stability in the reach (Photo #1).

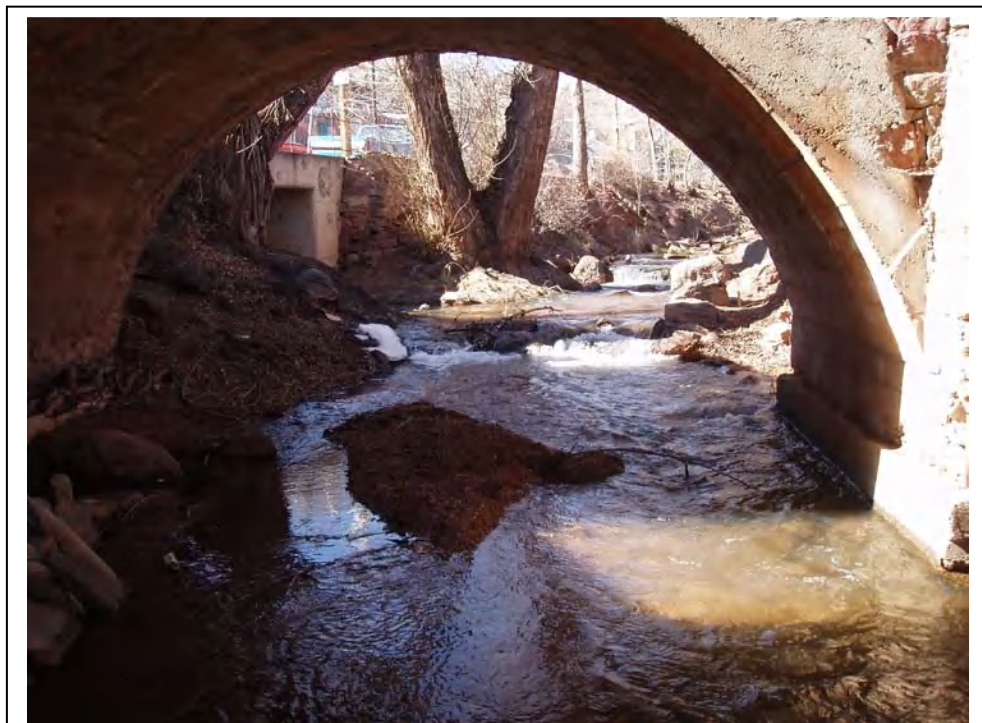
Photo 2: Plunge Pools #3 and 4. near the Confluence with Ruxton Creek.

In addition to the stream bank restoration on the right side of the channel, a small segment of the left bank between Pool #6 and Pool #7 will require similar toe-slope stabilization and bank revegetation. This segment of the bank is currently layered with large slabs of concrete rip-rap. It is recommended that this concrete be removed from the bank, or broken into smaller pieces that can be embedded into the bank and planted over with native vegetation. Additionally, a small portion of the old stone retaining wall on the right bank immediately upstream of the stone bridge (Pool #4) has collapsed, and will need to be repaired.

1. Adjust existing boulders to form a cross vane underneath the stone bridge at Pool #3. Excavate accumulated sediment from the pool and remove from the site.
2. Adjust existing boulders to form a cross vane immediately upstream of the confluence with Ruxton Creek at Pool #4. Excavate accumulated sediment from the pool and remove from the site.
3. Install interpretive signage at the stone bridge.
4. Adjust existing boulders to improve scour and protect eroding stream banks at Pool #5.
5. Use existing boulders to redefine riffle crest at log-drop Pool #7. Construct a rock vane on the right bank, and tie this structure into the existing log to create a cross vane.
6. Install six to eight micro-vortex structures in Riffle #8 upstream and downstream of the steel bridge.

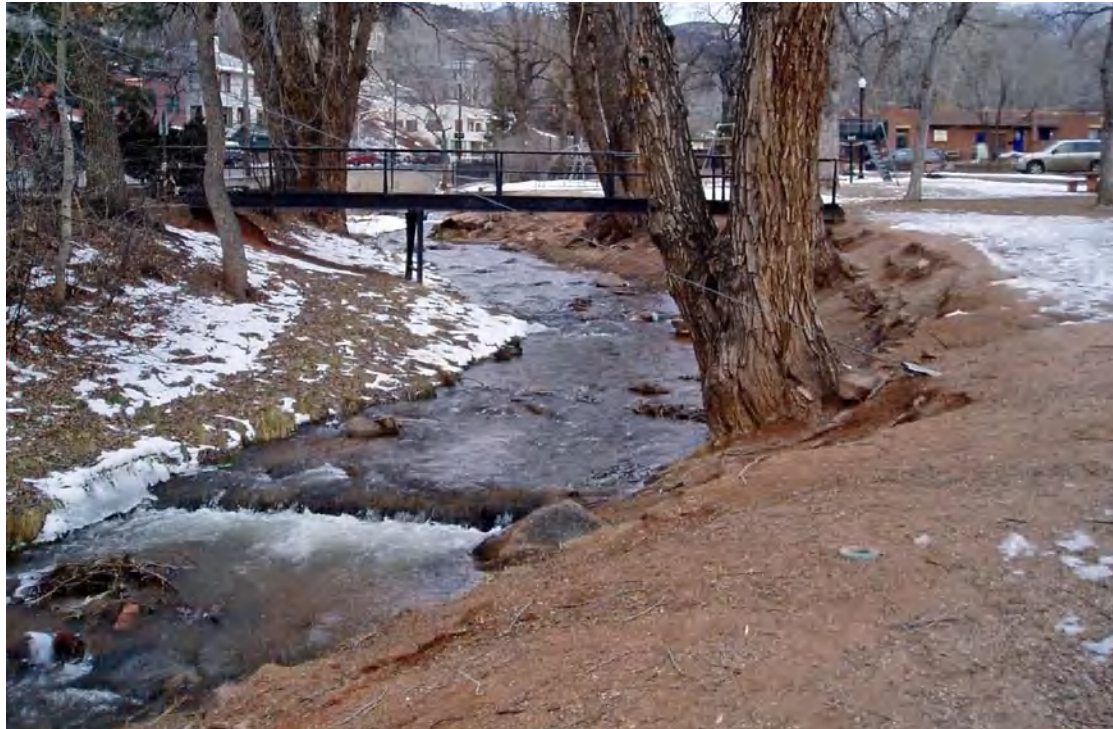
Photo 3: Actively Eroding Stream Banks in the Middle of Reach 11 - Fountain Creek.

The aquatic assessment indicates that stream bank erosion within Soda Springs Park is a significant contributing factor for sedimentation of pool habitats in the reach. Heavy recreational pressure continues to further erode these banks. Visually and esthetically, the bare gravel stream banks are detrimental to the overall park values, and may constitute a safety hazard, due to the unstable nature of the decomposing granitic material comprising these steep sided slopes.

The assessment identifies 217 feet of unvegetated, actively eroding stream bank on the right (north) side of the stream between Pool #5 and Glide #3 that may be stabilized and revegetated using a combination of techniques (Photo 3). First, the toe-slope along this segment of the reach will need to be stabilized through the anchoring of large diameter wood (10"-16"DBH) and boulder (1/2 - 2/3cy) at the base of the stream bank (see design drawings #5 & #10 - Appendix). This method of toe-slope stabilization will create a small bank-full bench on which riparian plants such as willow and sedge may be planted, further armoring the base of the stream bank. Due to the entrenched nature of the G channel, care must be taken in the installation of these toe slope structures so as not to further constrict the cross-sectional area of the stream channel throughout this segment.

In addition to toe-slope stabilization, the upper portion of the right stream bank between Pool #5 and Glide #3 may be revegetated by constructing one or two terraces using existing stone walls and landscape timbers. These terraces will reduce the velocity of storm water entering the creek from the park, and will allow for stabilization with upland woody vegetation such as mountain mahogany, native grasses and sedge. These areas will require additional top soil and erosion control fabric in order to allow the newly planted vegetation to become established.

In order to direct park visitors to the stream access paths and further protect the restored stream banks, it is recommended that the existing wrought iron fence near the stone bridge be extended along the top of the stream bank to the west end of the park.

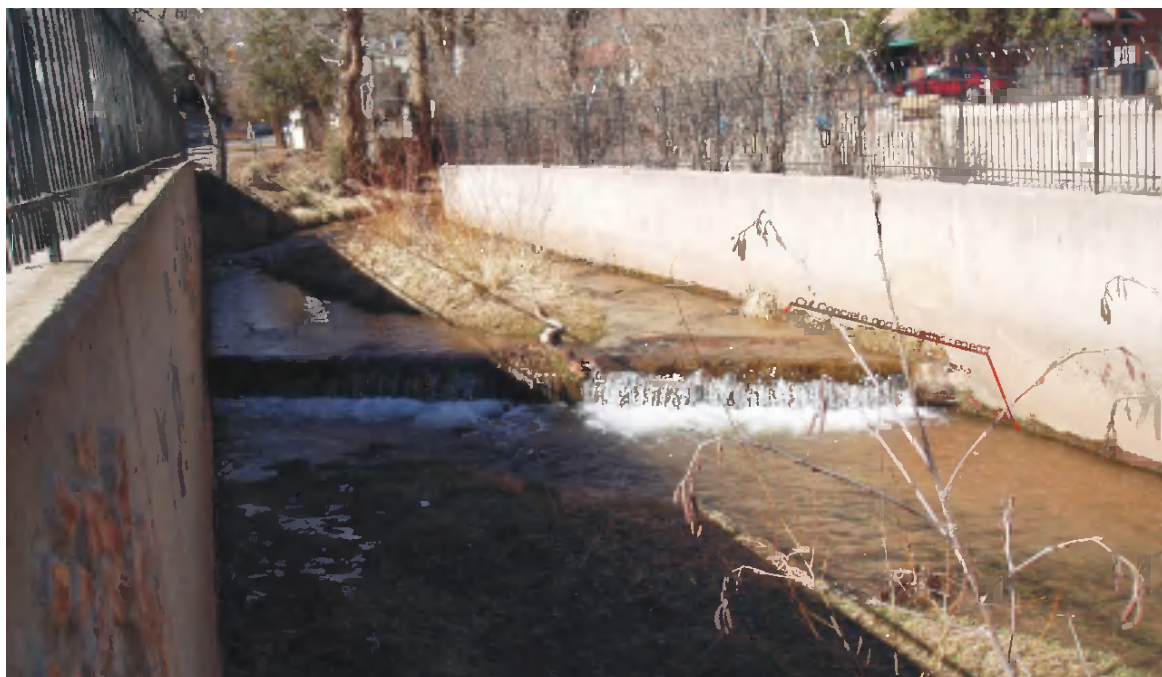
Photo 4: Playground Retaining Wall and Utility Crossing at Log Drop Pool 9

the inherent tendency of this structure type to over-widen the stream channel, these habitats occupy only a very small length along the stream channel. Additionally, one of these log drop structures currently protects a partially exposed utility pipe crossing the stream channel. The log drop structure immediately downstream of this structure has failed, causing the channel to head-cut back to this log drop structure. At present, the log drop is undercut approximately one foot, and is at risk of failure.

9. Reinforce existing log-drop structure protecting utility crossing at Pool #9 through construction of boulder cross vanes to create a continuous pocket water cascade between Pool #9 and Glide #3.

power during flood events. We propose to remove approximately 150' of the concrete wall, from Glide #3 upstream to Glide #4. Care will need to be taken in demolition of the concrete wall, to protect the historic wall immediately upstream and the utility crossing at Pool #9. At the utility crossing, it may be best to cut the wall at the bank-full elevation, and leave the segment anchoring the log and pipe in place (Photo 4). We recommend that the wall be cut at a downward angle where it ties to the existing stone wall to provide stability for this structure (Photo 5). The right stream bank will need to be sloped back to a similar angle as the downstream restored stream bank in Priority #1, and stabilized using the same toe-slope and revegetation techniques described above. The willow covered island upstream of Pool #9 can be removed, and the vegetation will be transplanted along the newly constructed stream bank. Two additional stream access paths have been identified to be installed in this segment to provide for visitor access to the stream.

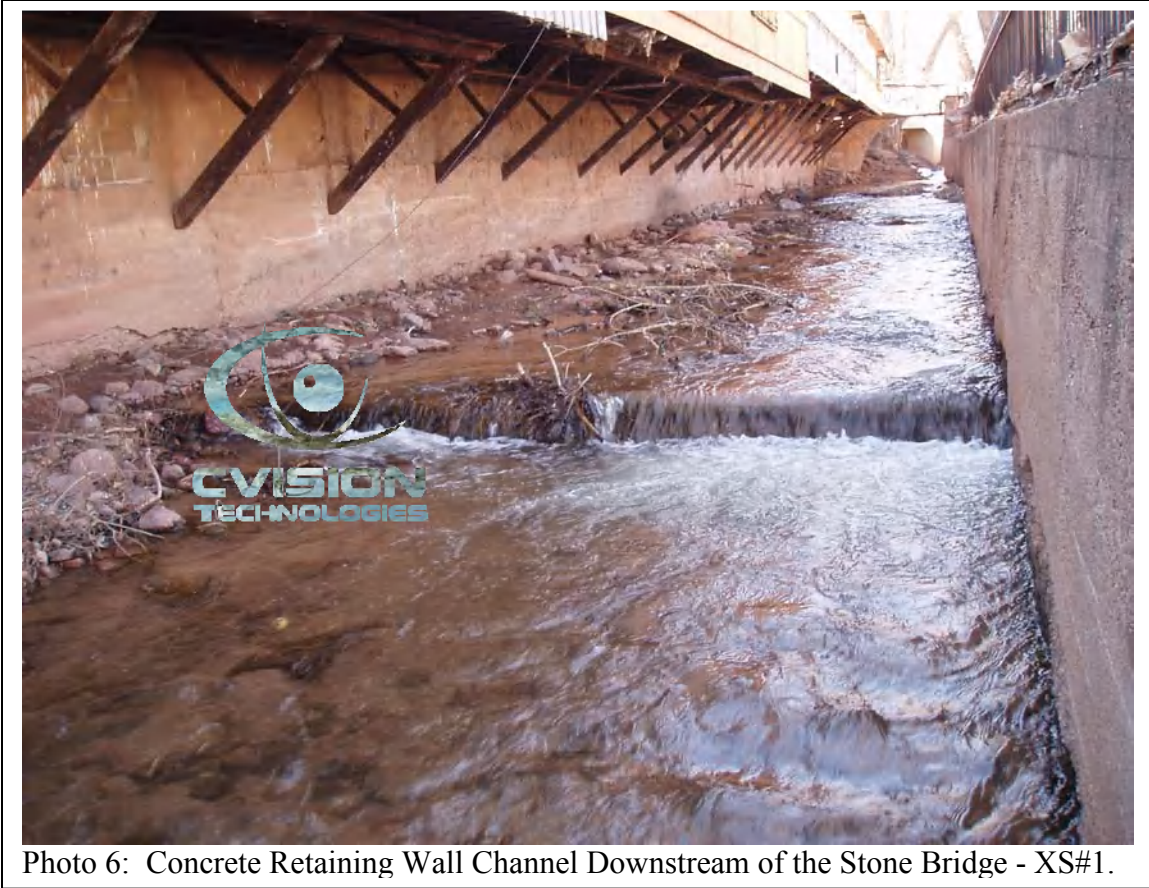
Photo 6: Concrete Retaining Wall Channel Downstream of the Stone Bridge - XS#1.

Improvements in this segment of the reach represent the greatest challenge for aquatic enhancement in Soda Springs Park. The stream has been straightened and channelized by concrete retaining walls on either side of the channel (Photo 6). Useable aquatic habitat is extremely limited in this segment, and the foundations of several of the buildings overhanging the channel on the left bank appear to be threatened by high flow shear stress. Enhancing the stream through this segment may help reduce some of the foundation erosion risk along the left bank, and provide a unique fish-viewing experience for customers of businesses such as Kinfolks, the Ancient Mariner, and Mate Factor, where the windows in the back of these establishments look directly down on the stream. While there is somewhat greater risk in working in this segment, the potential benefits may warrant consideration in implementing this portion of the enhancement project.

We propose to enhance the natural habitat features already present in this segment through strategic placement of small cross vanes, J-hook vanes and micro-vortex structures. Full channel cross vanes will provide vertical stability in the channel, helping to prevent undercutting of the building foundations. The smaller J-hook vanes will be installed along left bank to direct the thalweg away from and reduce sheer stress along the foundation walls, and to protect a utility crossing immediately upstream of Pool #2. Micro-vortex rock clusters may be installed within the riffle meso-habitats to provide critical velocity shelter and holding areas for trout along this severely confined segment (Artists Drawing #3).

1. Install a full channel cross vane at Glide #1, integrating the structure into the existing large boulder in the stream channel. Perform minor excavation of accumulated sediment downstream of the structure and remove from the site. This structure will provide important vertical profile stability in the channel, protecting the utility crossing upstream at Pool #1, and the foundation on the left bank, as well as providing fish viewing opportunities from Kinfolks.
