Brush Creek
Aquatic Habitat Enhancement Project
Elk Mountain Ranch
Carbon County, WY

Brush Creek Reach 2 Aquatic Habitat Enhancement Plan

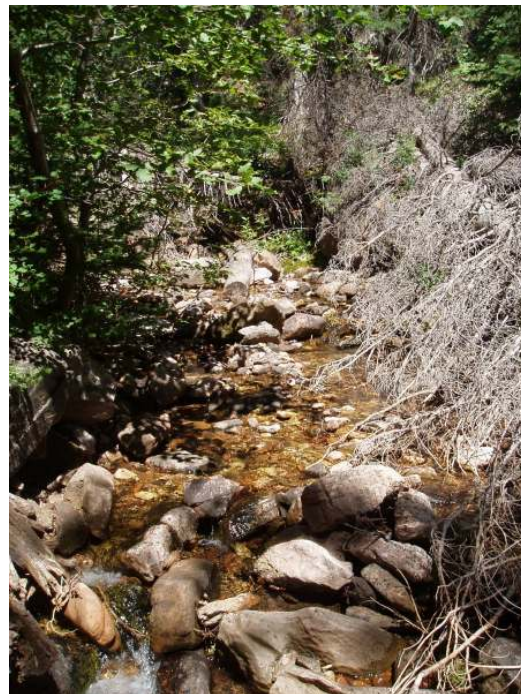
Photo 1: Typical Riffle on Brush Creek.

High-gradient, pocket water dominated cobble and boulder riffles were the most abundant habitat type, in terms of both numbers and area, in the study segment, comprising more than 86% of the wetted area (Chart 2). These riffles typically dominate A and B channel types, and depending on depth and substrate structure, may provide important holding and feeding habitats for trout, as well as critical habitat for benthic macro-invertebrates and other aquatic organisms. The average depth of these riffles was 0.23 feet in the study segment. Pocket water cover for trout was observed in many of the riffles, and comprised 1.5% of the wetted perimeter of these habitats. Riffles in the study segment did appear to provide adequate spawning habitat for trout.

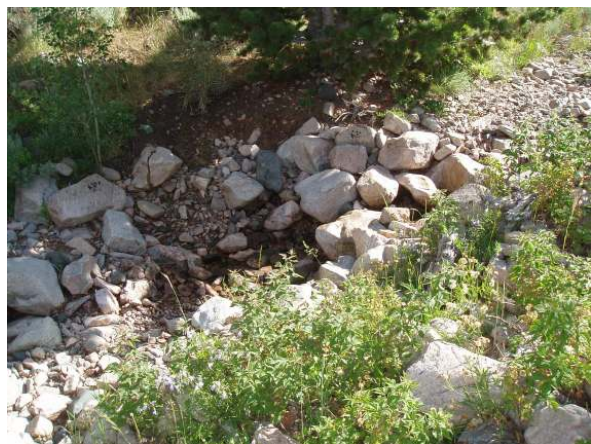
Photo 3 - Site P1 From the Right Bank

Pool #1 (P1) is located at the downstream boundary of Reach 2 (Photo 3). This pool occasionally dries up and maintains very little residual pool depth. Work on this meso-habitat will include re-aligning the existing boulders within the feature to create a boulder cross vane at the upstream transition between the pool and riffle. Additionally, large cobble and small boulder will be removed from the pool to create a residual pool depth of at least 1.0 ft and a maximum pool depth of 1.5 ft at bank full stage.

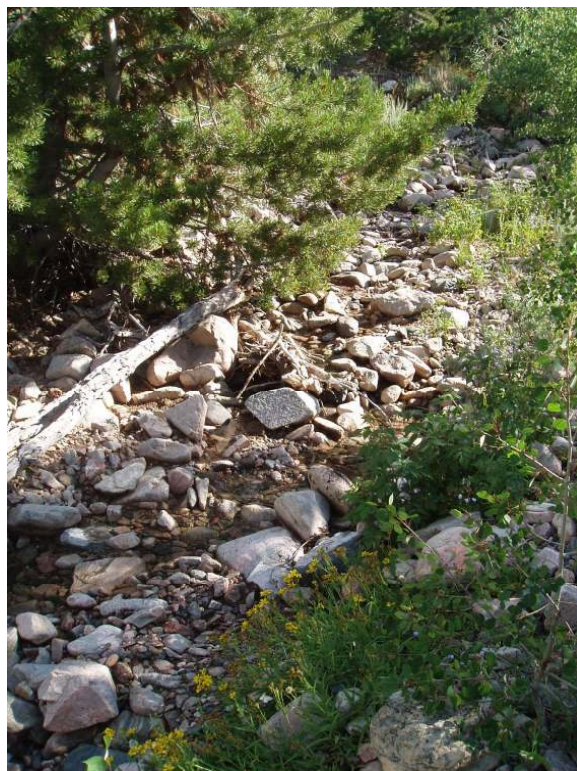
Photo 4 - Site NP1 Looking Upstream

A site for New Pool #1 (NP1, Photo 4) is found approximately 75 ft upstream of Pool 1, at a brief lesser gradient transition zone within the cobble/boulder riffle. A new pool may be constructed here using existing small boulders and large cobble within the stream channel. Small boulders will also be removed from the channel to create a pool approximately ten feet long and four feet wide. Target RPD will be 1.0 - 1.2 feet, and maximum pool depth will be 1.5 ft.

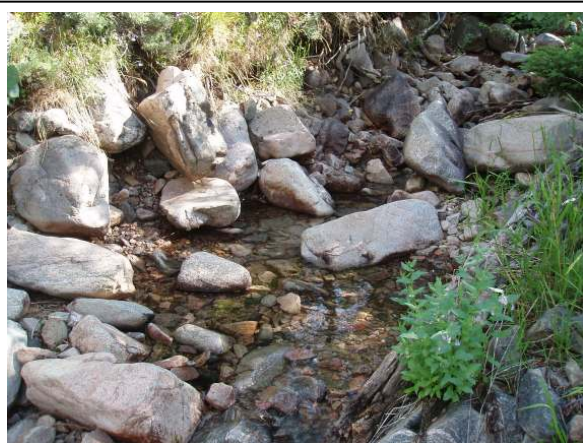
Photo 5 - Site P2 Looking Upstream.

Pool #2 (P2) is located 73 ft upstream of NP1 and 148 ft upstream of Pool 1 (Photo 5). This pool maintains a residual pool even when the channel is dry, but maintains very little depth. Work on this feature will include removing and re-aligning large cobble and small boulder to deepen the existing pool. The goal will be to create a residual pool depth of at least 1.0 ft and a maximum pool depth of 1.5 ft.

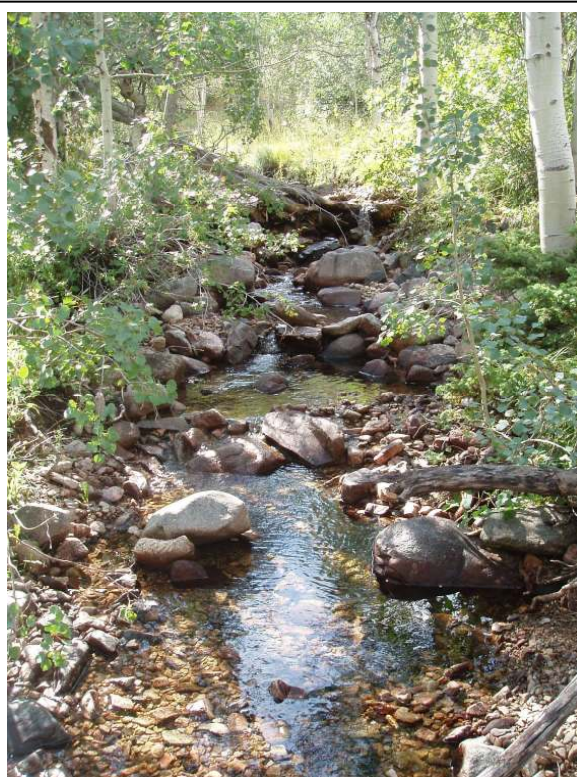
Photo 7 - Site P3 Looking Upstream

The existing pool at P3 is found 75 ft upstream of Pool 2, and will be enlarged and defined by removing armor from the stream channel (Photo 7). Larger cobble and boulder will be used to create a cross vane at the upstream boundary of the habitat to enhance scour through the feature. Target RPD will be 1.0 - 1.2 feet, and maximum pool depth will be 1.5 ft.

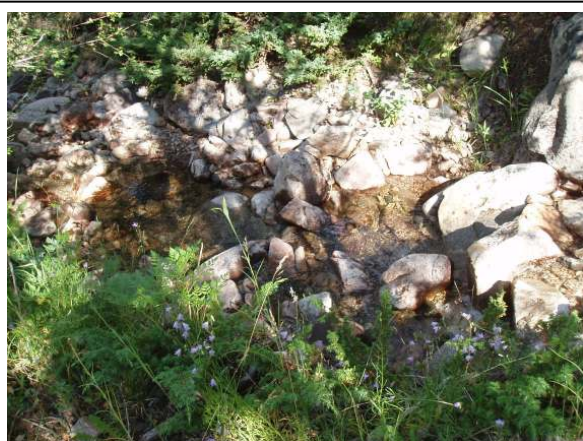
Photo 6 - Site NP2 From the Right Bank

A site for New Pool #2 (NP2, Photo 6) is found 10 ft upstream of Pool 2, at a lesser gradient transition zone within the cobble/boulder riffle. A new pool may be constructed here using existing small boulders and large cobble within the stream channel. Small boulders will also be removed from the channel to create a pool approximately ten feet long and four feet wide. Target RPD will be 1.0 - 1.2 feet, and maximum pool depth will be 1.5 ft.

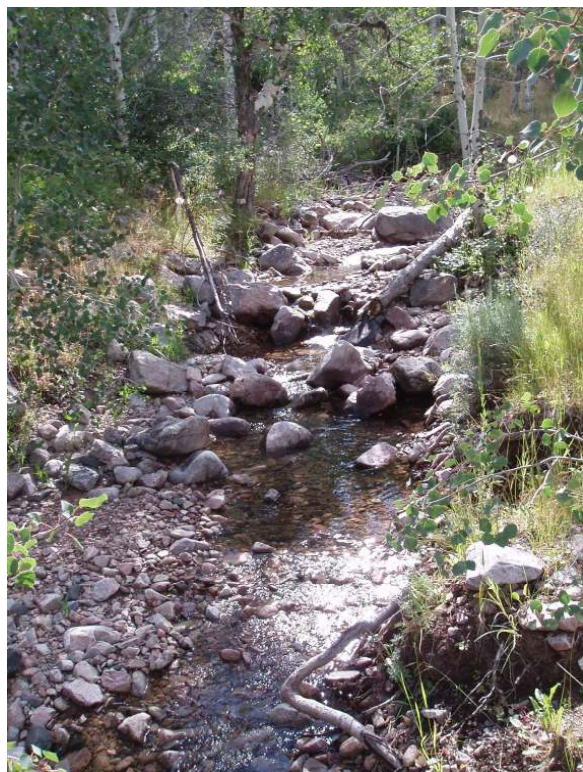
Photo 8 - Site P4 Looking Upstream

Pool 4 (P4) is 60 ft upstream of Pool 3, and features a naturally occurring cross-vane composed of small boulder (Photo 8). The boulders will be adjusted to improve scour, and some armor will be removed from the pool to improve RPD and depth. Target RPD will be 1.0 - 1.2 feet, and maximum pool depth will be 1.5 ft.

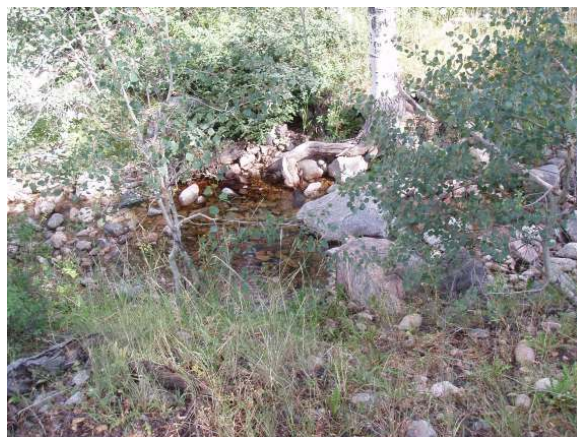
Photo 9 - Site P5 From the Right Bank

Pool 5 (P5) is similar to Pool 4, and is located 55 ft upstream (Photo 9). This pool also features a naturally occurring cross-vane composed of two large boulders. These boulders will be adjusted to improve scour, and some armor will be removed from the pool to improve RPD and depth. Target RPD will be 1.0 - 1.2 feet, and maximum pool depth will be 1.5 ft.

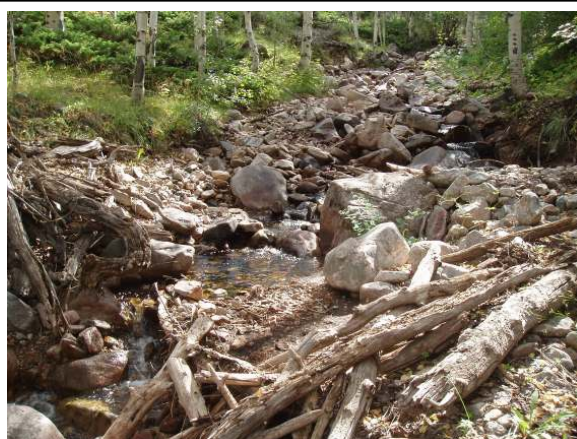
Photo 10 - Site P6 Looking Upstream

Pool 6 (P6) is similar to the preceding pools, and is located 80 ft upstream of P5 (Photo 10). This pool also features a naturally occurring cross-vane composed of several small boulders. These boulders will be adjusted to improve scour, and some armor will be removed from the pool to improve RPD and depth. Target RPD will be 1.0 - 1.2 feet, and maximum pool depth will be 1.5 ft.

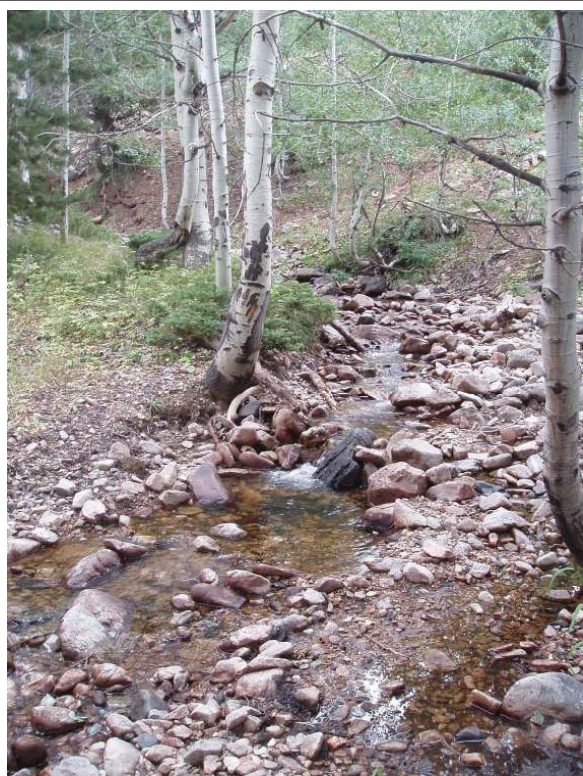
Photo 12 - P11 Looking Upstream

Pool 11 is located 80 ft upstream of the P8/9/10 step-pool complex, where the stream channel exhibits a somewhat lesser gradient, and returns to more of a Ba-Channel type of pool/riffle sequence (Photo 12). Pool 11 is another poorly developed pool, comprising less than 1/2 of the channel width, with limited scour due to channel armoring. We will use existing boulders in the feature to construct a small rock vane to enhance scour, and remove enough cobble armor in the bottom of the pool to make this a full-channel width habitat. Targeted RPD will be 1.2 - 1.4 ft, with a maximum depth of 1.5 -2.0 ft.

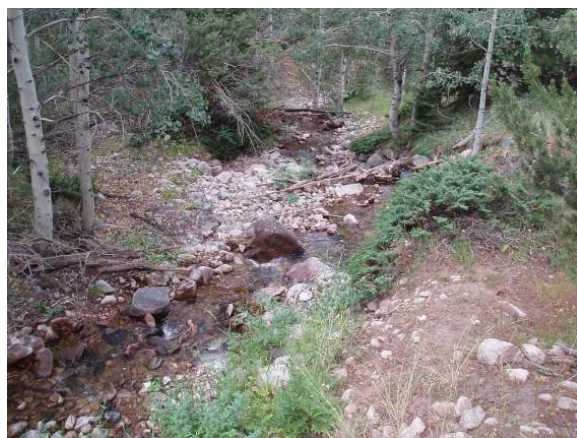
Photo 11 - P8 & P9 Looking Downstream

Pools 8, 9 and 10 are a closely spaced step-pool feature within a relatively steep channel segment (Photo 11). There is a potential barrier to fish passage at Pool 8, due to the very shallow depth of the pool and a considerable (1.5 ft) hydraulic jump at the upstream boundary of the habitat. This potential barrier will be minimized by deepening the pool to allow trout to obtain the necessary burst speed to pass this feature at low flow. The pool will be deepened to a maximum depth of 2 feet below the bank full stage by removing cobble from the bed.

Pool 9 will be enlarged to encompass the entire channel width by re-aligning and removing larger substrate material within the channel. Pool 10 will also be deepened by removing armor from the bed. Target average depths in these pools will be 1.2 to 1.4 ft, with RPD of at least 1.25 ft. Maximum depth of these pools will be 1.5 to 2 ft, depending on the composition of the stream substrate.

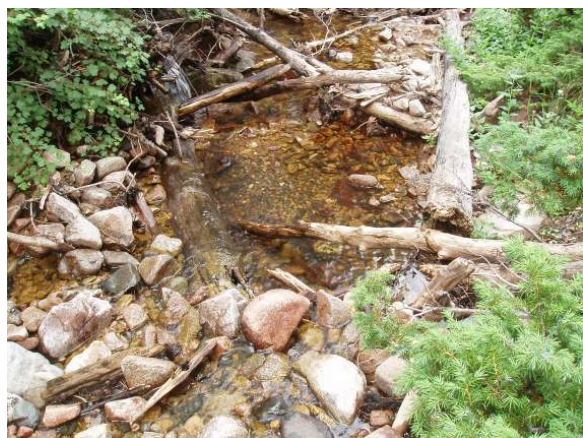
Photo 13 - P12 Looking Downstream

Pool 12 (Photo 13) is located 42 ft upstream of Pool 11, and is formed by a piece of large wood embedded into the channel. Pool 11 exhibits limited scour due to channel armoring. Existing boulders in the feature will be used to improve scour over the existing log, which will not be disturbed. Cobble armor in the bottom of the pool will be removed from the habitat to reach a targeted RPD of 1.0 ft and a maximum depth of 1.5 ft.

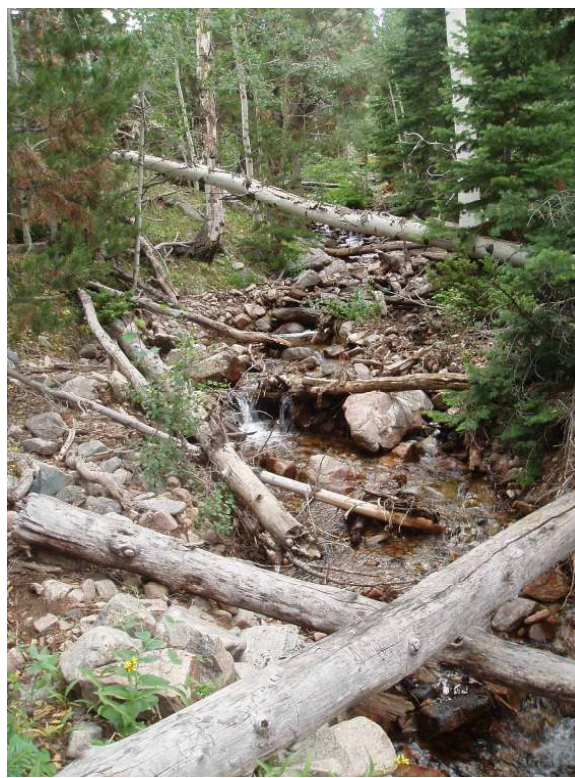
Photo 14 - P14 Looking Upstream

Pool 14 may also be accessed via the Access 2A route, and is approximately 87 ft upstream of Pool 13 (Photo 14). The stream channel gradient at this point begins to increase, exhibiting characteristics of an A channel step-pool system. There is a potential barrier to fish passage at this pool, due to the very shallow depth of the pool and a large (>1.0 ft) hydraulic jump at the upstream boundary of the habitat. Boulders and large wood along this segment will be re-aligned to create a series of three step pools to eliminate the potential barrier. Each step pool feature will be deep enough to allow trout to obtain the necessary burst speed to pass this feature at low flow. The step pool pockets will be deepened to a maximum depth of 1.5 feet below the bank full stage.

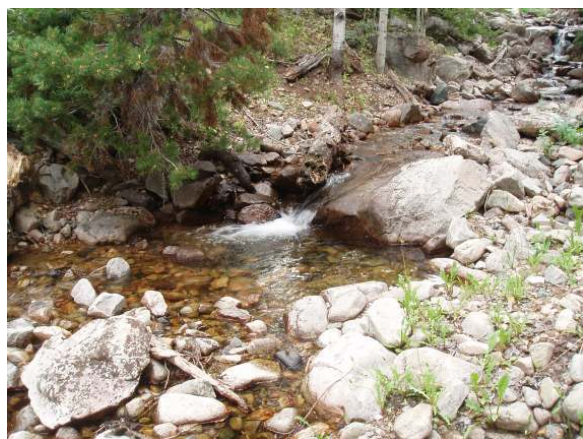
Photo 15 - P16 Looking Upstream

Pool 16 (Photo 15) is 32 ft upstream of Pool 15, and exhibits the first quality pool habitat encountered along Reach 2. This habitat feature will be left "as is", with no additional enhancement necessary. Pool 16 is formed by a boulder constriction creating a natural plunge into the center of the channel. Maximum depth is 1.5 ft, with an RPD of 1.1 ft.

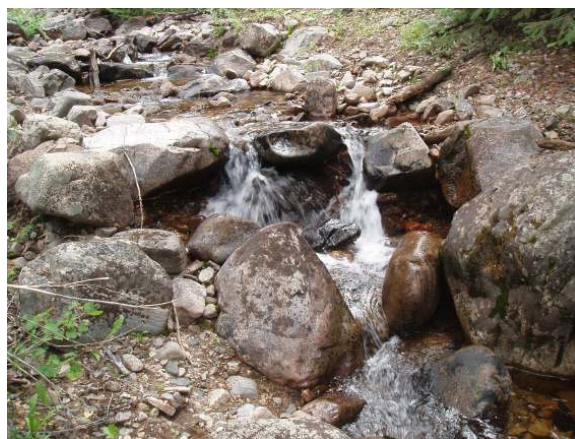
Photo 16 - NP3 Looking Upstream

The site for New Pool 3 (NP3, Photo 16) is found 60 ft upstream of Pool 16, in a brief, high gradient segment of the stream channel, and may be accessed either by Access3A or Access3. There is another potential barrier to fish passage at NP3, due to a series of hydraulic jumps through a boulder cascade with no pockets of deep water resting cover. This potential barrier will be minimized by creating a new plunge pool at this location to allow trout to obtain the necessary burst speed to pass the hydraulic jump at low flow. Armor will be removed to create a pool with a maximum depth of 2 feet below the bank full stage and a RPD of 1.2 to 1.4 ft.

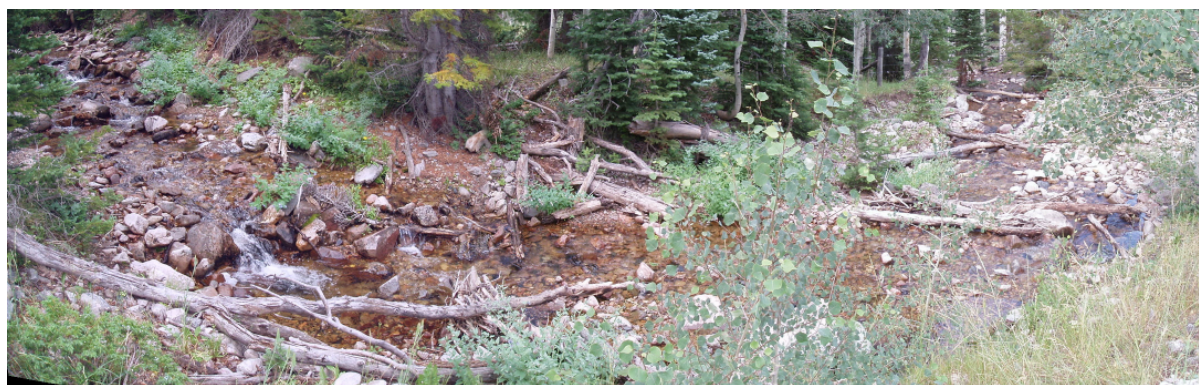
Photo 17 - NP4, 5 & 6 - From Left Bank

New Pool Sites 4 -6, and Pool 17 & 18 may be reached by following the Access 3 route to the downstream boundary of the BWSHI habitat study reach described in the preceding section. New Pool 4 and 6 (NP4 & 6, Photo 17) correspond with pools 1 & 2 in the BWSHI study. Neither of these pools currently exhibit cover for salmonids. New Pool site 5 (NP5) is found 52 ft upstream of NP4 within riffle2 in the BWSHI survey, at brief gradient transition within the habitat feature. Current RPD for these features is 0.5 ft and current maximum depth is

0.75 ft. RPD and maximum depth will be doubled in these habitats by removing substrate armoring in channel.

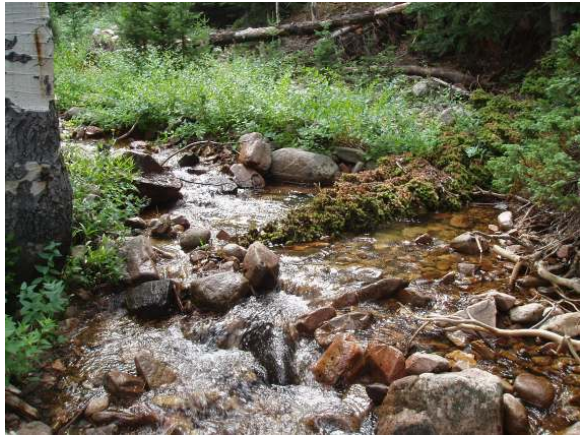
Photo 18 - P17 Looking Upstream

Pool Site 17 (P17, Photo 18) corresponds with pool 3 in the BWSHI survey, and is located 16 ft upstream of NP6. This pool currently has no measured cover for trout, with RPD of 0.6 ft and a maximum depth of 0.8 ft. Armor will be removed from the channel within this habitat feature to create a full channel pool with an RPD of at least 1.0 ft and a maximum depth of 1.5 ft.

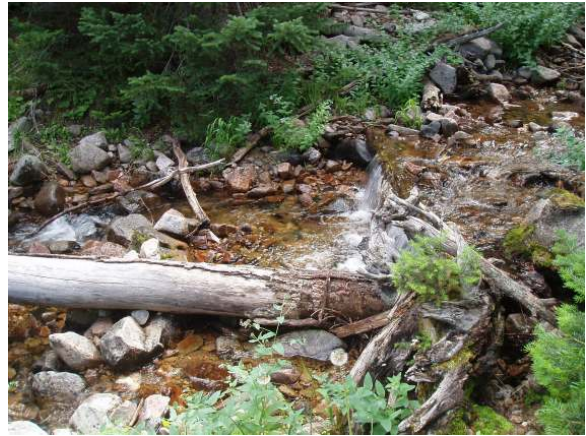
Photo 19 - P18 From the Right Bank

Pool Site 18 (P18, Photo 19) is a pocket water feature within riffle 3 in the BWSHI survey, and is located 50 ft upstream of P17. This pocket water feature occupies less than 1/2 the width of the channel, and is formed by a large log in the channel. This feature will be enhanced by re-aligning the log as a vane on the right bank of the stream to improve scour along the entire width of the channel. Armor will be removed from this habitat feature to create a full channel pool with an RPD of at least 1.0 ft and a maximum depth of 1.5 ft.

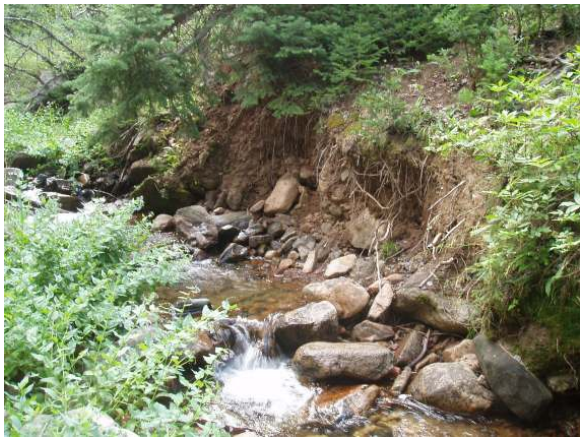
Photo 20 - P20 Looking Upstream

Pools 19 & 20 (P19, P20), are located a short distance downstream of the road crossing, and may be reached using the Access 4 route along the northwest side of the creek. P19 corresponds to the first glide habitat in the BWSHI survey, and will be converted to a pool through deepening by removing cobble and boulder. Pool 20 is a pocket water feature within riffle 4 in the BWSHI survey, and is located 10 ft upstream of P19 (Photo 20). This pocket water feature occupies less than 1/2 the width of the channel, and is formed by several large boulders in the channel. Additionally, twenty feet of actively eroding stream bank is present along the right bank of this feature. The boulders will be re-aligned to improve scour along the entire width of the channel. Armor will be removed from this habitat feature to create a full channel pool with an RPD of at least 1.0 ft and a maximum depth of 1.5 ft. The eroding stream bank will be treated and revegetated using a single log toe-slope stabilization structure. The log toe slope structure should not exceed greater than 0.1 yd³ of fill per linear foot of bank treated, and will not constrict the bank full cross-sectional area of the stream channel through this habitat.

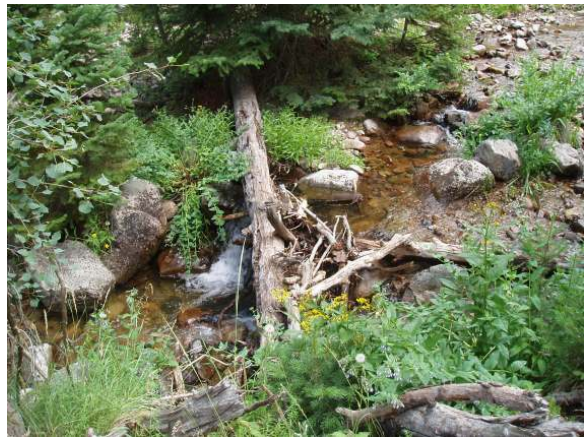
Photo 21 - P21 From the Right Bank

Pool 21 is immediately downstream of the ATV trail crossing, and corresponds to pool 5 in the BWSHI survey. The pool is formed by a debris jam of large wood and boulder (Photo 21), and appears to be one of the most significant barriers to fish passage within the reach, due to very limited pool depth and a hydraulic jump of greater than 1.5 ft. The large wood forming this habitat feature will be removed and replaced by a boulder cross-vane structure to stabilize the vertical profile of the stream channel at the road crossing. This potential barrier will be minimized by deepening and enlarging the plunge pool at this location to allow trout to obtain the necessary burst speed to pass the hydraulic jump at low flow. Armor will be removed to create a pool with a maximum depth of 2 feet below the bank full stage and a RPD of 1.2 to 1.4 ft.

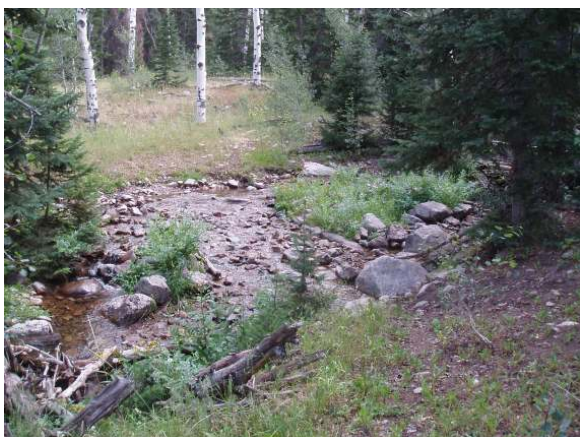
Photo 22 - Rd X-ing Upstream of P21

The trail crossing (Rd X-ing) corresponds to riffle 6 in the BWSHI survey, and is characterized by an over wide channel with multiple braiding and shallow depth (Photo 22). The stream throughout this feature will be narrowed to a single thread using large wood to define the stream banks, and the approach to the

crossing will be hardened using cobble available from sources nearby the stream. The current channel width of >12 ft will be narrowed to 8 ft, slightly wider than the natural average width of undisturbed riffles in the reach. four pieces of large wood will need to be harvested from the forest nearby to do this work.

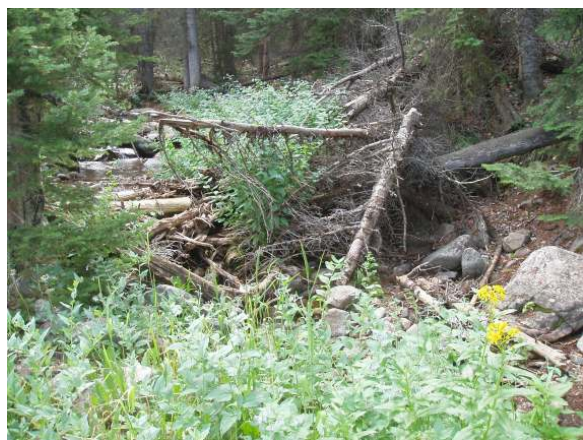
Photo 23 - NP7 Looking Upstream

New Pool Site 7 (NP7, Photo 23) is located within the riffle 7 habitat unit described in the BWSHI survey, where a large woody debris jam has caused the stream to abandon the original channel and cut a new channel through the riparian vegetation on the left bank. Work at this site will include removing the debris jam and re-establishing the stream in the old channel. Large wood within the debris jam will be used to construct a double log cross-vane structure and new pool at this point along the stream channel.

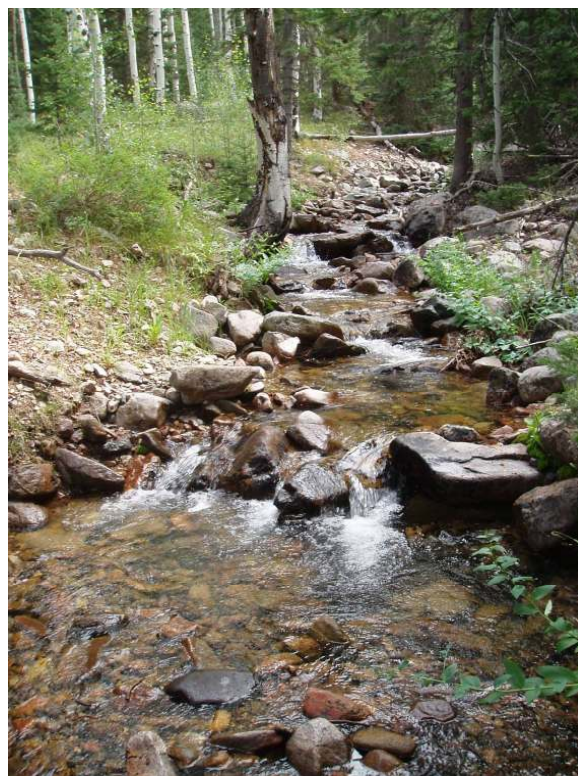
Photo 24 - P22, P 23, & P24 Step-Pools

Pools 22, 23 and 24 are a closely spaced step-pool feature within a relatively steep channel segment (Photo 24), and correspond to pool 8 and pocket water features in riffle 9 in the BWSHI survey. This segment may be accessed using the Access 5 route on the northwest side of the stream. The existing pool and the pocket water features will be deepened to approximately 1.5 ft by removing large cobble from the bed of the stream in these features.

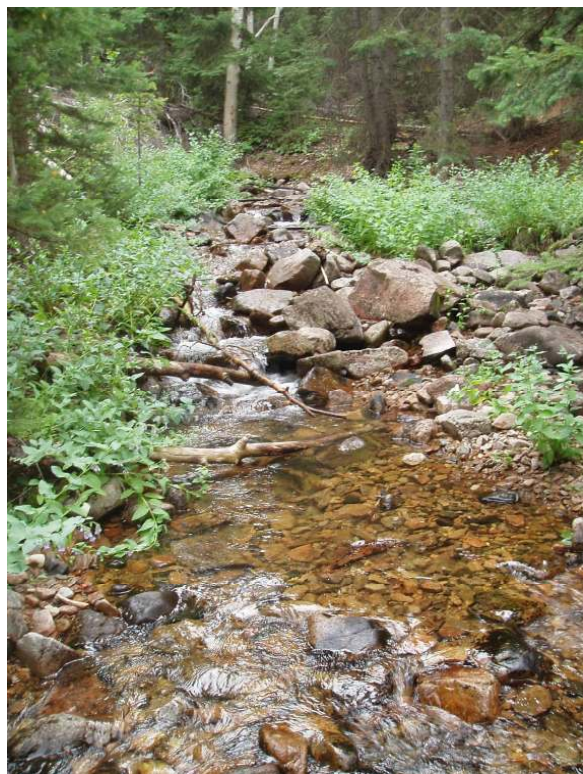
Photo 25 - NP8 Looking Upstream

Pools at sites P25, P26 and P27 are not accessible by equipment, and will not be treated under this project. The new pool site at NP8 (Photo 25) may be approached from the southeast side of the creek following the Access 6 route. A boulder plunge pool will be created here using large boulders from the riffle immediately upstream to create a cross-vane. Cobble armoring the channel within the habitat will be removed to achieve an RPD of >1.0 ft and a maximum depth of 1.5 - 2.0 ft.

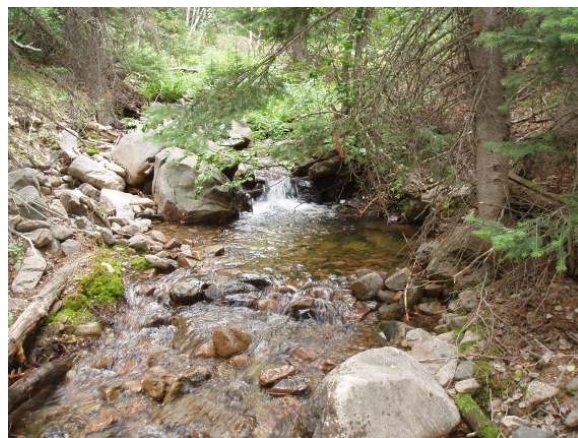
Photo 26 - Plunge Pool

The existing pool at site P29 (Photo 26) corresponds to pool 10 in the BWSHI survey, and exhibits some of the best pool habitat and cover of any pool in Reach 2. Nearly 1/4 of the wetted perimeter of this feature contains some form of cover for trout, with a maximum depth exceeding 1.8 ft and a RPD of 1.3 ft. This habitat will not be altered under this project, and will, in fact, be used as a reference to compare enhancements in the reach.

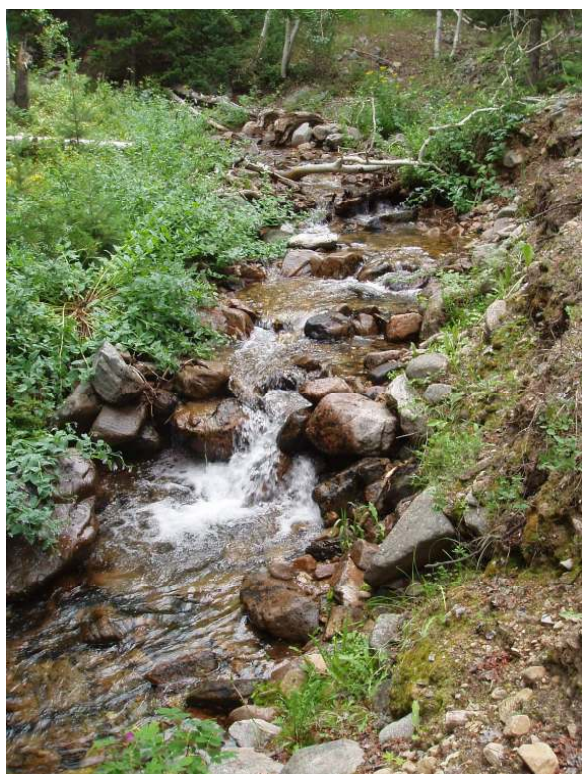
Photo 27 - NP9 Looking Upstream

New Pool site 9 (NP9) will convert a small pocket within a higher gradient pocket water riffle to a full channel boulder plunge pool by reconfiguring boulder within the channel to create a cross vane feature. Additionally, the forty feet of unstable right stream bank will be treated with large wood to stabilize the toe slope of the bank. The log toe slope structure will require two large trees, harvested from an adjacent area along the access route that is outside the water influence zone, and should not exceed greater than 0.1 yd³ of fill per linear foot of bank treated. The bank stabilization work will not constrict the bank full cross-sectional area of the stream channel through this habitat.

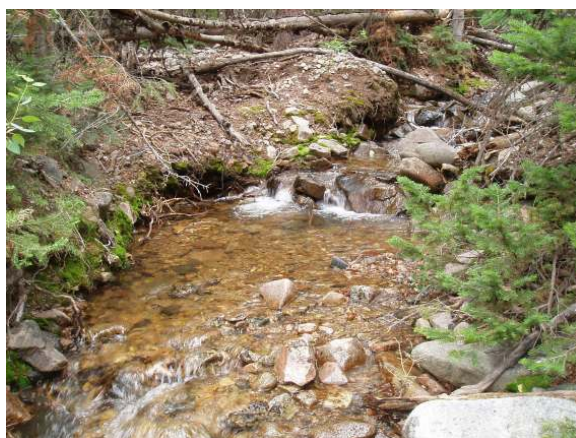
Photo 28 - P30 Looking Upstream

Pool 30 is a very shallow plunge pool feature formed by boulder (P30, Photo 28). This pool currently provides only a small amount of overhead cover for trout, with RPD of 0.8 ft and a maximum depth of 1.0 ft. Armor will be removed from the channel within this habitat feature to create a full channel pool with an RPD of at least 1.0 ft and a maximum depth of 1.5 ft.

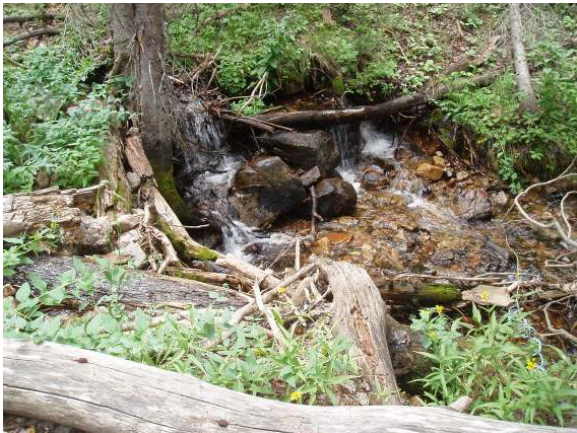
Photo 32 - NP13 From the Left Bank

New Pool site 13 (NP13, Photo 32) may also be accessed via the Access 10 route, and is found 36 ft upstream of Pool 56. The site at NP13 is a natural low-gradient transition along a steep cobble/boulder pocket water dominated riffle. There is a significant hydraulic jump upstream of this feature that may create a barrier to fish passage during low flows. A new cross-vane plunge pool will be constructed at this site, using existing boulders and large wood, to provide additional pool habitat and to allow trout to obtain the necessary burst speed to pass the hydraulic jump at low flow. Armor will be removed to create a pool with a maximum depth of 2 feet below the bank full stage and a RPD of 1.2 to 1.4 ft.

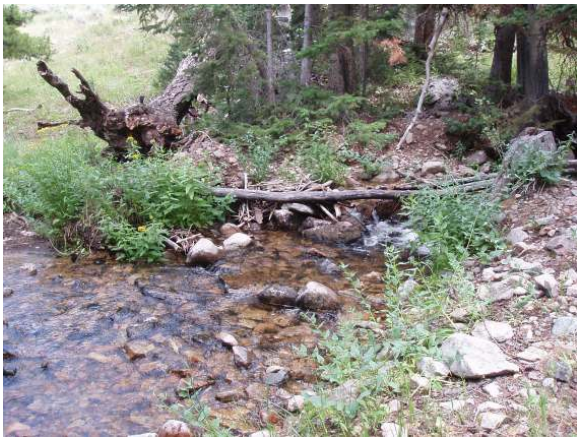
Photo 33 - NP14 Looking Upstream.

New Pool site 14 (NP14, Photo 33) may also be accessed via the Access 9 route, and is found 50 ft upstream of Pool 57. The site at NP14 is a natural low-gradient transition ideally suited for a double log cross-vane structure and new plunge pool. The cross-vane plunge pool will be constructed using existing boulders and large wood adjacent to the site, to provide additional pool habitat. Armor will be removed downstream of the cross-vane to create a pool with a maximum depth of 2 feet below the bank full stage and a RPD of 1.2 to 1.4 ft.

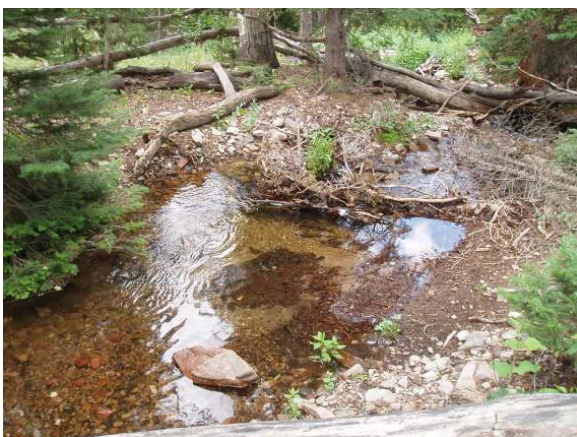
Photo 34 - P58 Looking Downstream

Pool 58 is a shallow debris dam pool located 124 ft upstream of Pool 57 (Photo 35). P58 may be approached from the Secret Meadow using the Access 8 route. Pool 58 is another feature ideally suited for a double log cross vane to increase depth of the dam pool, as well as creating a new plunge pool immediately downstream of the structure. The cross-vane will be constructed using existing boulders and large wood adjacent to the site.

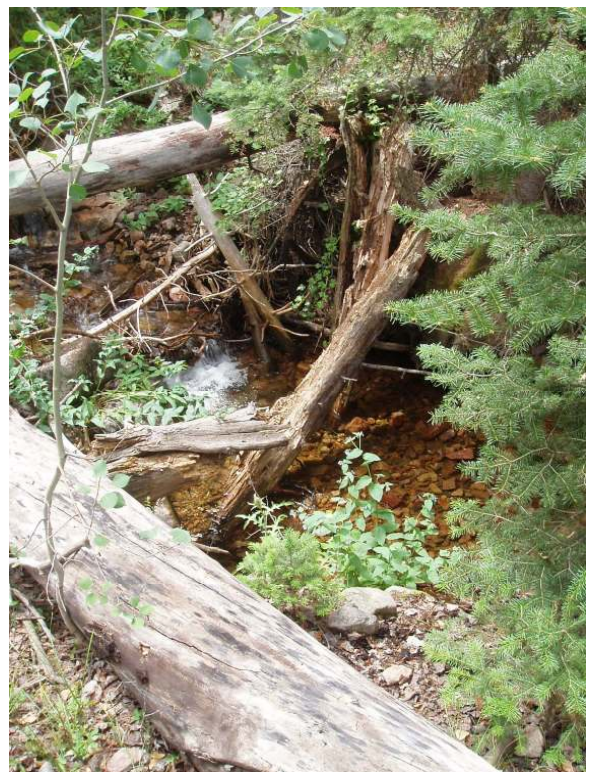
Photo 35 - NP15 Looking Upstream

New Pool site 15 (NP15, Photo 35) may also be accessed via the Access 8 route, and is found 34 ft upstream of Pool 58. A small plunge pool will be constructed at NP15 using existing boulders in the channel. Armor will be removed downstream of the cross-vane to create a pool with a maximum depth of 1.5 feet below the bank full stage and a RPD of >1.0 ft.

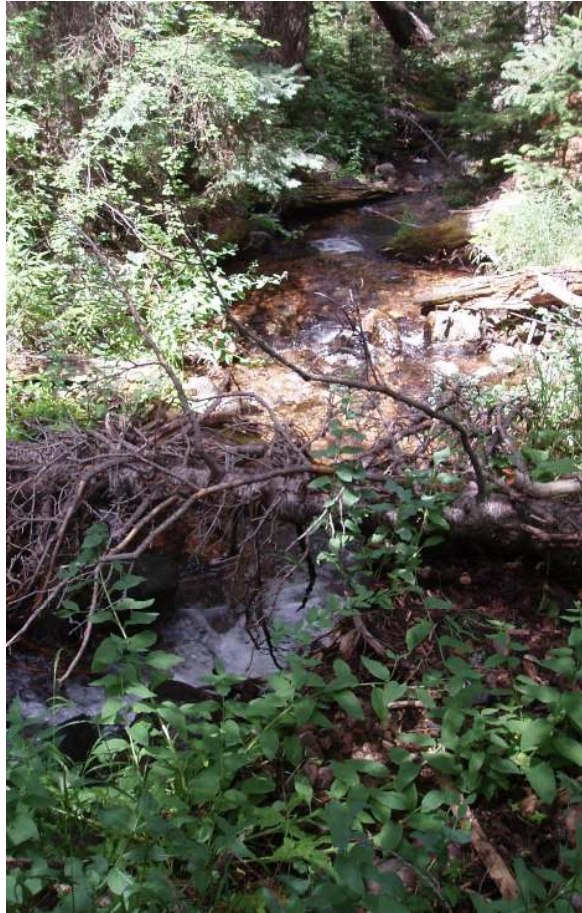
Photo 36 - P59 & P60 Looking Upstream

Pools 59 and 60 (P59 & P60, Photo 36) are shallow plunge pools located 110 ft upstream of Pool 58. These pools can be approached from the Secret Meadow using the Access 8 route. Stream bed cobble will be removed from the channel within these two habitat features to create pools with an RPD of at least 1.0 ft and a maximum depth of 1.5 ft.

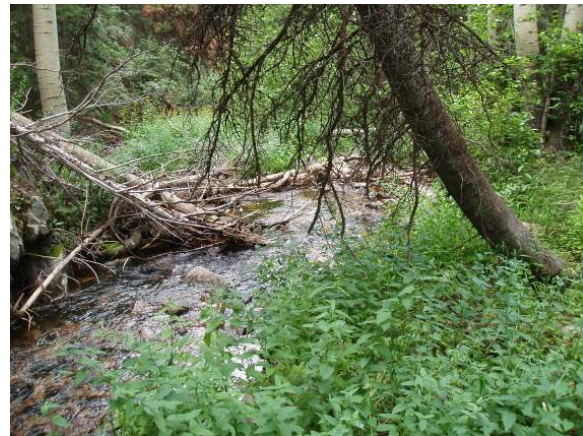
Photo 38 - P65 Looking Downstream

Pool 65 is another shallow debris dam pool (Photo 38). P65 may be approached from the Secret Meadow using the Access 7 route near the upstream boundary of Reach 2. Pool 65 is formed by a large woody debris dam, and may be enhanced using the same technique of small tree cross-felling described above for Pool 62. In addition to adding woody debris to the dam, cobble armor will

be removed from the existing pool substrate to increase with a maximum depth of 1.5 feet below the bank full stage and a RPD of >1.0 ft.
