Aquatic Assessment
&
Habitat Enhancement Plan
Fountain Creek - The Fields Park
City of Manitou Springs
El Paso County - Colorado

FIN-UP Habitat Consultants, Inc.

In February 2008, FIN-UP Habitat Consultants, Inc. was contracted by the City of Manitou Springs to conduct an aquatic habitat analysis and habitat enhancement strategy for a segment of Fountain Creek within The Fields Park, near the eastern limits of the city. The stream within the park is approximately 1,200 feet in length, consisting of a moderately entrenched natural channel flowing through a cottonwood and alder dominated floodplain. An aquatic assessment was conducted within the project area during the 2nd week of May, 2008, and the results of this study are summarized in this document.

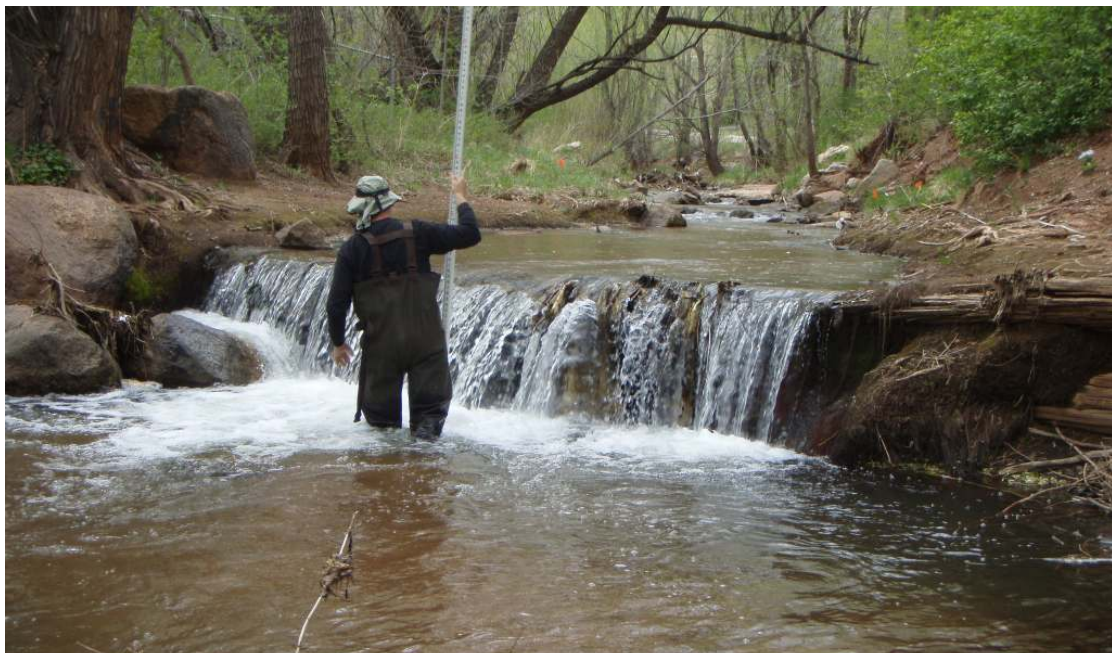
Photo 3: Potential fish barrier on Reach 2 - The Fields Park.

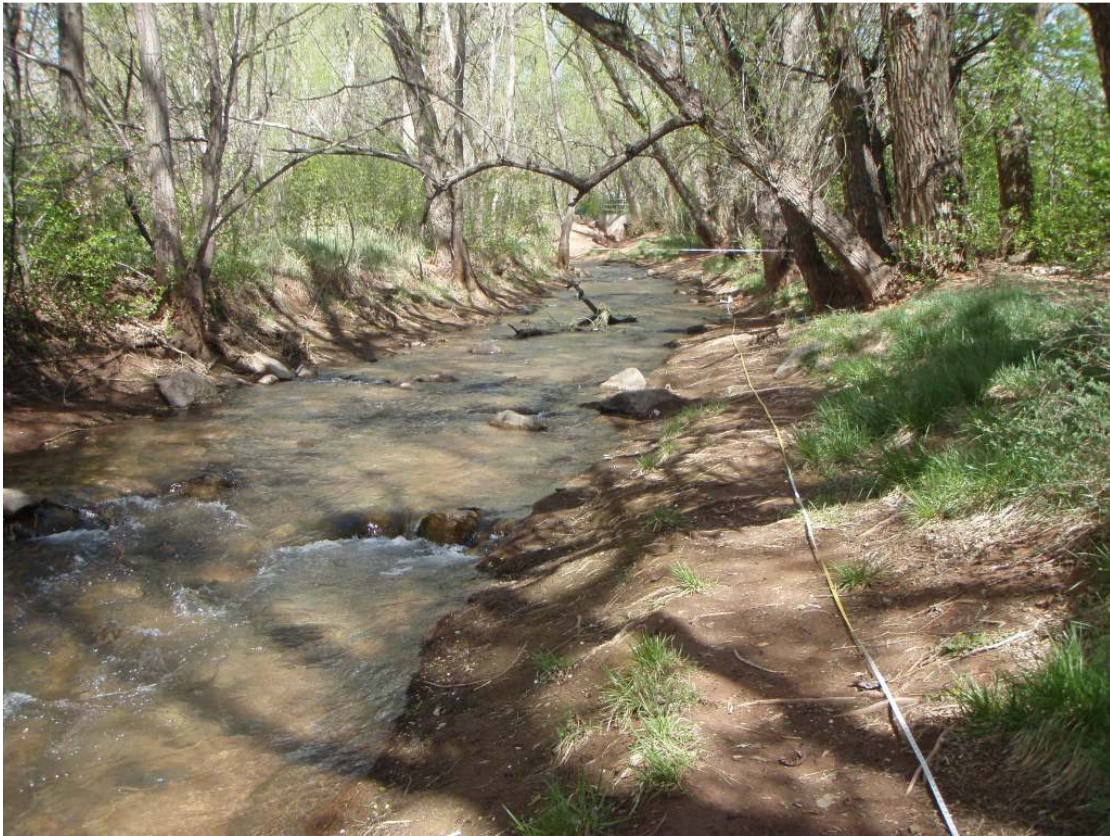
Photo 3: Lower half of The Fields Park project reach, looking upstream.

Pool habitat is somewhat limited in the reach, with trench pools being the most abundant, comprising 15% of the total wetted area of the reach (Chart 2). The trench pools were mostly associated with constrictions in the stream channel created by cottonwood and other tree root systems, and boulders along the stream bank. Dam pools and plunge pools were also observed in the reach, accounting for somewhat less wetted area than the trench pools. One of the plunge pools is principally associated with log-drop structure near the upstream boundary of the reach. This plunge pool consists of a 3 ft drop that may be a barrier to migration of trout through the reach. This structure is beginning to fail, which will result in a new head-cut migrating upstream into Reach 3.

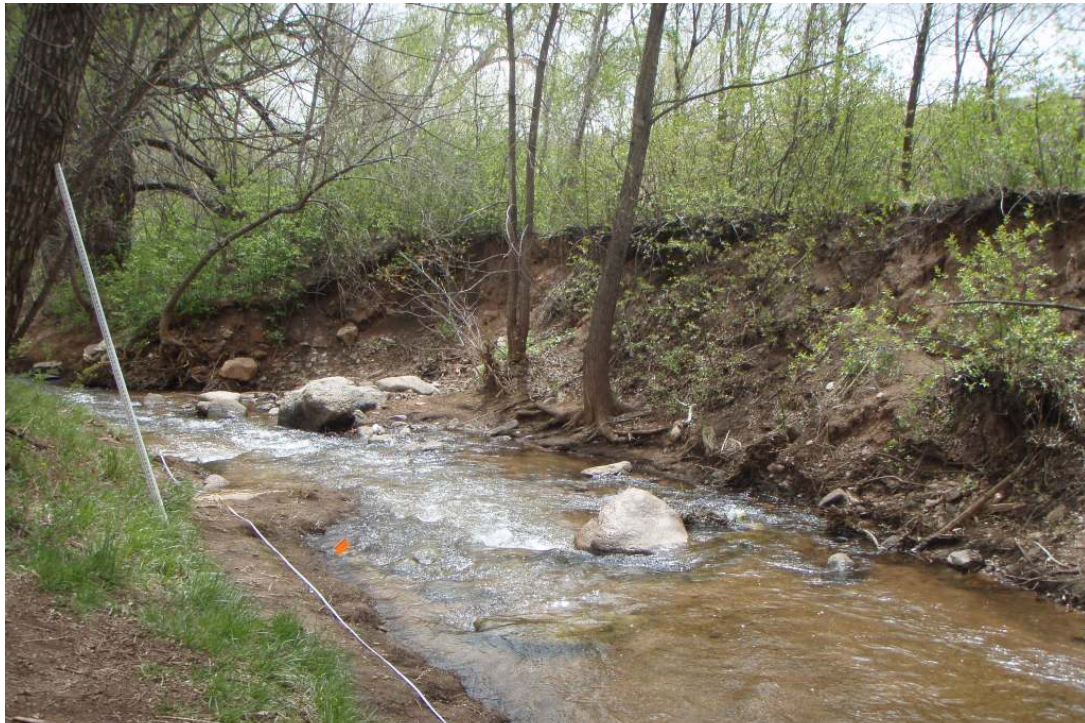
Stream bank stability was generally fair to poor in the reach, depending on vegetation composition degree of recreation use along any particular stream bank. Generally well vegetated stream banks were found on the side of the stream opposite of The Fields Park. Several areas of actively eroding stream banks were observed, particularly along the side of the stream adjacent to the park, and in the upstream half of the reach where the channel is more deeply entrenched. Forty-eight percent of the left bank and 63% of the right bank were found to be stable. The remaining 52% of the left bank and 37% of the right bank were found to be generally unstable and at risk of failure due to high flow shear forces on the banks (Chart 9). Bank rock content in the reach is shown in Chart 10, and consisted principally of gravel and smaller fragments (Type 8). Smaller fragments of less than 1/8"

were the most dominant type, indicating that the stream banks are more susceptible to erosion due to high flows than other reaches already assessed in Manitou Springs.

Photo 5: Eroding Stream Bank near the center of The Fields Park Reach 2.

All forms of cover for adult trout accounted for only 1.4% of Reach 2 (Chart 8). Available cover was significantly less than that observed in Reach 4 (Shryver Park), appears to be a significant limiting factor to the health of the fishery. Creating additional cover will be an important component in the Habitat Enhancement Plan. Instream object cover (Cover Type 2 - >1' deep) was the dominant type observed in the reach, but was limited mostly to the pool habitats. Pool cover (Cover Type 5 - >1.5' deep) was very limited in the reach, and comprised only 1.6% of the wetted area of the pools and 0.5% of the total reach area. Pool cover is an important indicator for determining the available over-wintering capacity of the stream reach, and appeared to be severely limited in this reach. Combination and overhead cover were the least abundant cover types, due to the lack of velocity shelter along the stream bank and limited large wood in the channel. Instream and overhead cover could be enhanced in the riffle habitats by adding structure and velocity shelters along the stream banks with strategically placed boulders and large wood. Pool cover may be increased by improving scour in existing pools as well as creating new pool habitats. Combination cover may be improved throughout the reach through stabilizing and revegetating the eroding stream banks using large wood toe-slope stabilization techniques.

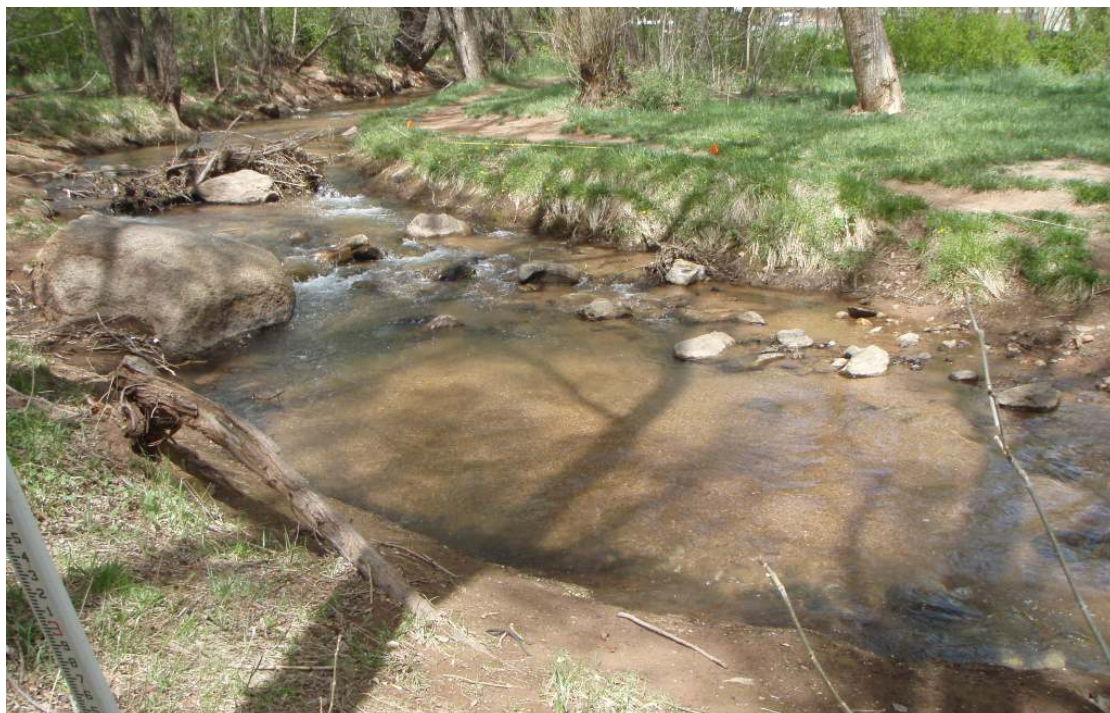
Dam pools and plunge pools comprised 14% of the total wetted area of the reach. All of the pools exhibited some degree of in-filling of sediment, mostly consisting of smaller particles of decomposed granite. The average pool depth in Reach 2 was 0.94 feet. Residual pool depth (RPD) in Reach 2 was found to range from 0.1 to 1.7 feet, with an average of 0.9 foot throughout the reach. It is interesting to note that pool depth and RPD were significantly less than in Reach 4 (Shryver Park), and is likely due to sedimentation impacts from Sutherland Creek. RPD in Reach 2 is considered to be very poor, and may limit adequate over-wintering habitat for salmonids and other native species in this segment of Fountain Creek.

Photo 6: Typical poorly formed pool habitat - The Fields Park Reach 2.

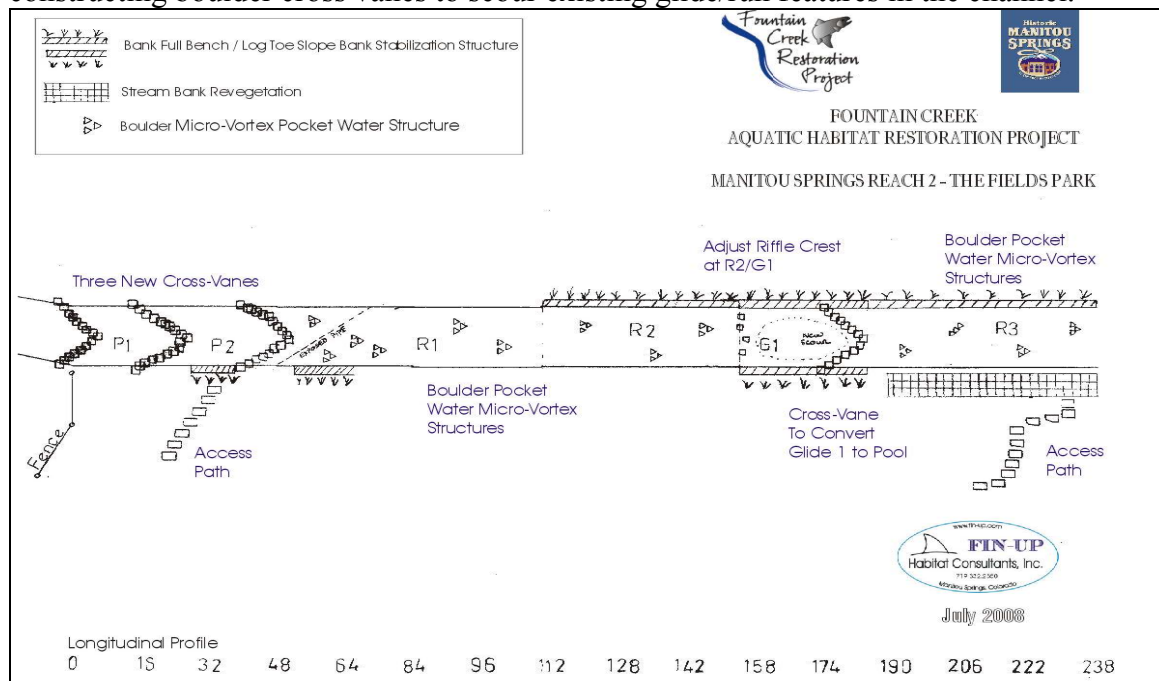
Plan view of Habitat enhancements and bank stabilization from Pool 1 through Riffle 3 of Reach 2 of Fountain Creek within The Fields Park.

Two boulder cross-vanes will be installed at the downstream boundary of the reach, enhancing the existing plunge pools in this location. These cross vanes will also provide enhanced vertical stability in the stream channel. Pocket water cover will be increased within Riffle 1, 2 & 3, using small rock cluster vortex structures. Glide 1 will be converted to a pool by installing a boulder cross-vane near the top of this habitat, improving scour through the feature. 178 feet of stream bank will be stabilized using large wood and/or boulders embedded in the toe of the bank slope to create riparian benches at the bank-full elevation of the stream channel. Willows and sedge mats will be planted along these benches, creating a small riparian floodplain. Additional slope stabilization and re-vegetation will take place above the toe-slope structures, using landscaping timbers and other features to create benches that will capture sediment and run-off from the adjacent park areas. 48 ft of stream bank will be re-vegetated without toe-slope stabilization. Stabilized slopes will be covered with biodegradable geo-textile fabric and planted with native willow, sedge and upland grasses. A minimum of two access paths will be constructed leading to the creek in this segment.

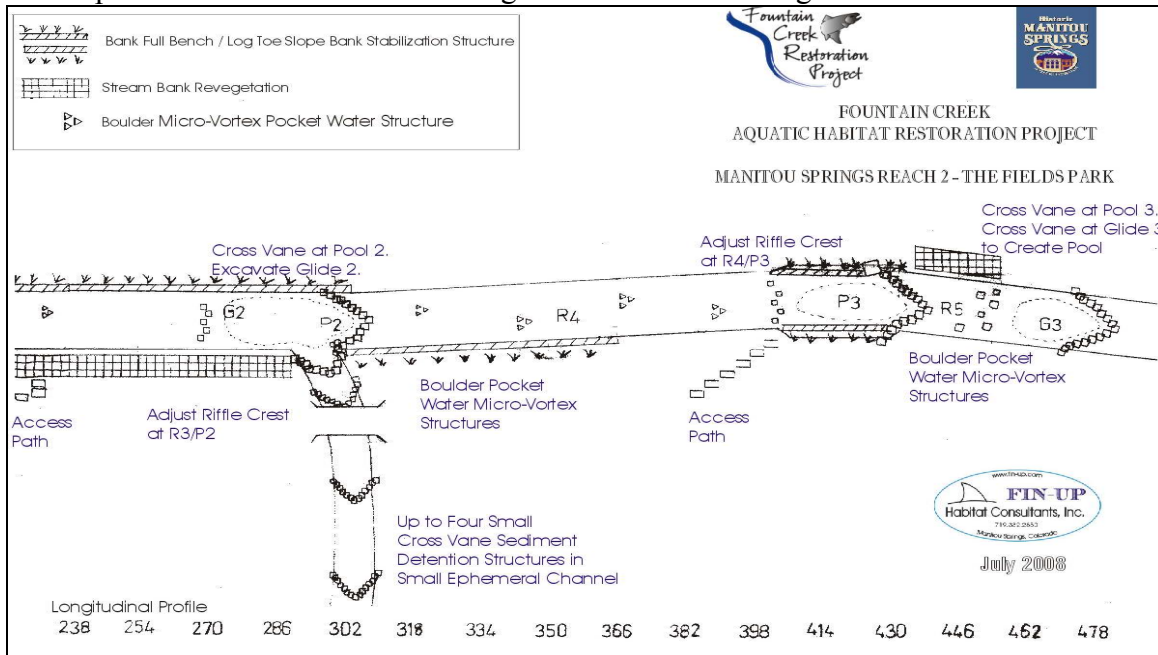
Plan view of Habitat enhancements and bank stabilization from Glide 2 through Glide 3 of Reach 2 of Fountain Creek within The Fields Park.

Glide 2 has formed due to the in-filling of sediment in Pool 2, and will be excavated, with spoils removed completely from the site. A cross-vane will be constructed at Pool 2 to improve scour through the feature. Additionally, up to four small sediment detention structures will be constructed on the small tributary channel adjacent to Pool 2 to reduce sediment inputs from this channel. Small boulder will be used to slightly raise the riffle crest of Pool 2, further enhancing the RPD.

The elevations of existing boulders in the channel in Riffle 4 & 5 will be adjusted to produce more effective pocket water and velocity shelter. Excess accumulated sediment will be excavated from Pool 3, and a small cross vane will be installed. Glide 3 will be converted to a pool habitat through construction of a boulder cross vane and excavation.

130 feet of stream bank will be stabilized using large wood and/or boulders embedded in the toe of the bank slope to create riparian benches at the bank-full elevation of the stream channel. Willows and sedge mats will be planted along these benches, creating a small riparian floodplain. 95 ft of stream bank will be re-vegetated without toe-slope stabilization. Stabilized slopes will be covered with biodegradable geo-textile fabric and planted with native willow, sedge and upland grasses. A minimum of two access paths will be constructed leading to the creek in this segment.

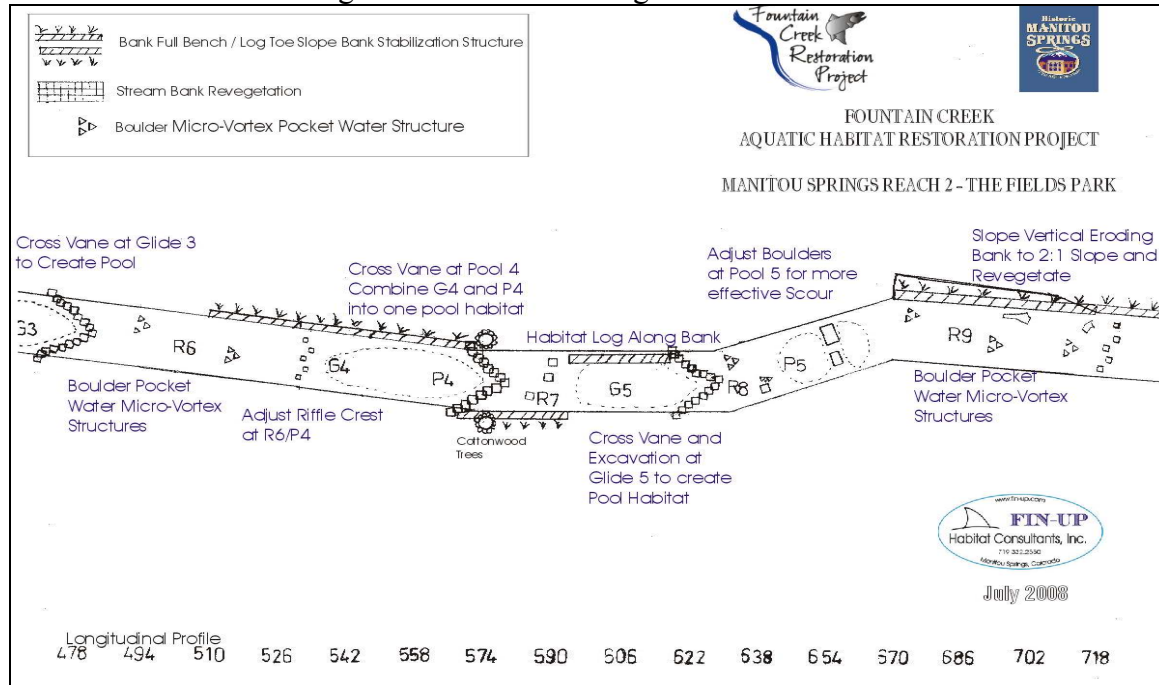
Plan view of Habitat enhancements and bank stabilization from Glide 3 through Riffle 9 of Reach 2 of Fountain Creek within The Fields Park.

Glide 4 suffers from similar sedimentation effects as Glide 2, and has formed due to the in-filling of sediment in Pool 4. This feature will be excavated, with spoils removed completely from the site. A cross-vane will be constructed at the transition of Pool 4 and Riffle 7 to improve scour through the pool. Glide 5 will be converted to a pool by installing a boulder cross-vane near the top of this habitat and by raising existing boulders at the riffle crest between Riffle 7 and Glide 5. Additionally, a habitat cover tree may be anchored to the left (south) stream bank along the new pool created at Glide 5.

New small boulder clusters will be installed, and existing boulders in the channel in Riffle 6, 7, 8, & 9 will be adjusted to produce more effective pocket water and velocity shelter. A minor adjustment to the existing boulders forming Pool 5 may be made to improve this habitat.

120 feet of stream bank will be stabilized using large wood and/or boulders embedded in the toe of the bank slope to create riparian benches at the bank-full elevation of the stream channel. Willows and sedge mats will be planted along these benches, creating a small riparian floodplain. Additional access paths will be constructed leading to the creek in this segment.

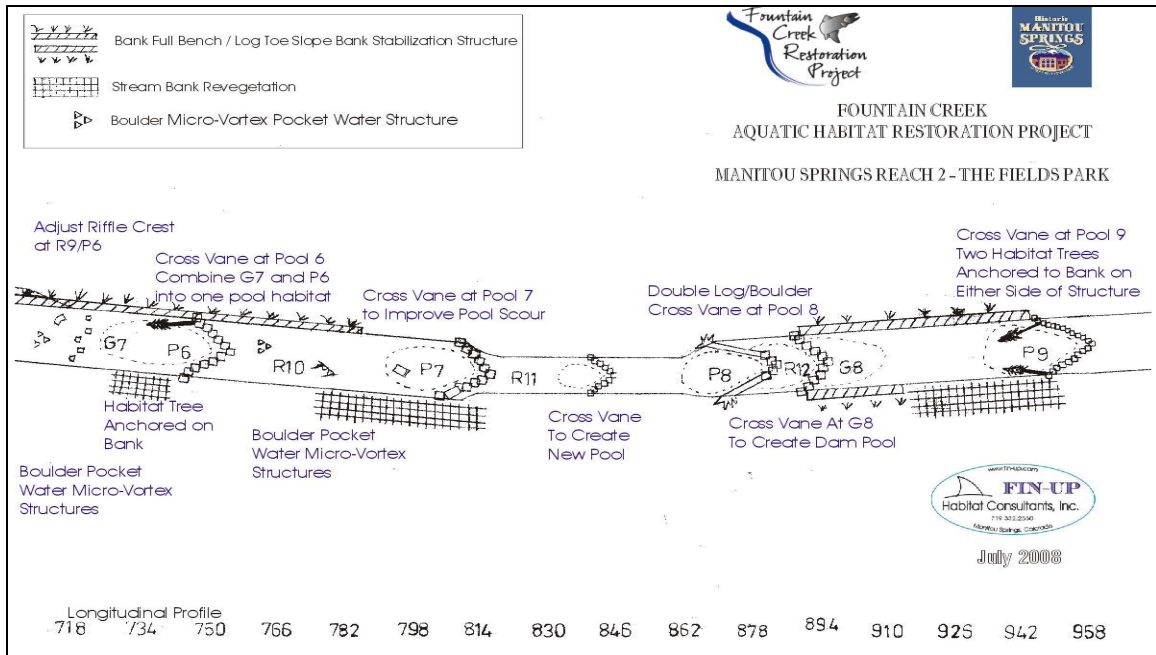
Plan view of Habitat enhancements and bank stabilization from Riffle 9 through Pool 9 of Reach 2 of Fountain Creek within The Fields Park.

Glide 7 has formed due to the in-filling of sediment in Pool 6. This feature will be excavated, with spoils removed completely from the site. A cross-vane will be constructed at the transition of Pool 6 and Riffle 10 to improve scour through the pool. The riffle crest at the transition of Riffle 9 and Glide 7 will be adjusted to improve residual pool depth and cover. Additionally, a habitat cover tree may be anchored to the left (south) stream bank. Scour in Pool 7 will be enhanced by installing a boulder cross vane immediately upstream. A new pool will be created within the existing Riffle 11 by installing a small boulder cross vane. A double log/boulder cross vane will be installed at Pool 8 to improve scour and depth. The logs will be anchored using Manta-Ray MR-1 or equivalent dead-man anchors. A boulder cross vane will be installed at the transition of Riffle 12 and Glide 8 to create a dam pool habitat in the existing glide. Pool 9 will be enhanced by installing a boulder cross vane to improve scour, and two habitat trees anchored to the structure and extending into the pool to provide cover and velocity shelter.

New small boulder clusters will be installed, and existing boulders in the channel in Riffle 9 and 10 will be adjusted to produce more effective pocket water and velocity shelter. 155 feet of stream bank will be stabilized using large wood and/or boulders embedded in the toe of the bank slope to create riparian benches at the bank-full elevation of the stream channel. Willows and sedge mats will be planted along these benches, creating a small riparian floodplain. 85 ft of stream bank will be re-vegetated without toe-slope stabilization. Stabilized slopes will be covered with biodegradable geo-textile fabric and planted with native willow, sedge and upland grasses.

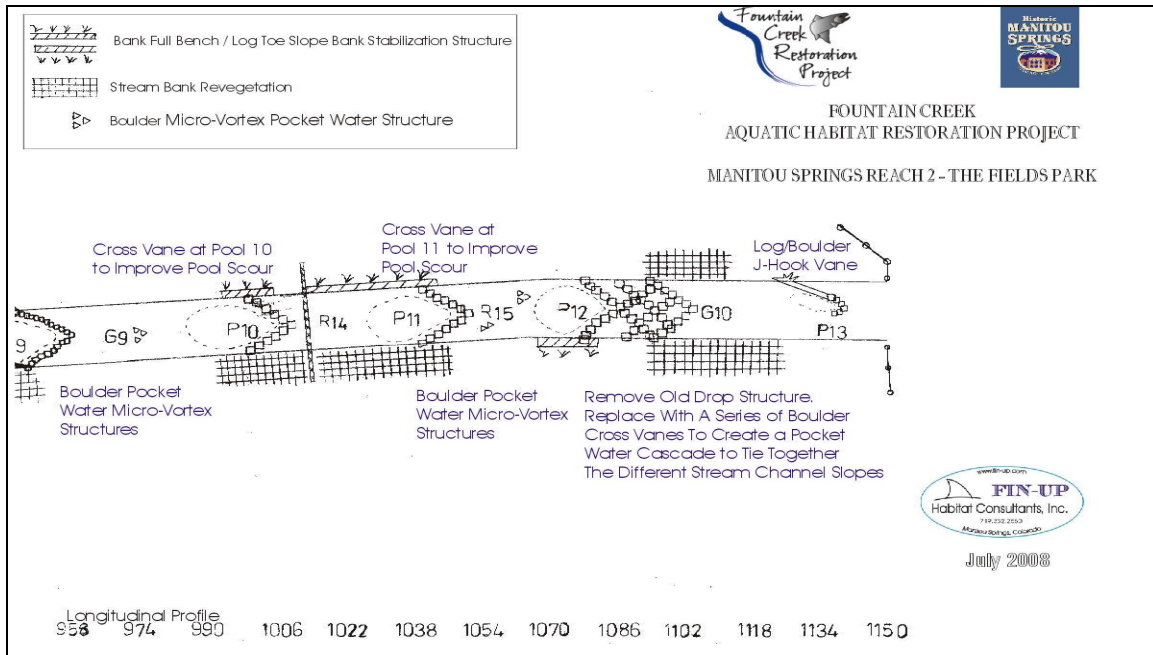
Plan view of Habitat enhancements and bank stabilization from Pool 9 through the end of Reach 2 of Fountain Creek within The Fields Park.

Scour and pool depth will be improved in Pool 10 and Pool 11 through the installation of boulder cross vanes immediately upstream of these habitats. The existing log drop structure at Pool 12 will be removed, and replaced with a series of boulder cross vanes that will create a short pocket water cascade habitat to allow for fish passage and control any potential for a head-cut developing upstream of this feature. Care will need to be taken to assure that sediment in storage upstream of the existing log drop structure is not released downstream. A log/boulder J-Hook structure will be installed along the left bank of Pool 13 at the upstream boundary of the reach.

New small boulder clusters will be installed in Glide 9 and Riffle 15 to produce more effective pocket water and velocity shelter. 60 feet of stream bank will be stabilized using large wood and/or boulders embedded in the toe of the bank slope to create riparian benches at the bank-full elevation of the stream channel. Willows and sedge mats will be planted along these benches, creating a small riparian floodplain. 125 ft of stream bank will be re-vegetated without toe-slope stabilization. Stabilized slopes will be covered with biodegradable geo-textile fabric and planted with native willow, sedge and upland grasses.
