Aquatic Assessment & Habitat Enhancement Plan
The South Platte River
Lake George Company
Park County - Colorado

FIN-UP Habitat Consultants, Inc.

J. Peter Gallagher
220 Illinois Ave
Manitou Springs, CO 80829
(719) 685-9768 (Office)
(719) 332-2550 (Cell)
pete@fin-up.com
January, 2009

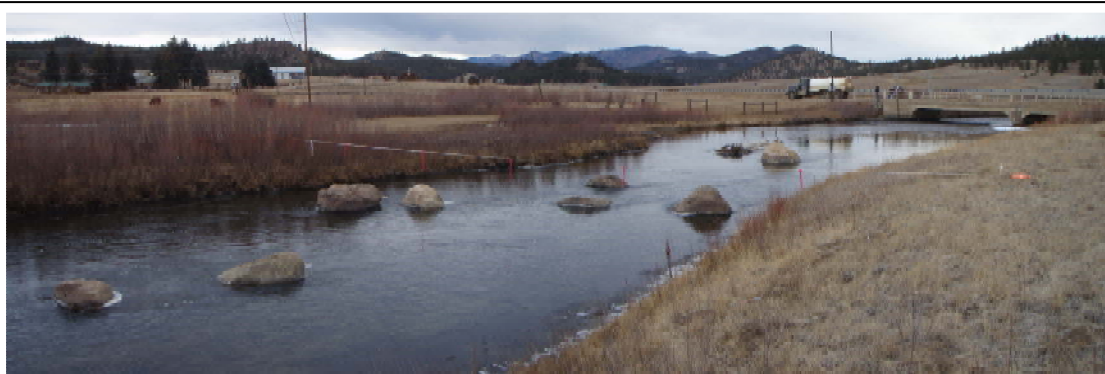
Photo 1: Typical Random Boulder Cluster Structure in Reach 1, South Platte River.

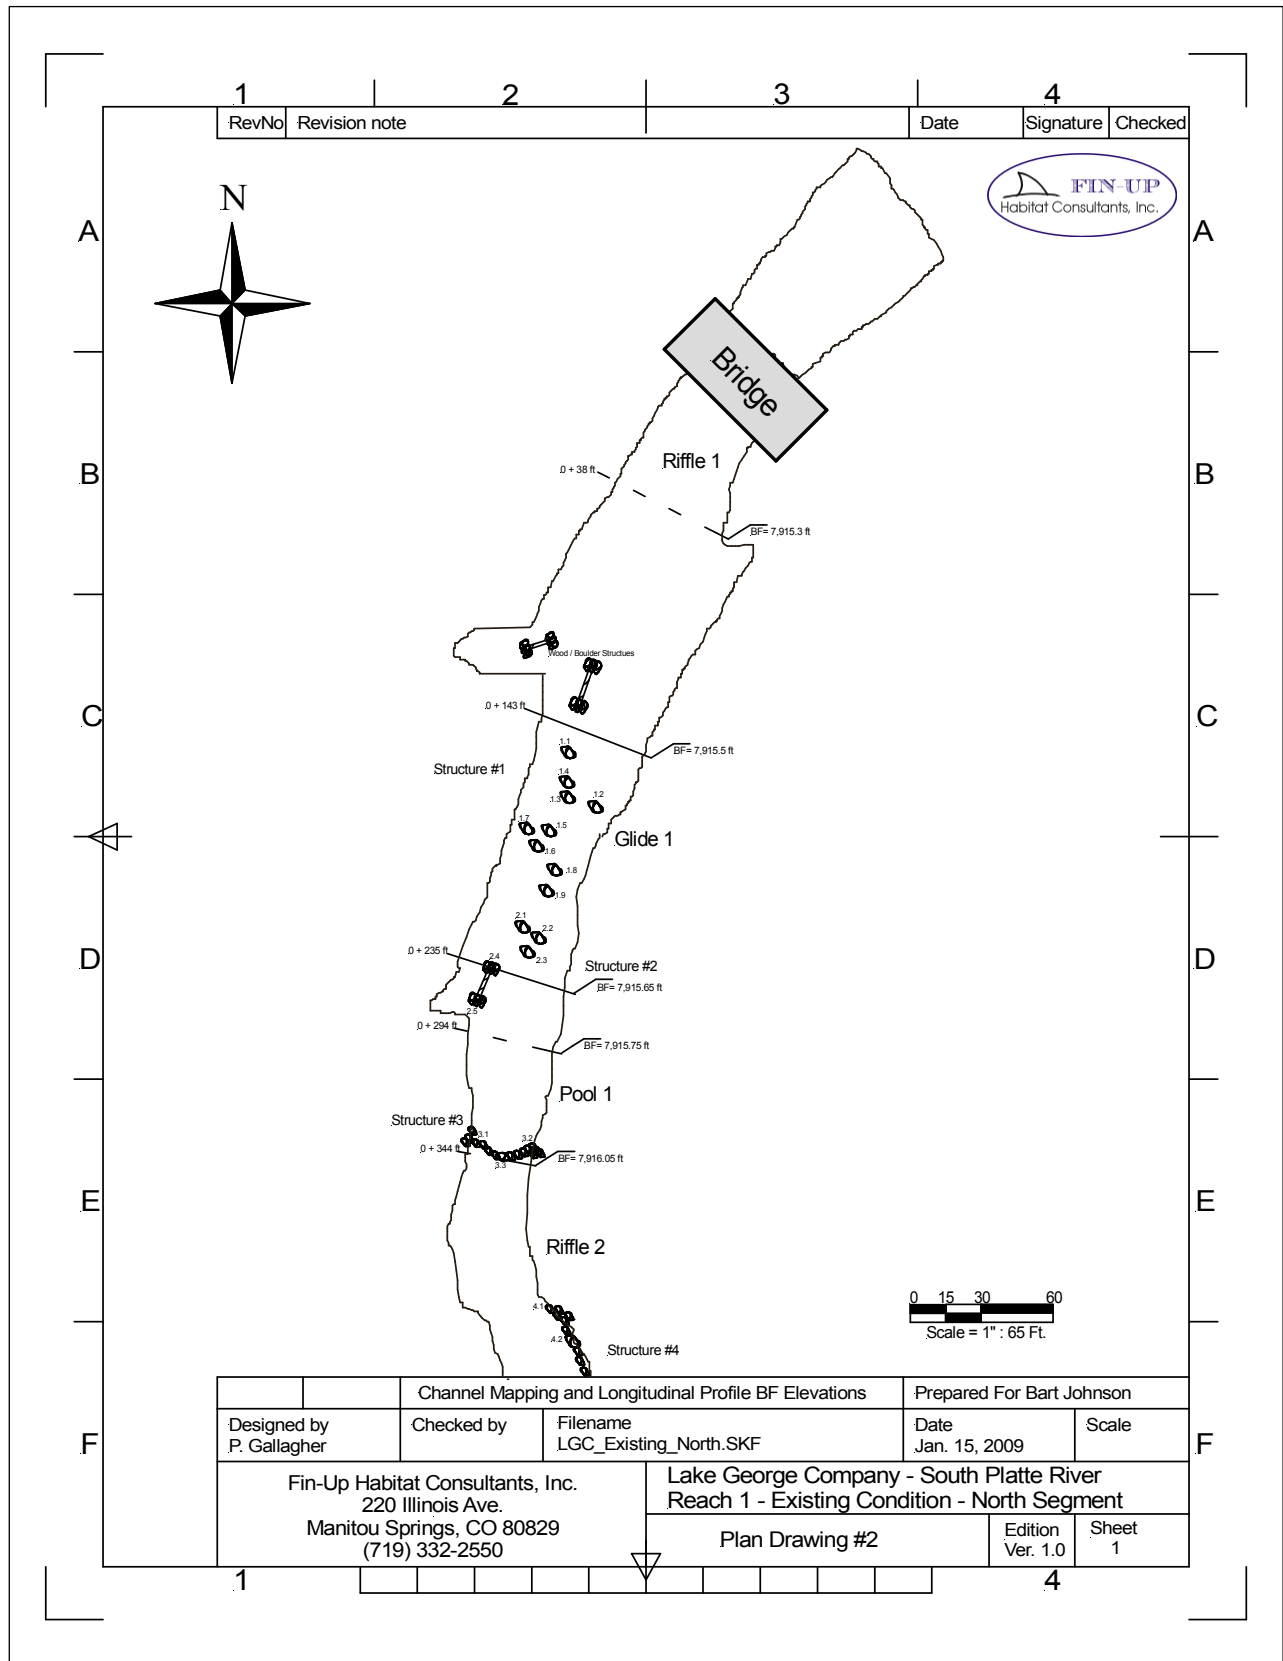
Drawing #2: Reach 1 Existing Condition – North Segment.

This structure consists of two pieces of large wood and twelve boulders placed in the center of the stream channel in Glide #1 and near the confluence with the lake outflow channel. The estimated fill below the bank full elevation of these structures is 14yd³. Both structures are aligned parallel to the direction of flow, and provide little, if any velocity shelter. Sediment has accumulated under the logs, and they no longer provide cover for trout.

This structure consists of eleven large boulders randomly placed throughout the middle of Glide #1. The estimated fill below the bank full elevation of these structures is 17yd³. Nine of the boulders were surveyed to determine elevation, with one boulder found to be at precisely bank full stage, and the others ranging from 0.1 to 1.75 feet higher than bank full. See Table 3 and 4 in the Appendix for individual boulder elevations in the project reach. While stream bank stability and riparian composition is relatively good on both banks along Glide #1, these boulders can be expected to exert pressure on the river banks during high flows, and may result in gradual over-widening of the channel through this habitat. Some sediment deposition behind the boulders is becoming evident, as is lateral channel scour on either side of these features.

This structure consists of three large boulders placed in a cluster near the upstream boundary of Glide #1. Additionally, a log/boulder cluster consisting of a small log and three boulders has been installed adjacent to a small back-water area along left bank. The estimated fill below the bank full elevation of these structures is 7yd³. Six of the boulders were surveyed to determine elevation. Three boulders were found to be higher than the bank full elevation, ranging from 1.1 to 1.45 feet above bank full. The boulder cluster in Structure #2 exhibits similar scour patterns, sedimentation effects and risk factors as Structure #1. The log/boulder structure has filled in with sediment, and should probably be removed.

The three existing log/boulder structures in this glide are not providing effective cover and velocity shelter for trout, and should be removed. To enhance large wood recruitment in this segment, we recommend installing two habitat trees on either side of the channel upstream of the riffle crest defining the transition between Riffle #1 and Glide#1. The habitat trees should be whole trees, with the root ball and as many branches as is practical still attached. Ideally, the trees will be ponderosa pine, approximately 30 – 40 ft long, with a basal diameter (DBH) of 18-24". The trees should be placed in the channel with the root-ball embedded into the river bank, and extending upstream at an angle not to exceed 30° off of the stream bank. The elevation of the tree, where it meets the river bank, should not exceed the bank full stage of the channel at this point. Habitat trees are typically anchored near the root ball and at the end of the tree with large flat

The existing boulders in Structure #1 and Structure #2 may be used to anchor the habitat trees, riparian bank full benches, and to construct the log/boulder J-hook vane. The remaining boulders should be reconfigured into small micro-vortex in-channel object cover clusters. The elevations of these boulders should be varied so as to look more natural in the river, however, none should exceed $\geq \frac{1}{2}$ of the bank full elevation of the river channel. Additionally, when possible, the top facet of each boulder should be tilted downstream between 5° and 20° to improve scour function in this habitat feature. No additional boulders are expected to be necessary in order to complete the work in this segment of the channel.

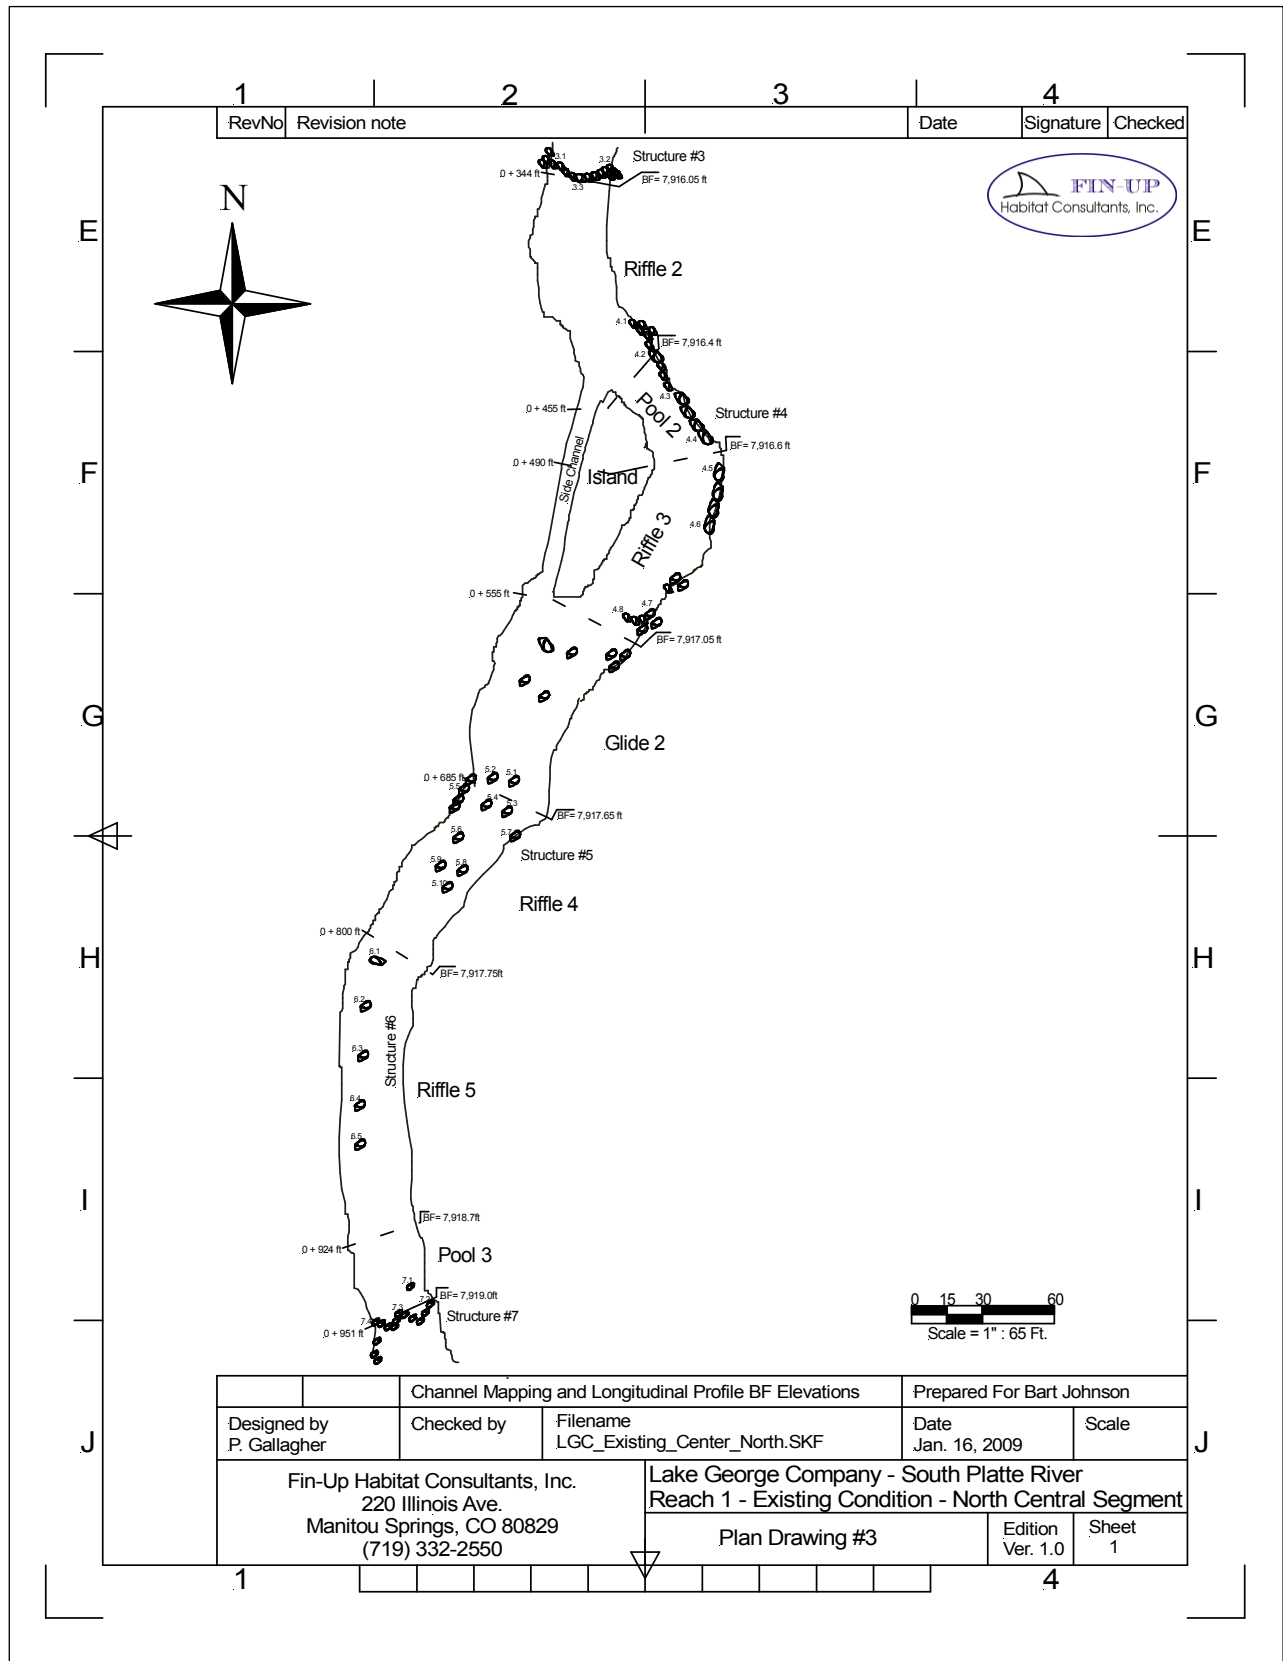
Drawing #3: Reach 1 Existing Condition – North Central Segment.

Structure #3 consists of an inverted “V” boulder cross-vane, spanning the entire bank full channel width, near the upstream boundary of Pool #1. The structure consists of fifteen boulders, with an estimated fill below the bank full elevation of 12yd³. Boulders at each edge of the bank full channel, and the lowest boulder in the center (thalweg) of the structure were surveyed to determine elevation. The center of the structure was close to the optimal ½ bank full elevation (+0.25 ft), however the boulders where the structure ties into the river bank ranged from 0.85 to 1.73 feet higher than bank full. The structure was constructed without any footing boulders, and is likely at risk for failure in the center, due to scouring of fine grained substrates under the center boulder. Vane/bank angle of the structure is greater than 45° on both banks, increasing the risk of bank failure and channel widening downstream of the structure. Stream bank stability and riparian composition is relatively good on both banks; however, some lateral migration and bank failure can be expected during high flows, due to the high elevation of boulders on the bank and inadequate anchoring of the structure into the banks.

This structure consists of approximately 100 feet of stream bank boulder revetment, with one boulder groin/vane extending into the river channel near the upstream boundary of the structure. There are twenty-nine large boulders in the structure, with an estimated fill below the bank full elevation of 31yd³. The fill/foot of stream bank is estimated to be 0.21 yd³/feet. Seven boulders were surveyed at intervals along the bank to determine elevation. Additionally, the lowest boulder in the groin/vane was surveyed to determine elevation related to ½ bank full. All of the bank-side boulders were found to be higher than the bank full elevation, ranging from 0.68 to 3.15 feet above bank full. The groin/vane boulder was found to be 1 foot higher than optimal. The boulders forming the stream bank revetment are not tightly placed together, and the river has begun to erode the bank within the gaps. Stream bank stability and riparian composition is relatively poor along this bank, and further erosion and bank failure can be expected in this segment.

This structure consists of thirteen large boulders randomly placed throughout the middle of Riffle #4. The estimated fill below the bank full elevation of these boulders is 17yd³. Ten of the boulders were surveyed to determine elevation. Six boulders were found to be

higher than bank full, ranging from 0.13 to 1.71 feet above the bank full elevation in this riffle. Although four of the boulders were found to be below the bank full stage, none were at the optimal elevation for this structure type. Stream bank stability and riparian composition is less than ideal along the west bank within Riffle #4, due to an unrehabilitated access route and the proximity with a road accessing the lower lake. The boulders in Structure #5 will likely exert additional shear on this stream bank, and may result in gradual over-widening of the channel through this habitat. Some sediment deposition behind the boulders is becoming evident, as is lateral channel scour on either side of these features.

Structure #3 should be reconstructed so that the vanes extend from the stream bank at no greater than 30°. It is recommended that footer boulders be added throughout the structure, and that a low footer inverse “V” be added to the center of the structure for increased stability. The vanes should be anchored at least five feet into the stream bank, and should not exceed BF (7,916.05ft at this point). The center of the structure should be set no higher than (7,914.35ft). An additional 6yd³ of boulders may be necessary to properly reconfigure this structure, and likely will be brought down from Structure #4.

Structure #4 will be reconfigured using riparian benches with log toe slope stabilization, complimented by a series of boulder vanes and boulder J-hook vanes to reduce shear on this relatively tight meander bend in the river. The log toe-slope features should be placed so that the top edge of the tree does not exceed the bank full elevation of the channel. The natural bend of the log should be utilized so as to create an under-cut stream bank effect to provide additional cover and velocity shelter. Existing boulders will be used to build one new small boulder vane at 0+455ft, and three new boulder J-vanes at approximately 0+480ft, 0+510ft, and 0+555ft along the right bank of the river. Boulder vanes and J-hook vanes will be constructed according to the plan and profile drawings found in the Appendix, and should not exceed BF at the point were they tie into the river bank, or $\frac{1}{2}$ of the BF stage at the in channel end of each structure.

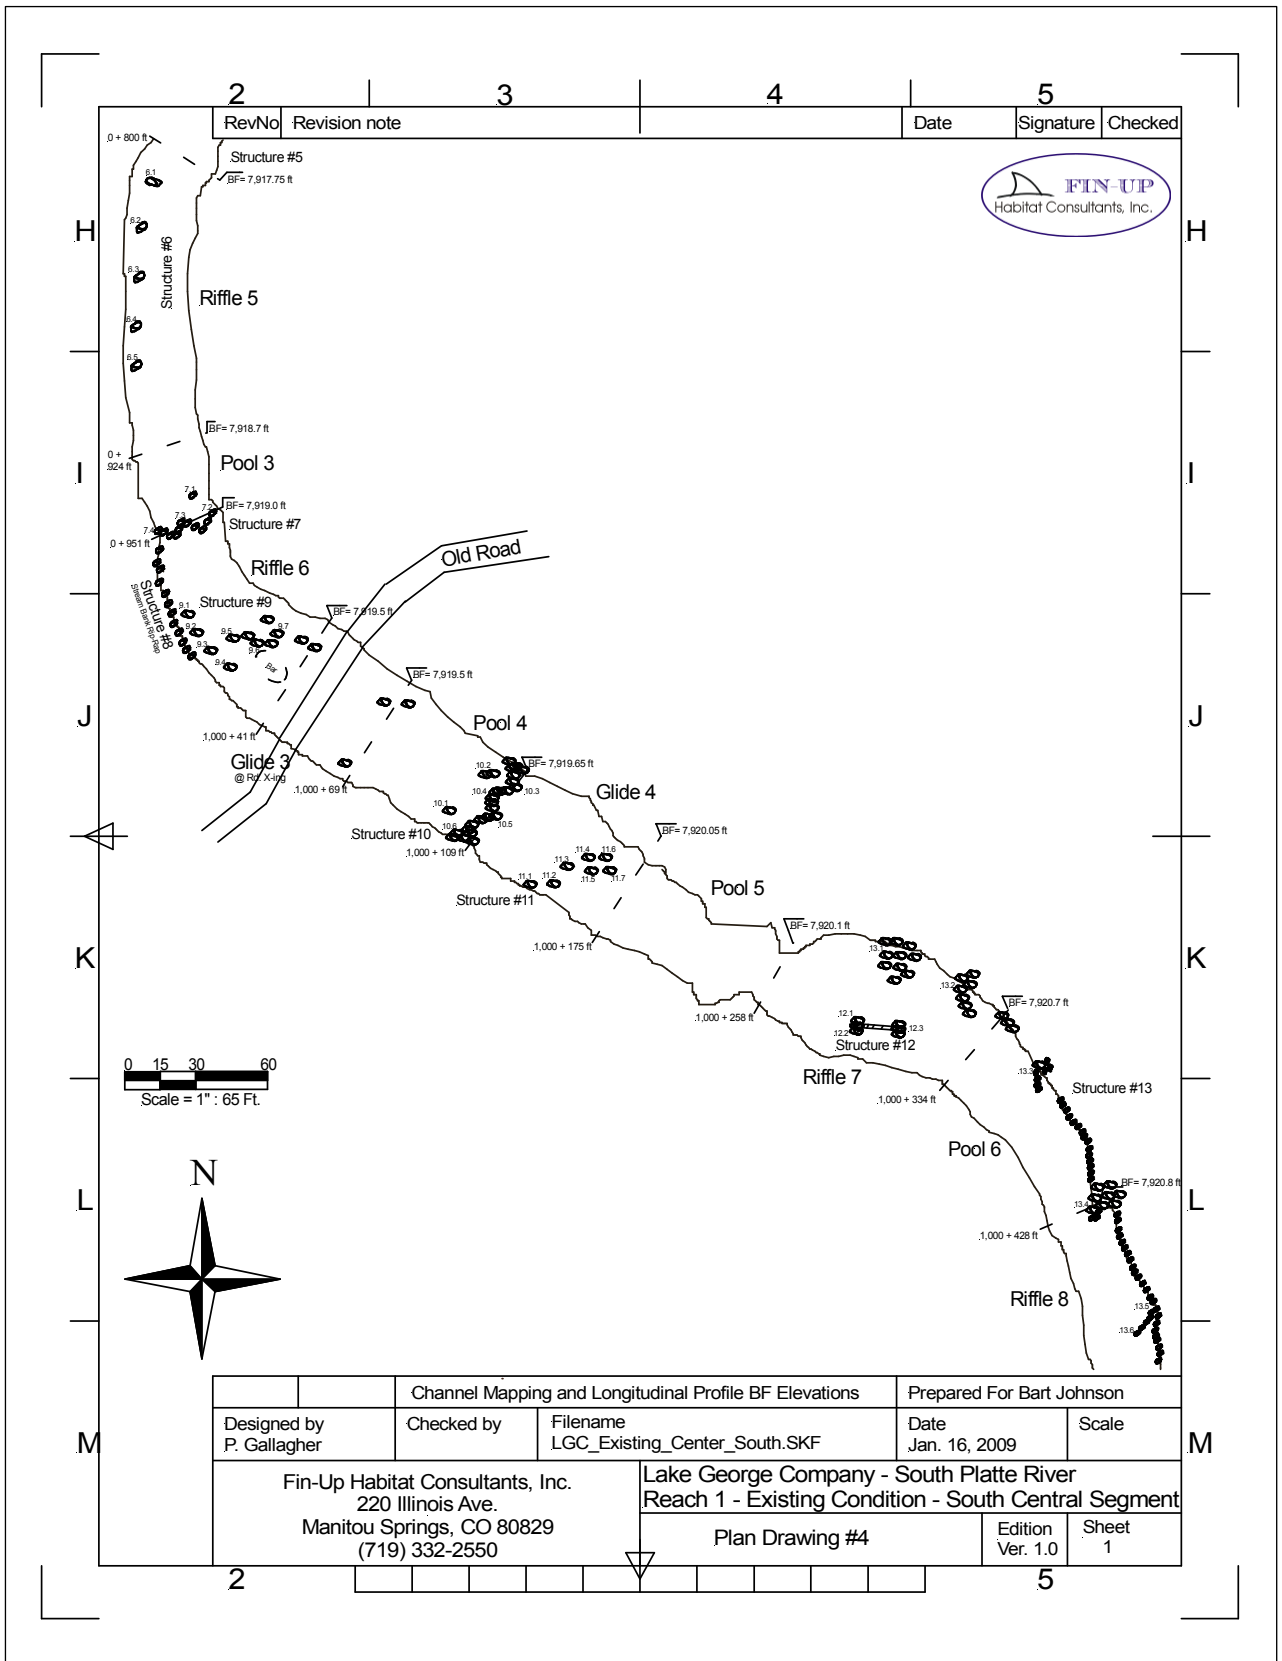
Drawing #4: Reach 1 Existing Condition – South Central Segment.

Structure #6 is another series of randomly placed boulders within Riffle #5. The structure consists of 6 very large boulders placed in a line approximately 10 feet out from the left (west) bank. The estimated fill below the bank full elevation of these boulders is 12yd³. Five boulders were found to be higher than bank full, ranging from 0.4 to 1.7 feet above the bank full elevation in this riffle. One of the boulders was nearly at the optimal elevation of ½ bank full, and was functioning reasonably well, with little evidence of deposition and adequate velocity shelter behind the feature. The close proximity of the access road adjacent to this riffle limits the width and function of the riparian zone on the left bank. The boulders in Structure #5 will likely to exert additional shear on the left stream bank during high flows, and may result in further degradation of the riparian buffer between the river and the road. Sediment deposition behind the boulders is evident, as is lateral channel scour on either side of each boulder.

Structure #7 consists of a boulder “W” weir, spanning the entire bank full channel width, near the upstream boundary of Pool #3. The structure consists of ten boulders, with an estimated fill below the bank full elevation of 13yd³. Boulders at each edge of the bank full channel, and the lowest boulder in the center (thalweg) of the structure were surveyed to determine elevation. One additional random boulder, placed immediately downstream adjacent to the right bank was also surveyed. The center of the structure was found to be 1.64 ft higher than the optimal ½ bank full elevation (0.39 higher than BF). The boulders located where the structure ties into the river banks were 2.64 and 2.58 feet higher than bank full. The random boulder was found to be 1.13 ft higher than the optimal elevation. The structure was constructed without any footing boulders, and is likely at risk for failure in the center, due to scouring of fine grained substrates under the center boulder. Additionally, the structure is not adequately tied into the right river bank, and there is a significant risk of lateral failure of the structure at this point. Vane/bank angle of the structure is greater than 60° on both banks, increasing the risk of bank failure and channel widening downstream of the structure. Stream bank stability and the riparian buffer is good on the right bank, but very poor on the left, due to the immediate proximity of the access road fill slope. It is likely that lateral migration of flow around the structure, with corresponding bank and road fill slope failure, can be expected during high flows, due to the high elevation of boulders on the bank and inadequate anchoring of the structure.

This structure consists of approximately 100 feet of stream bank boulder rip-rap revetment along the left (west) bank of Pool #3 and Riffle #6. There are forty-five boulders of various size in the structure, with an estimated fill below the bank full elevation of 35yd³. The fill/foot of stream bank is estimated to be 0.12 yd³/foot. Structure #8 provides protection to the access road fill slope, which is immediately adjacent and parallel to the left bank of the river. In several segments, the boulders forming the stream bank revetment are not tightly placed together, and the river has begun to erode the bank within the gaps. Stream bank stability and riparian buffer composition is very poor along this bank, and further erosion and bank failure can be expected in this segment.

Structure #9 is another series of randomly placed boulders throughout Riffle #6. The structure consists of 12 large boulders in various locations within the riffle. Four of the largest boulders are placed in a line 8 to 10 feet out from the left (west) bank. The remaining boulders are in a series of clusters in the center of the channel near the top of the riffle. The estimated fill below the bank full elevation of these boulders is 16yd³. Seven of the largest boulders were surveyed to determine elevation. All were found to be higher than bank full. The ideal elevation for this structure type would be ½ of the BF, and these boulders ranged from 1.43 to 2.63 feet above this optimal elevation. A mid-channel bar has begun to form in the center of the channel as a result of the placement of these boulders, which has split the thalweg of the river, and is causing increased stress on both banks. Additionally, the four boulders placed in a line parallel to the left bank may cause an over-topping of the road during high flows. An over-topping event could result in lateral migration of the river into the road corridor, with potentially catastrophic consequences. Sediment deposition behind, and lateral channel scour along the sides of each boulder is evident throughout this feature.

Existing boulders from Structure #5 and Structure #6 will be used to construct three new boulder J-vanes at approximately 0+690ft, 0+850ft, and 0+925ft along the right bank of the river. Boulder vanes and J-hooks should not exceed BF at the point were they tie into the river bank, or $\frac{1}{2}$ of the BF stage at the in channel end of each structure. The remaining boulders will be reconfigured into small micro-vortex in-channel object cover clusters. The elevations of these boulders should be varied so as to look more natural in the river; however, none should exceed $\geq \frac{1}{2}$ of the bank full elevation of the river channel. These clusters should be placed at along the thalweg of the channel between the J-hook vanes, to provide additional pocket water complexity and velocity shelter in the segment, and to aid trout migration through the riffle at high flows.

Structure #7 consists of a “W” weir placed in the channel near the center of a meander bend. This structure type is not typically used along a meander bend, and may not be appropriate in this location. Furthermore, the structure is constructed so that it may cause an undesirable lateral migration of the channel to the east, and should be removed. Boulders from this structure will be used to construct J-hook vanes and other features in the riffles upstream and downstream of this feature.

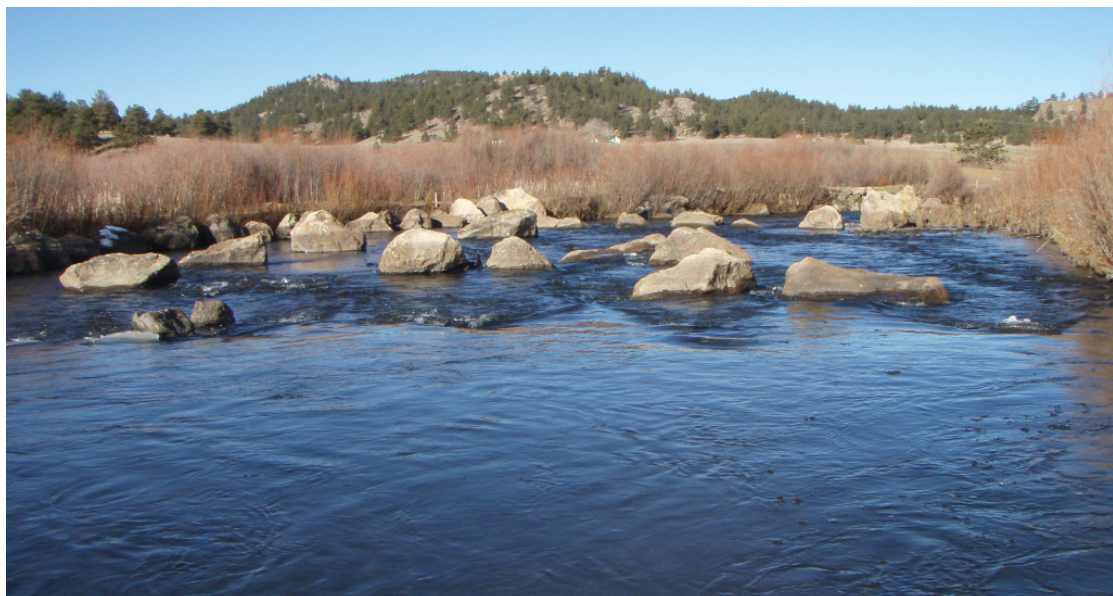
Photo 2: Boulder Clusters in Structure #9 with Bank Structure #8 in background.

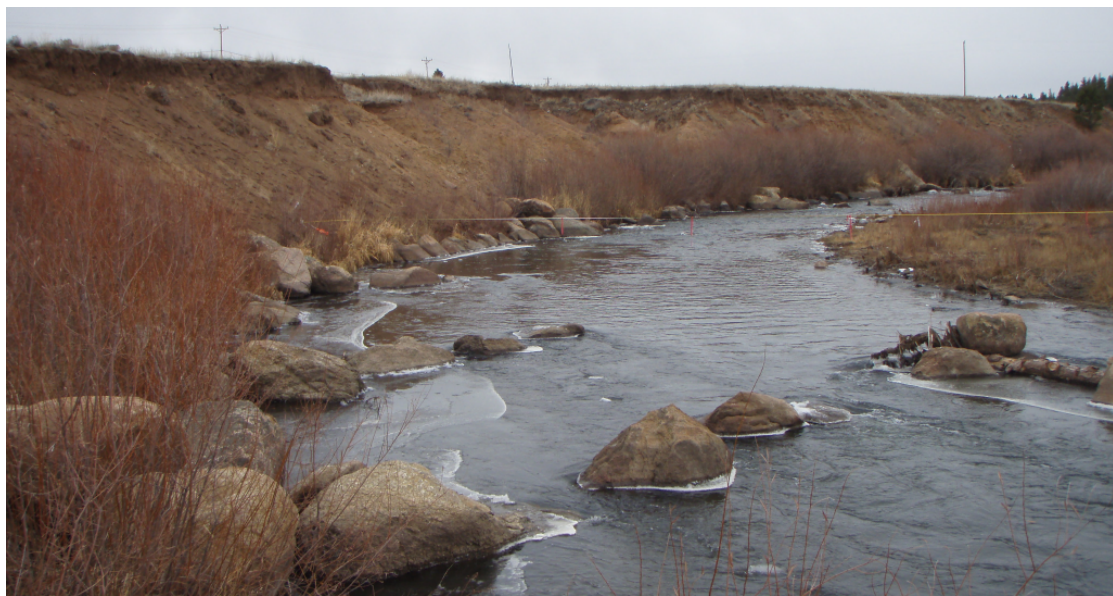
This structure consists of approximately 300 feet of stream bank boulder rip-rap revetment in Riffle #7, Pool #6, and Riffle #8. Five boulder groin/vanes extend into the river channel at various intervals along the length of the structure. The structure provides toe-slope stability to an unstable and sparsely vegetated 1:1 slope, approximately 25 feet high, that extends along the length of the large outside meander bend near the upstream boundary of the project reach. There are seventy-four boulders, ranging from medium to very large size, in the structure, with an estimated fill below the bank full elevation of 66yd³. The fill/foot of stream bank is estimated to be 0.22 yd³/feet. Five boulders were surveyed at intervals along the bank to determine elevation. Additionally, the lowest boulder in the upstream vane was surveyed to determine elevation related to $\frac{1}{2}$ bank full. All of the bank-side boulders were found to be higher than the bank full elevation, ranging from 1.82 to 3.1 feet above bank full. The groin/vane boulder was found to be 0.78 foot higher than optimal. The boulders forming the stream bank revetment in the downstream half of the structure are not tightly placed together, and the river has begun to erode the bank within the gaps. Several segments in the middle and upstream segments are functioning effectively. The boulder groins/vanes, for the most part, are functioning at less than optimal efficiency, providing little protection to the stream banks and poor cover for trout. Stream bank stability and riparian composition is relatively poor, particularly in the downstream 100 feet of the structure, and further erosion and bank failure can be expected in this segment.

Photo 3: Structure #13 and Cross-Section #9 – Reach 1 – South Platte River.

Several segments of Structure #13 will be reconfigured using riparian benches with log toe slope stabilization, complimented by a series of boulder J-hook vanes, to reduce shear on this large meander bend in the river. Stable segments of the structure are shown in Drawing #8, and will be left “as is”. The log toe slope features will be installed so that the top edge of the tree does not exceed the bank full elevation of the channel.

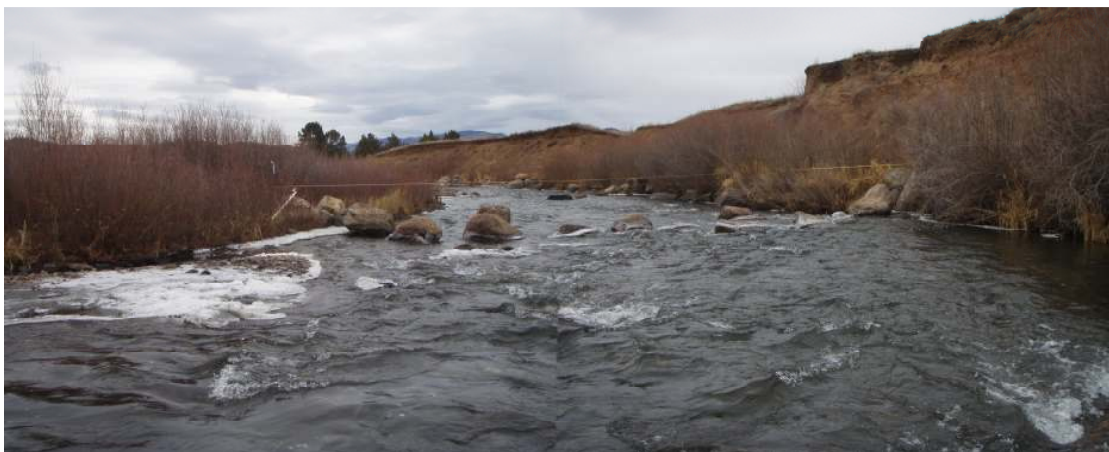
Structure #14 consists of a boulder “W” weir, spanning the entire bank full channel width, immediately downstream of the riffle crest defining the transition of Riffle #8 and Pool #5. The structure consists of eighteen boulders, with an estimated fill below the bank full elevation of 15yd³. Boulders at the edges of the bank full channel, at the upstream “peaks”, and at the center (thalweg) of the structure were surveyed to determine elevation. Two additional random boulders, placed approximately fifteen feet downstream of each of the “peaks” are also present, but were not surveyed. Cross-Section #10 transects the channel through the structure. The center of the structure was found to be 1.43 ft higher than the optimal ½ bank full elevation. The boulders at the “W” weir peaks were 0.73 and 0.88 feet higher than bank full. The boulders located where the structure ties into the banks were 2.08 and 3.49 feet higher than bank full. The structure has no footing boulders, and is likely at risk for failure in the center. The structure is relatively well anchored to the right river bank, and relatively poorly anchored on the left. Riparian condition is relatively robust. Vane/bank angle of the structure is greater than 60° on both banks, increasing the risk of bank failure and channel widening downstream of the structure. The high boulders at the left bank anchor point will likely result in lateral migration of flow around the structure during high flows, with a risk of corresponding bank failure.

Photo 4: Structure #14 and Cross-Section #10 – Reach 1 – South Platte River.

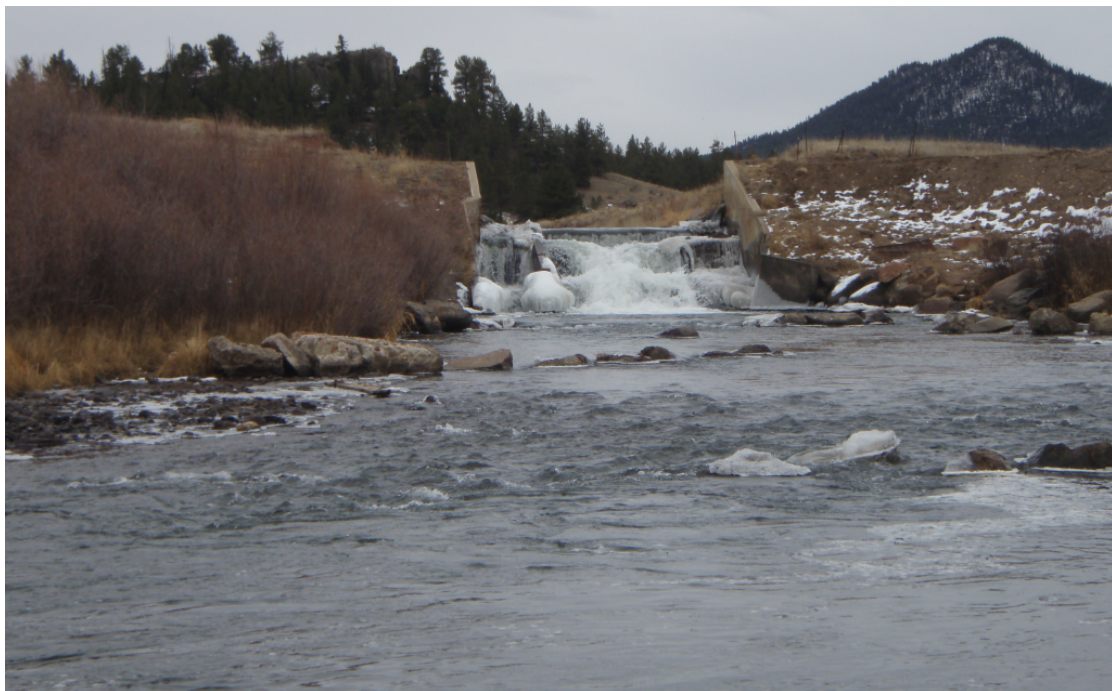
Structure #16 consists of a large boulder vane extending from the right bank upstream into Glide #5. The structure consists of nine boulders, with an estimated fill below the bank full elevation of 7yd³. The largest “boulder”, closest to the bank, is actually a large piece of recycled concrete with a brick veneer. This “boulder”, and the boulder furthest

out into the channel were surveyed to determine elevation. The boulder located closest to the bank was 0.88 feet higher than bank full, and the boulder in the channel was 0.63 ft higher than the $\frac{1}{2}$ BF elevation. The structure has no footing boulders, and is likely at risk for failure due to movement of boulders downstream. The structure is not anchored to the right river bank, and it is evident that high flows have eroded the bank behind and downstream of the structure. Vane/bank angle of the structure is greater than 30° , likely increasing the risk of channel widening downstream of the structure.

Photo 5: Fish Ladder and Structure #16, at the Upstream Boundary of Reach 1.

Structure #16 consists of a boulder vane on the right side of the river, and will be reconstructed into a boulder J-hook vane. The structure will be properly anchored into the river bank, and a new bank full riparian bench, with large wood used to provide a stable toe slope, will be installed downstream of the J-hook vane on the right bank to repair the eroding bank. The bank full bench will be constructed so as to create pockets of under-cut bank cover. The boulder vane on the left bank, designated Structure #17, will also be converted into a J-hook vane. The boulders forming the tail-out between Pool #8 and Pool #9 will be left “as is”, in order to preserve the velocity reducing function these boulders provide from flows exiting the concrete fish ladder. Existing boulders will be used to construct these features. An additional 10 -12 yd³ of boulders may be necessary to complete this work.
