South Platte River
Sportsman's Paradise – Reaches 20 & 21
River Assessment & Restoration Plan
May 2010

Prepared for the Coalition for the Upper South Platte
&
The Sportsman's Paradise Home Owners Association

**FIN-UP** Habitat Consultants, Inc.

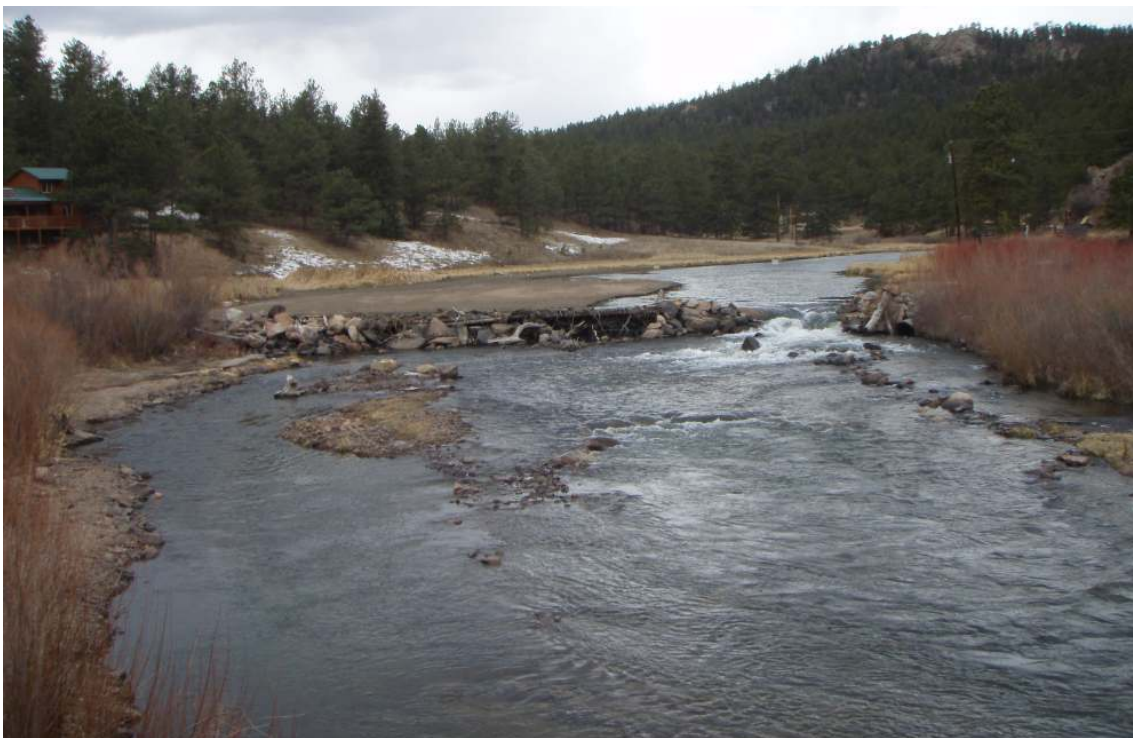
Photo 1: The diversion structure at the upstream boundary of Reach 21 on the S. Platte River in Sportsman's Paradise.

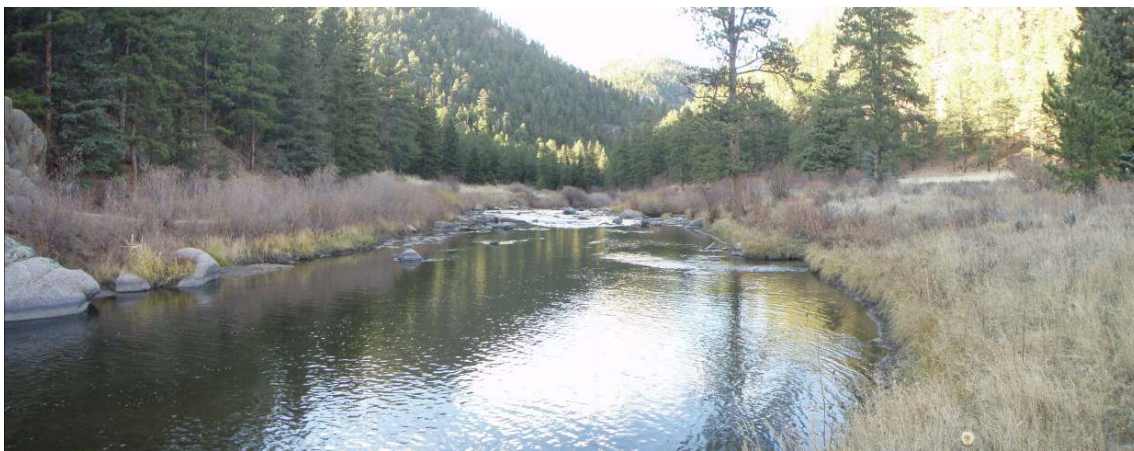
Cross Section 110 is found at 0+439ft, across the tail-out segment of Pool 2. Flow measurements for the study were taken at this cross-section. The wetted width at the time of the survey was 57 feet, and the bank-full width of the channel at this point is 70 ft. The flood prone width of the channel was determined to be 90 ft. Channel entrenchment was 1.29, and the width/depth ratio was calculated to be 32.

Photo 2: View downstream to Cross-Section #110 and the confluence with Beaver Creek on the right.

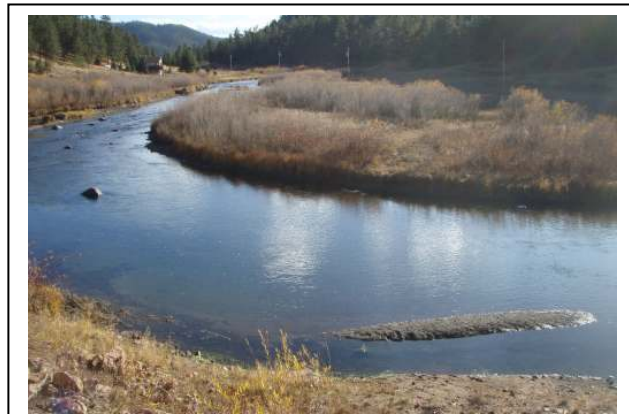
Photo 3: View from Pool #3 upstream to Riffle #4.

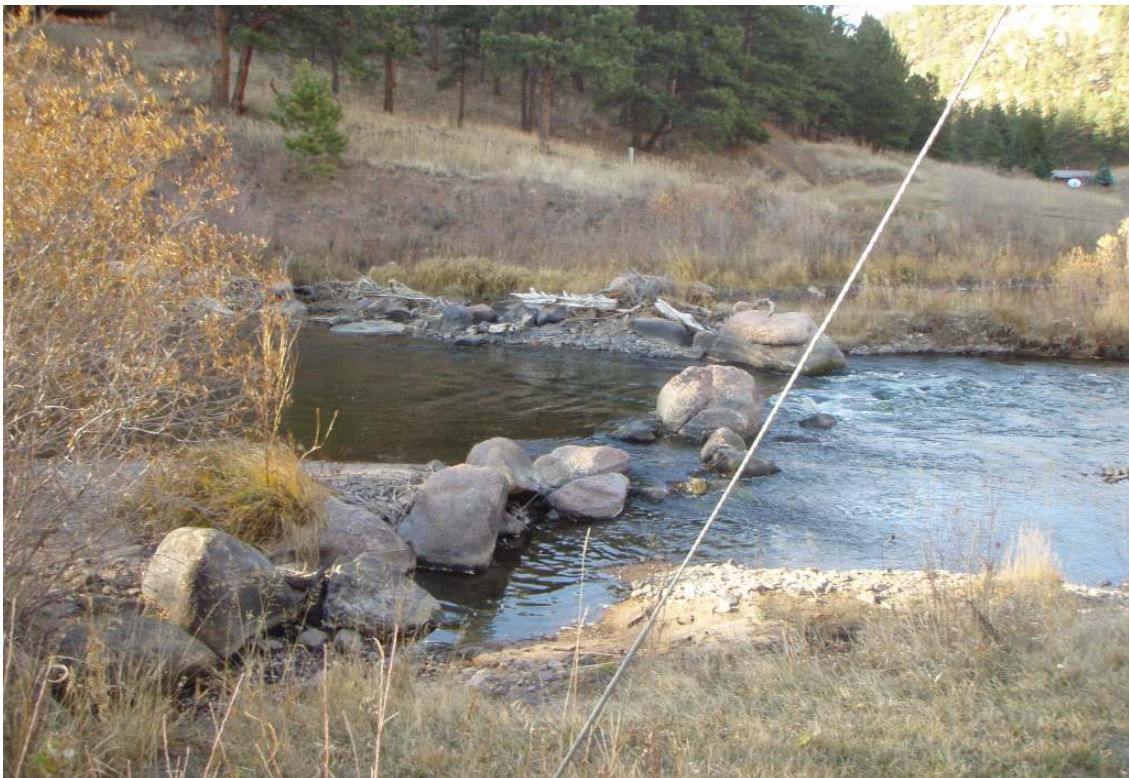
Photo 4: Structure #8, looking from the right bank to the left bank at Cross-Section #114.

Two boulder structures are found in this segment, consisting of boulder vanes extending into the channel. Boulder elevations are random, with most of the boulder top elevations ranging from $\frac{3}{4}$ of the bank-full stage to slightly above bank-full. Structure #7 has been previously described. Structure #8 consists of a boulder drop structure that completely spans the active channel, and is oriented so that the vanes forming the feature extend downstream. The structure is much higher than the bank-full stage elevation in the center of the channel, and is likely the cause of the large mid-channel island that has formed downstream. The structure is creating some additional depth in Pool #5, but also functions as a significant sediment trap, holding back a considerable quantity of fine sediment in the pool. The consequence of the downstream orientation of the feature is evident, particularly on the right river bank downstream in Pool #4, where over-widening of the river channel has destabilized the river bank. Rip-rap has been added along a portion of the right bank of Glide #3 to address this problem, but is likely not very effective at this point.

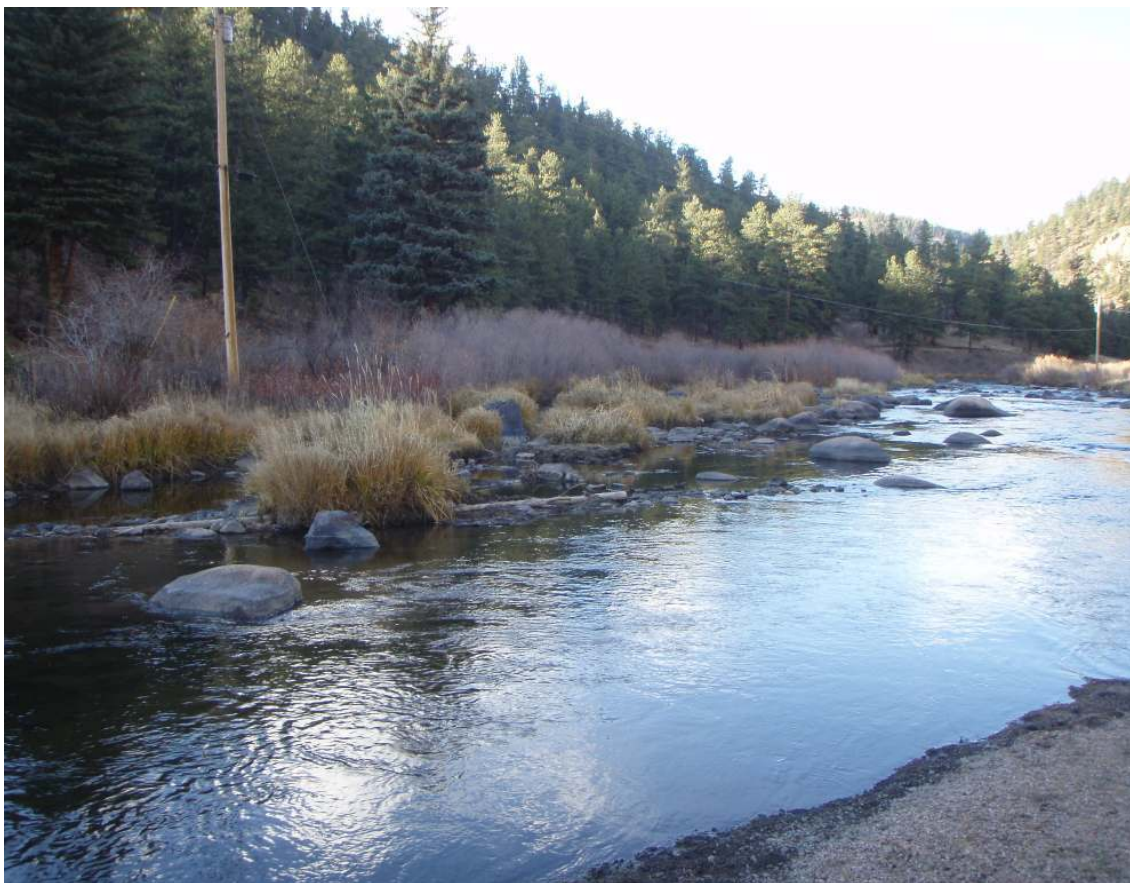
Photo 5: Looking downstream from the mid-channel bar at Cross-Section #114.

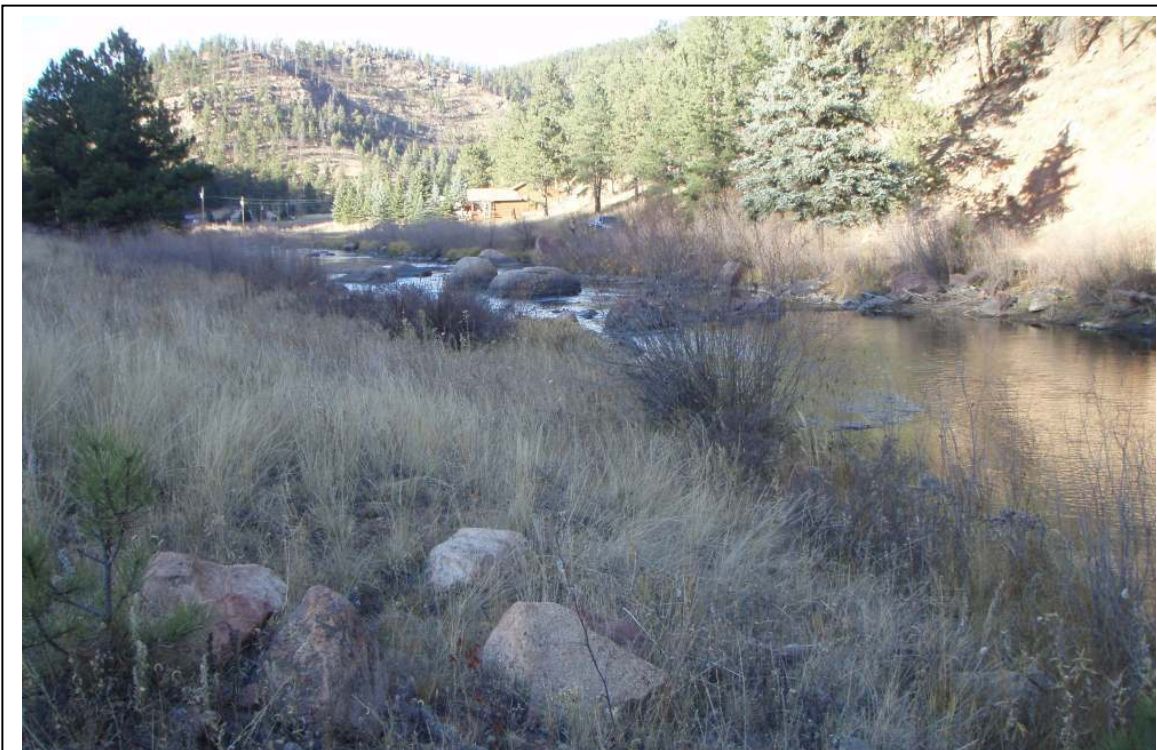
Photo 6: View downstream from Cross-Section #115 to Structure #15 and the large boulders at Glide 4.

Two structures are found in this segment, consisting of boulder vanes extending into the channel. Boulder elevations are random, with most of the boulder top elevations ranging from $\frac{3}{4}$ of the bank-full stage to slightly above bank-full. Structure #14 has been previously described. Structure #15 consists of a boulder drop structure that completely spans the active channel, and is oriented so that the vanes forming the feature extend downstream. The structure is constructed at or near the bank-full stage elevation throughout its length, and is likely the cause of the large mid-channel sediment bar that has formed downstream. The structure is creating some additional depth in Pool #8, but also functions as a significant sediment trap, holding back a considerable quantity of fine sediment in the pool. The consequence of the downstream orientation of the feature is evident, particularly on the left river bank downstream in Pool #7, where a significant blow-out of the left bank has occurred. Gradual over-widening of the river channel from this destabilized river bank will likely continue to occur.

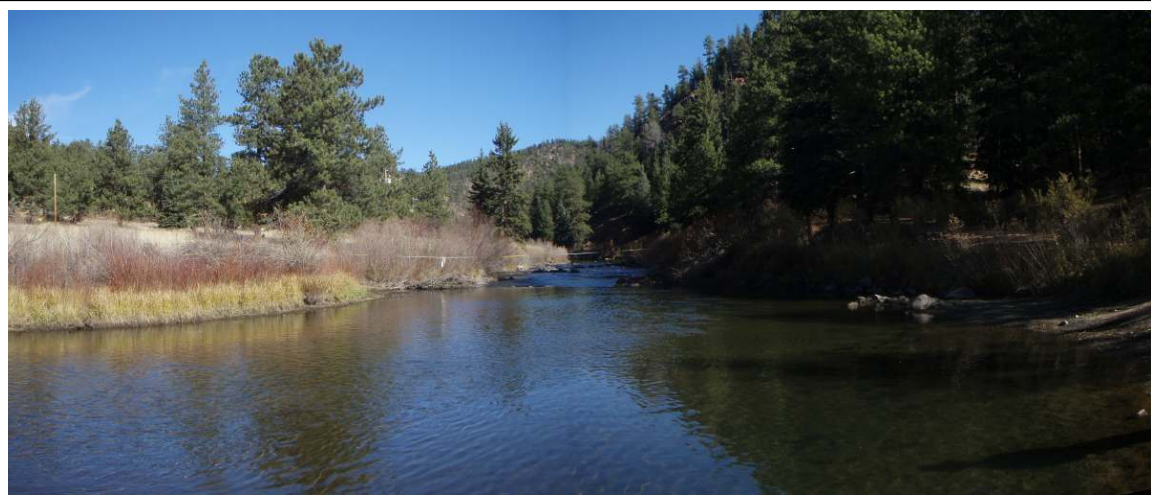
Photo 7: View downstream to Cross-Section #117. Note the dredged spoils on the right bank.

Two structures are found in this segment, consisting of boulder vanes extending into the channel. Boulder elevations are generally random and similar to other structures in the survey. Structure #16 consists of a boulder drop structure that completely spans the active channel, and is oriented so that the vanes forming the feature are perpendicular to the direction of flow. The structure is at or near the bank-full stage elevation throughout its length, and has captured a large quantity of sediment behind the feature in Pool 10. There has been at least one attempt to dredge the accumulated sediment. Spoils from this effort were piled along the right river bank, but have, for the most part, sloughed back into the channel. The alignment of the structure has increased shear along both river banks downstream in Pool #9. While large rip-rap has protected the road fill slope on the right bank, there is some evidence of erosion and loss of bank on the left side.

The right river bank upstream of Structure #16 has been damaged by previous dredging efforts in Pool #10. This unstable bank will be rehabilitated using large wood to redefine the toe of the stream bank along this outside meander bend. Accumulated sediment will be excavated from the right third of the channel in Pool #10, and this material will be used to back-fill the large wood. While riparian plantings will be used extensively along this bank, it will be necessary to provide some hardened access points to the river to provide for the heavy recreation use this pool receives.

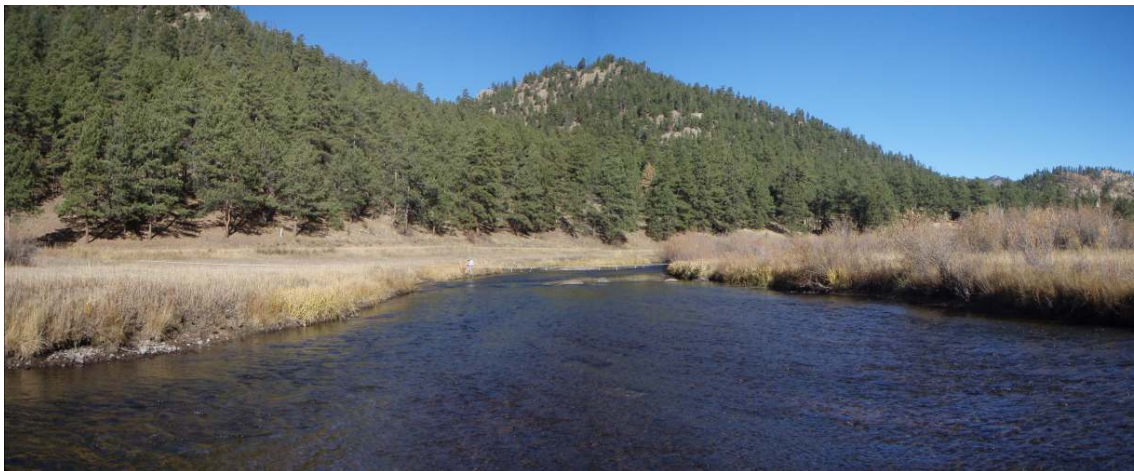
Photo 8: View downstream to Cross-Section #119 and Structure #22.

Five structures are found in this segment, and consist of boulder vanes extending from the stream bank both downstream into the channel and perpendicular to the direction of flow. Additionally, there is a boulder cluster structure found near the tail-out of Pool #12. Boulder elevations are random, with most of the features ranging from $\frac{3}{4}$ of the bank-full stage to slightly above bank-full elevation. Structure #22, is responsible for an over-widening of the channel and a small river bank blow-out on the left side, as well as the formation of a mid-channel sediment bar downstream. The three smaller vanes on the left bank are creating additional shear along the outside of the meander bend, resulting in the river bank downstream of each feature exhibiting signs of erosion and failure.

At the current location of Structure #22, near the upstream boundary of Riffle 10, a large habitat tree will be installed along the right river bank. Another large habitat tree will be installed on the left bank, approximately 75 feet downstream, functioning as a vane to redirect the thalweg away from the left bank. Structure #22 will be completely removed, and the gravel bar that has formed immediately downstream will be excavated down to the original cobble bed of the river. The avulsion on the left bank immediately opposite of Structure #22 will be repaired using a log toe-slope riparian bank-full bench. Some material from the bar excavation may be used to back-fill behind this structure.

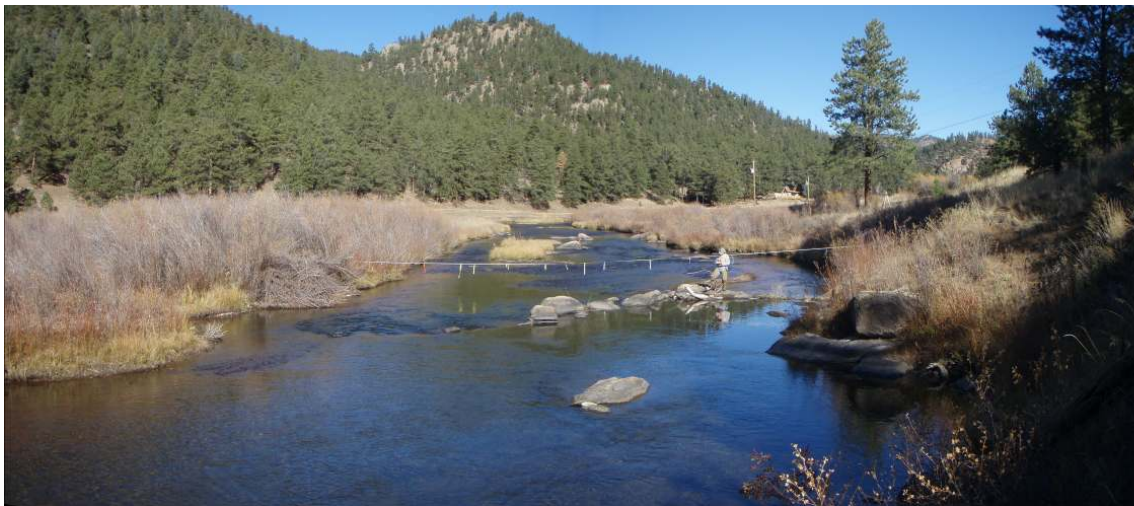
Photo 9: View downstream to Cross-Section #120 and Structure #25.

Four structures are found in this segment, and consist of boulder vanes extending from the stream bank both downstream into the channel and perpendicular to the direction of flow. Additionally, there is a boulder cluster structure found near the middle of Riffle #12. Boulder elevations are random, with most of the features ranging from $\frac{3}{4}$ of the bank-full stage to slightly above bank-full elevation. Structure #24 is causing over-widening of the channel and a small river bank blow-out on the right side. Structure #23, a boulder cluster, is likely causing the formation of a mid-channel sediment bar downstream on the left third of the channel. Structure #25 consists of a boulder drop structure that has failed on the left side of the channel. The structure is oriented so that the right vane extends downstream, increasing the shear forces on the downstream right bank. The structure is at or near the bank-full stage elevation throughout its length, and has captured a large quantity of sediment behind the feature in Pool 15.

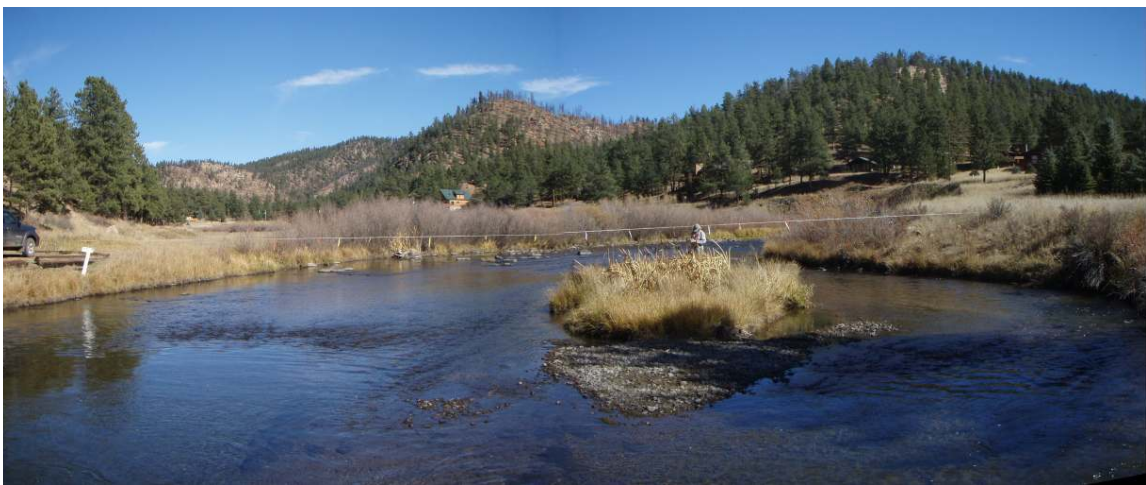
Photo 10: View downstream from Structure 26 to Cross-Section #121.

Two structures are found in this segment, and consist of boulder drop structures extending completely across the active channel, and aligned perpendicular to the direction of flow. Boulder elevations are entirely random, with most of the features ranging from $\frac{3}{4}$ of the bank-full stage to slightly above bank-full elevation. Structure #26 is quite high in the center of the channel, and has formed a large island immediately downstream. The structure is slightly lower on the right side of the channel, and has directed much of the flow into the smaller right channel downstream. This has, in turn, resulted in much higher shear on the right bank on the inside of the river meander, and this bank has partially failed. The higher elevation of the left side of the structure has resulted in loss of usable pool habitat in Pool #16 and the formation of a gravel bar on the left side of the channel in Glide #9. Structure #27 consists of a boulder drop structure with some additional randomly placed boulders along the center and left side of the structure. The structure may be low enough that a significant downstream bar has not yet formed, but it is causing stress to the downstream left bank and gradual over-widening of the channel.

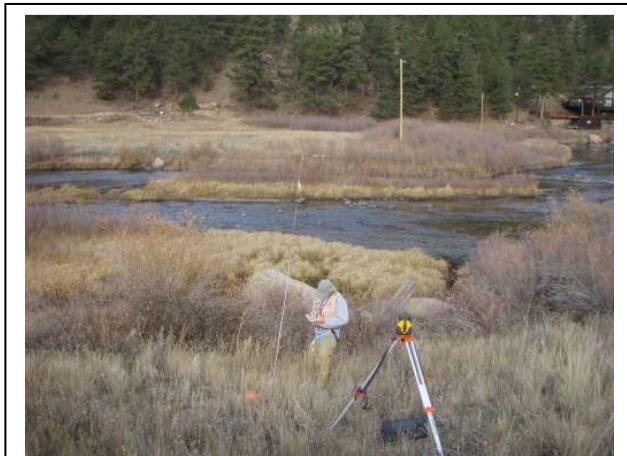
Photo 11: Reach 21-Riffle #2 and Cross-Section #124.

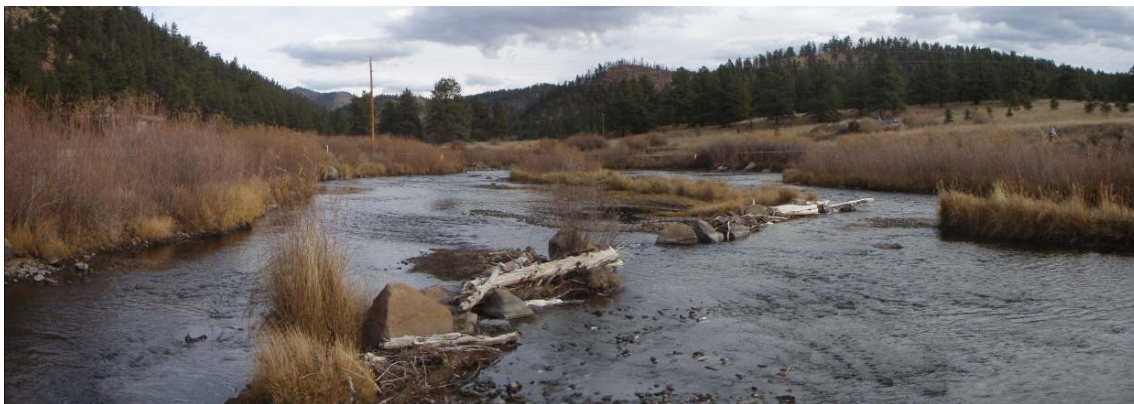
Photo 12: View downstream from Structure 30 to the island in Riffle #2 and Cross-Section #124.

Four structures are found in this segment, consisting of boulders placed at random intervals in the channel. The elevations of most of the boulders appear to be entirely random; and most range from $\frac{3}{4}$ of the bank-full stage to slightly above bank-full elevation. Structure #30 consists of a boulder vane located in the left third of the channel beginning at the upstream end of the large island at Riffle #2 and extending almost 150 ft upstream to a small vegetated island. Many of the boulders are at bank-full-elevation or slightly higher, and the left bank shows signs of stress from high flows. This structure may have been initially installed as armor and rip-rap to protect the outside bank of a meander bend, but has resulted in the channel splitting, resulting in the severe over-widening of the river channel described in the previous segment.

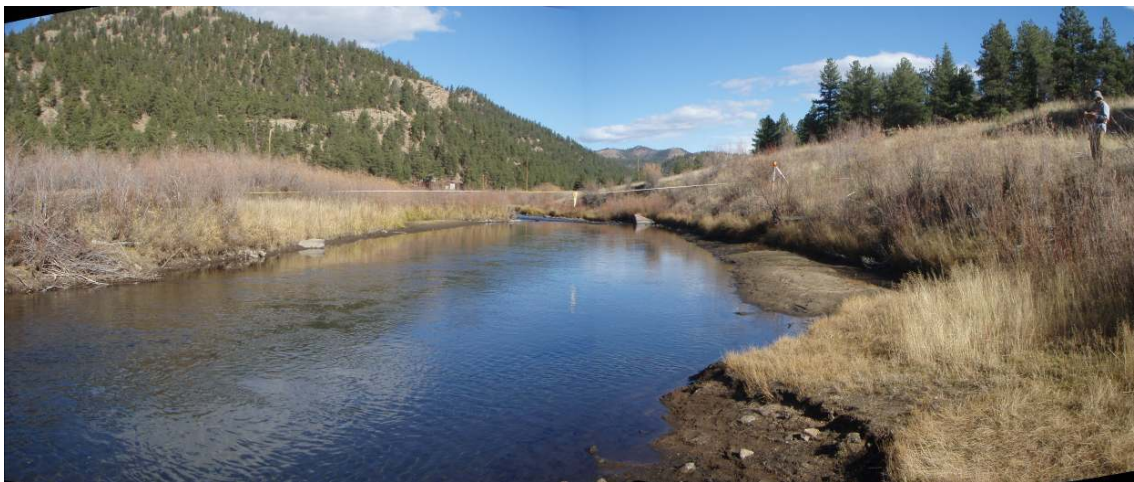
Photo 13: Pool #4, Structure #34, and Cross-Section #126.

Three structures are found in this segment. Structure #32 and #33 have been described in the previous section. Structure #34 consists of a channel spanning boulder drop structure. Like most of the full-channel drop structures on the property, this feature is constructed in a downstream orientation, and is impacting the river banks immediately downstream. Most of the boulders are at less than one half of the bank-full-elevation, however, somewhat lessening the shear effects on the banks and reducing the accumulation of material in the center of the channel. The pool shows signs of accumulating sediment, particularly immediately upstream of the structure.

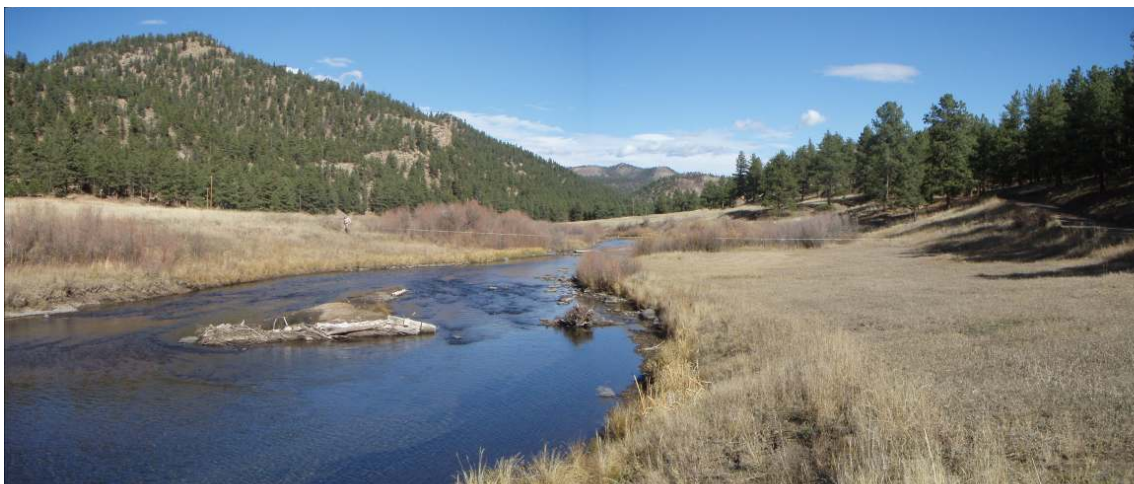
Photo 14: Glide #5, Structure #36, and Cross-Section #127.

Three structures are found in this segment. Structure #35 consists of another full-channel boulder drop structure. The structure is constructed in a downstream orientation, and has partially failed on the right side. The result of this failure has been significant over-widening of the channel downstream of the structure, as well as the formation of a significant sediment bar on the left. Most of the boulders are higher than necessary, capturing additional sediment upstream. It is likely that Glide #4 formed due to accumulation of sediments in the dam pool initially created by this structure.

Structure #36 is an accumulation of small boulders and one piece of large wood in the center of the channel in Glide #5. The structure is higher than $\frac{1}{2}$ of the bank-full elevation, and accumulates debris floating downstream during high flows. A large island exists below the structure, and is well established and vegetated. The structure and island effectively split the center of the channel, increasing the shear forces on both banks downstream. Structure #37 consists of a small cluster of boulders on the left bank, and has little hydrological effect on the river or bank.

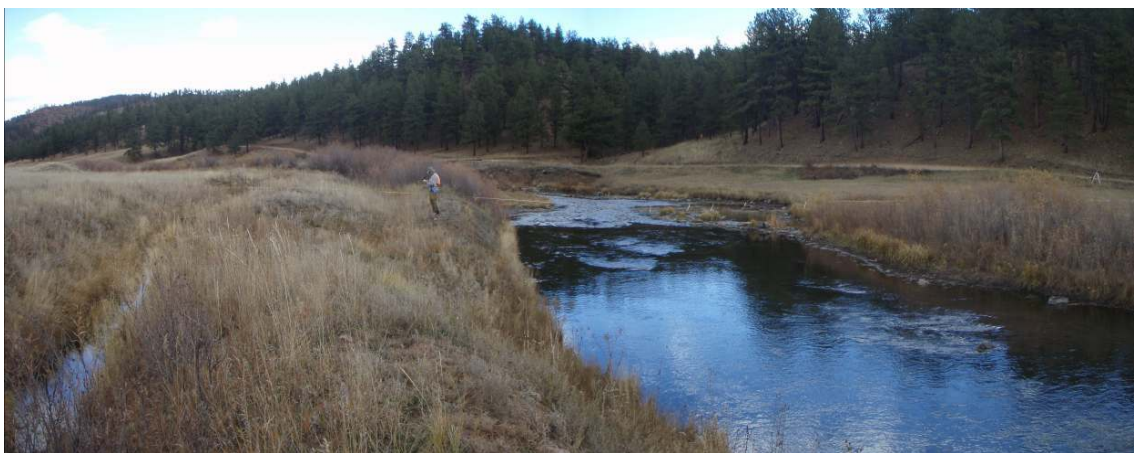
Photo 15: The lake diversion ditch, Structure #40, Glide #6, and Cross-Section #128.

Three structures are found in this segment. Structure #35 consists of another full-channel boulder drop structure. The structure is constructed in a downstream orientation, and has partially failed on the right side. The result of this failure has been significant over-widening of the channel downstream of the structure, as well as the formation of a significant sediment bar on the left. Most of the boulders are higher than necessary, capturing additional sediment upstream. It is likely that Glide #4 formed due to accumulation of sediments in the dam pool initially created by this structure.

The mostly failed boulder vane/drop structure between Riffle #8 and Glide #6 (Structure #40 / Grid C-3) and the associated mid-channel sediment bar immediately downstream, will be completely removed from the channel. In its place, a full channel boulder cross-vane may be installed 65-75 ft upstream in Glide #6 to form a new pool in the channel extending downstream to the existing riffle crest at the top of Riffle #8. The blown out right bank will be restored using the large wood and riparian benching techniques previously described.

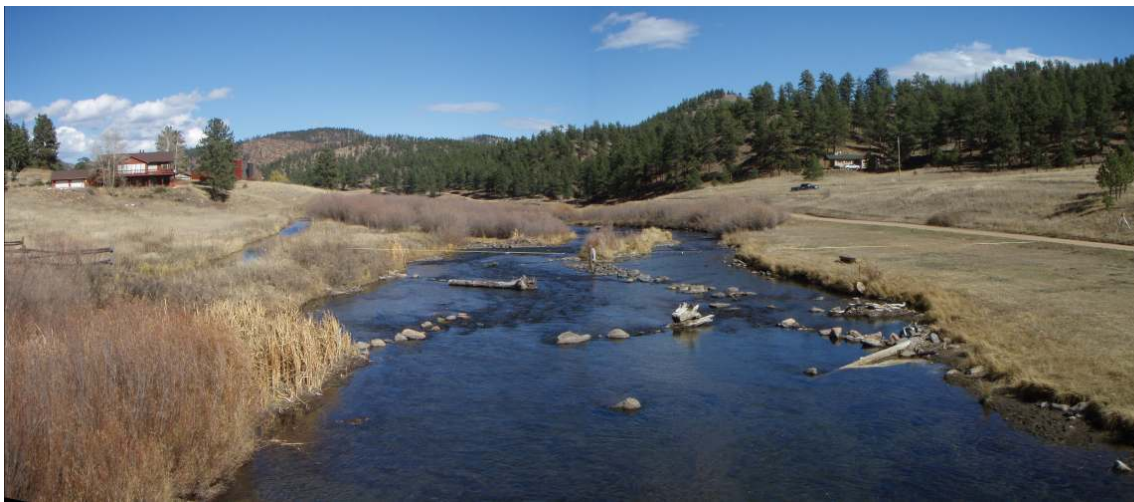
Photo 17: Riffle #111 & Cross-Section #130 from the bridge. Note the numerous structures in the riffle.

Structures #42 and 45 consist of boulder vanes extending from the left bank of Riffle #11, extending downstream across one third of the channel width. These structures exhibit similar characteristics to Structure #43, resulting in increased erosion along the downstream bank and causing over-widening of the channel. In addition to these structures, there are several random boulder placements in Riffle #11, as well as three pieces of large wood. The elevations of all of these features are greater than ½ of the bank-full stage, and their effectiveness in creating habitat for resident trout is somewhat limited.
