Lower Rattlesnake Creek Head-Cut and Bank Stabilization Project Elk Mountain Ranch Carbon County, WY

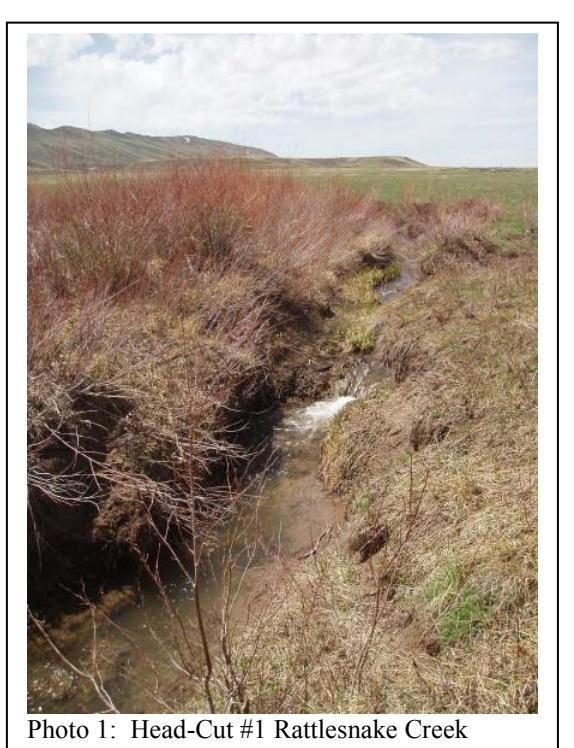
Head-cut #1 is found approximately 1,000 feet upstream of the boundary of the Elk Mountain Ranch on Rattlesnake Creek, within Reach 1. The head-cut was determined to be moderately severe, and there was evidence of considerable historic channel lateral migration and instability in the vicinity of the cut. The treatment priority is determined to be medium, with high value C and E channels upstream of the head-cut being at risk. A cross section and longitudinal profile of the 70 foot channel segment containing the cut were collected during the survey and are shown in Chart 1 below.

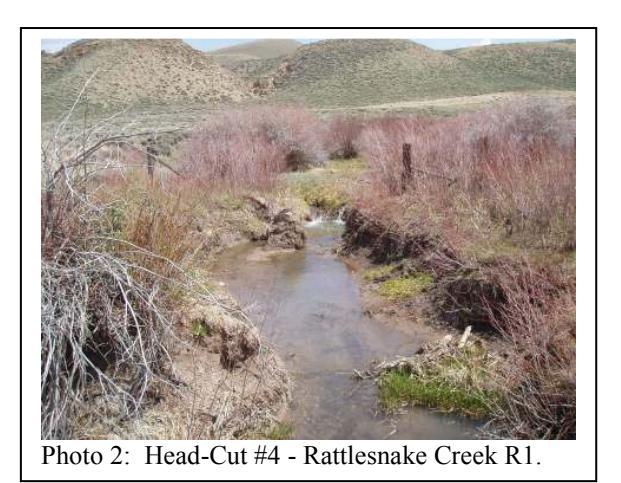
Head-cut #4 is found approximately 1/2 mile upstream of the boundary of the Elk Mountain Ranch on Rattlesnake Creek, adjacent to an old abandoned building on the south bank of the stream. The head-cut was determined to be very severe, and the treatment priority is high, with a large beaver pond complex immediately upstream of the head-cut being at risk. Once this head-cut migrates into the first beaver pond, it will rapidly continue upstream through the fine sediments accumulated in the ponds,

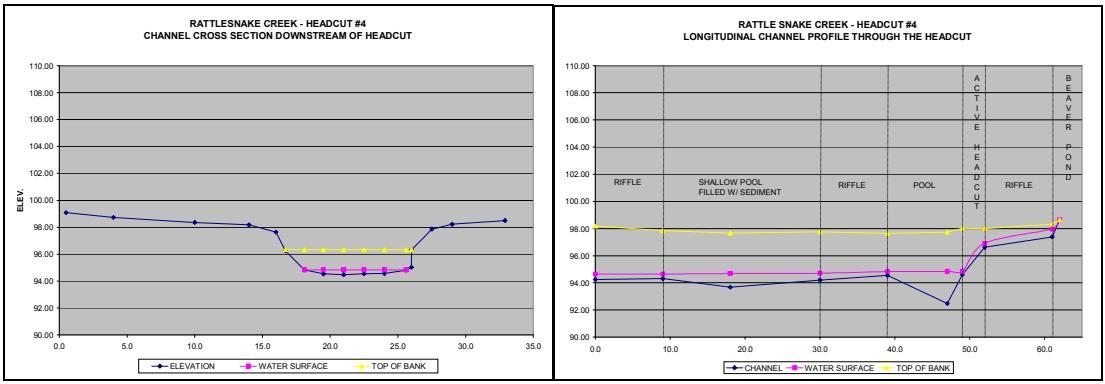
Chart 2: Cross Section and Longitudinal Profile of Head-Cut #4 - Rattlesnake Creek Reach 1.

resulting in significant sedimentation to habitats downstream A cross section and longitudinal profile of the 62 foot channel segment containing the cut were collected during the survey and are shown in Chart 2 below.

A boulder cross vane should be constructed at the top of the head-cut. The bank full width of the channel at the cross-vane is approximately 9.3 feet. The center of the cross-vane should be set to an elevation of 96.6, relative to the Left Head Pin 2 (LHP2 = 100.0). The elevation of the legs of the cross-vane, at the point where they intersect the stream bank, should be at the bank full stage, at approximately 98.0 relative to LHP2. The legs of the cross vane will be firmly anchored into the stream bank by extending the structure at least 5-7 feet into each bank. These extensions should not exceed the bank full elevation referenced above, and will be buried and revegetated. The structure should be constructed of large flat boulders approximately 0.5 - 0.75 cubic yards in volume. It is estimated that approximately 25 - 30 boulders, including footers, will be required for the structure. Total estimated fill volume for this structure is approximately 11 -15 cubic yards within the bank full stage of the stream.

Once the structure is installed, it is recommended to treat the vertical, collapsing left stream banks downstream of the site be treated using the same toe-slope stabilization technique described for Head-cut #1. These areas will require 3 -4 pieces of large wood to create a stable toe and bank full bench on the bank, then the upper portion of the bank may sloped back and revegetated. The bank full bench can be revegetated using locally available willow and sedge mats harvested from areas nearby the site. Estimated fill below the bank full stage for this structure type is estimated to be less than 0.1 cubic yard / linear foot of stream bank.

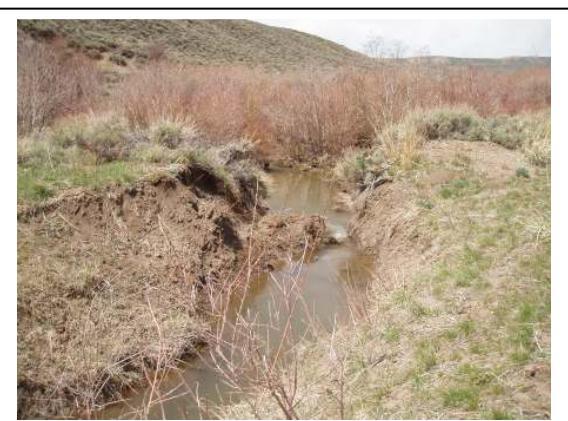
Photo 3: Head-Cut #5 - Rattlesnake Creek R1.

Head-cut #5 is found approximately 0.8 mile upstream of the boundary of the Elk Mountain Ranch on Rattlesnake Creek, and was initially identified during the 2006 assessment. The head-cut was determined to be very severe, and the treatment priority is high, with a diversion structure and irrigation ditch immediately upstream of the head-cut being at risk. We propose to treat the head-cut, and also construct an additional cross-vane at the diversion structure to assure

A boulder cross vane will be constructed at the top of the head-cut. The bank full width of the channel at the head-cut cross-vane is approximately 9.5 feet. The center of the cross-vane should be set to an elevation of 94.3, relative to the Left Head Pin 3 (LHP3 = 100.0). The elevation of the legs of the cross-vane, at the point where they intersect the stream bank, should be at the bank full stage, at approximately 96.2 relative to LHP3. The legs of the cross vane will be firmly anchored into the stream bank by extending the structure at least 5-7 feet into each bank. These extensions should not exceed the bank full elevation referenced above, and will be buried and revegetated. The structure should be constructed of large flat boulders approximately 0.5 - 0.75 cubic yards in volume. It is estimated that approximately 25 - 28 boulders, including footers, will be required for the structure. Total estimated fill volume for this structure is approximately 11 -14 cubic yards within the bank full stage of the stream.

Once the structures are installed, it is recommended to treat the vertical, collapsing left stream banks within the site using the same toe-slope stabilization technique described for Head-cut #1. These areas will require 7 -8 pieces of large wood to create a stable toe and bank full bench on the bank, then the upper portion of the bank may sloped back and revegetated. The bank full bench can be revegetated using locally available willow and sedge mats harvested from areas nearby the site. Estimated fill below the bank full stage for this structure type is estimated to be less than 0.1 cubic yard / linear foot of stream bank.

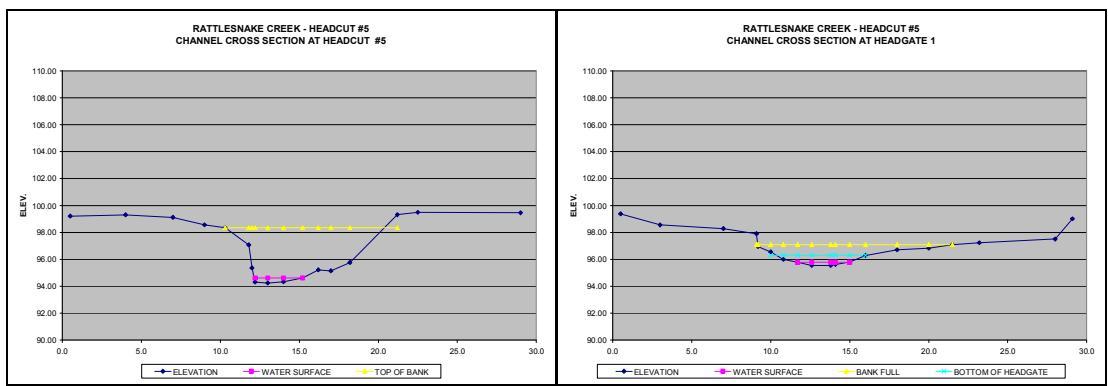
Chart 3: Cross Sections of Head-Cut #5 and Head-gate #1- Rattlesnake Creek Reach 1.

delivery to the ditch during base flow conditions. Two cross sections, showing the active head-cut and the diversion structure, and a longitudinal profile of the 150 foot channel segment containing the cut and the head-gate were collected during the survey and are shown in Chart 3 and 4 below.

An additional boulder cross vane may be constructed at the riffle crest immediately below Head-gate 1. The bank full width of the channel at this cross-vane is approximately 12.3 feet. The center of the cross-vane should be set to an elevation of 96.3, relative to the Left Head Pin 3 (LHP3 = 100.0). The elevation of the legs of the cross-vane, at the point where they intersect the stream bank, should be at the bank full stage, at approximately 97.1 relative to LHP3. The legs of the cross vane will be firmly anchored into the stream bank by extending the structure into each bank. These extensions should not exceed the bank full elevation referenced above, and will be buried and revegetated. The structure should be constructed of large flat boulders approximately 0.5 - 0.75 cubic yards in volume. It is estimated that

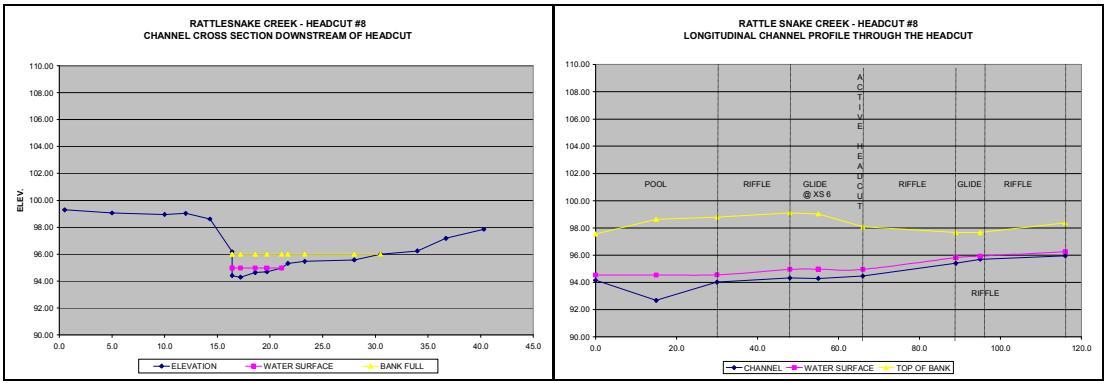
Chart 5: Cross Section and Longitudinal Profile of Head-Cut #8 - Rattlesnake Creek Reach 3.

Head-cut #8 is found approximately 250 feet upstream of the boundary of the Rattlesnake Ranch on Rattlesnake Creek, near the downstream boundary of Reach 3. The head-cut was determined to be moderately severe, and the treatment priority is high, with a large beaver pond complex containing an irrigation diversion structure immediately upstream of the head-cut being at risk. Once this head-cut migrates into the first beaver pond, it will rapidly continue upstream through the fine sediments accumulated in the ponds, resulting in significant sedimentation to habitats downstream A cross section and longitudinal profile of the 116 foot channel segment containing the cut were collected during the survey and are shown in Chart 5 below.

A boulder cross vane may be constructed at the top of the head-cut. The bank full width of the channel at the cross-vane is approximately 14.1 feet. The center of the cross-vane should be set to an elevation of 94.5, relative to the Left Head Pin 6 (LHP6 = 100.0). The elevation of the legs of the cross-vane, at the point where they intersect the stream bank, should be at the bank full stage, at approximately 96.0 relative to LHP6. The legs of the cross vane will be firmly anchored into the stream bank by extending the structure at least 5-7 feet into each bank. These extensions should not exceed the bank full elevation referenced above, and will be buried and revegetated. The structure should be constructed of large flat boulders approximately 0.5 - 0.75 cubic yards in volume. It is estimated that approximately 28 - 30 boulders, including footers, will be required for the structure. Total estimated fill volume for this structure is approximately 11 -15 cubic yards within the bank full stage of the stream.

Once the structure is installed, it is recommended to treat the vertical, collapsing left stream banks downstream of the site be treated using the same toe-slope stabilization technique described for Head-cut #1. These areas will require 3 -4 pieces of large wood to create a stable toe and bank full bench on the bank, then the upper portion of the bank may sloped back and revegetated. The bank full bench can be revegetated using locally available willow and sedge mats harvested from areas nearby the site. Estimated fill below the bank full

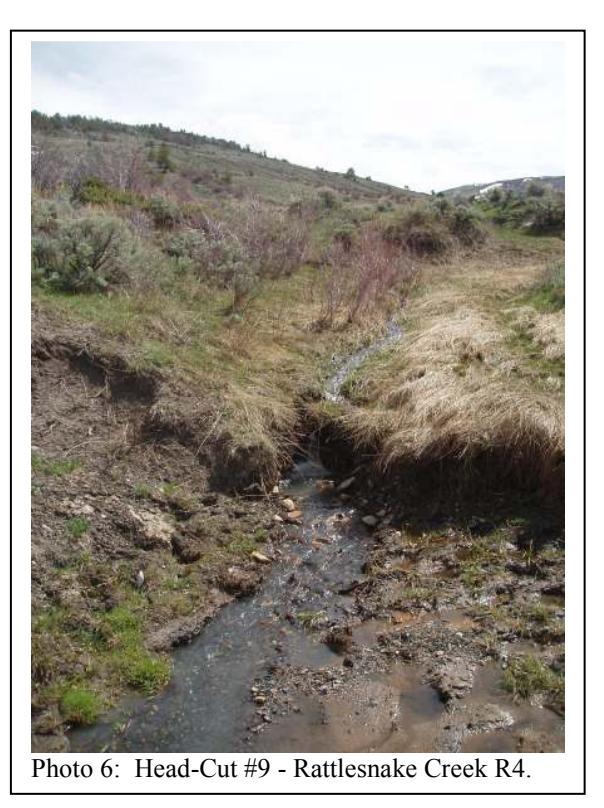
Head-cut #9 is found approximately 1,000 feet upstream of the bridge at the beginning of Reach 4 on Rattlesnake Creek, on a small tributary entering Rattlesnake Creek from the south. The head-cut was determined to be moderately severe, and the treatment priority is high. This is a relatively easy head-cut to treat, given the small size of the tributary, and can be accomplished by constructing a small rock cross-vane of boulders approximately 0.5 cubic yards in volume. The cross vane should be constructed to hold the grade of the stream channel upstream of the cut, and will likely not exceed 3 -5 cubic vards of volume below the ordinary high water mark of the tributary.

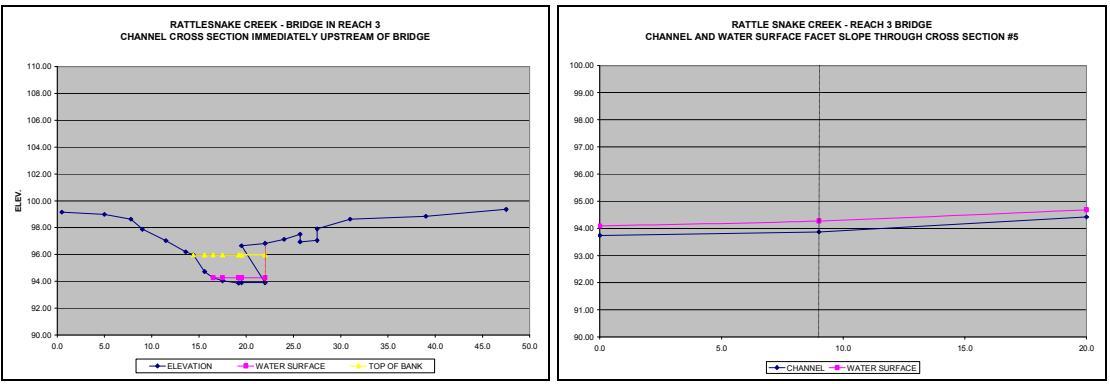
Chart 6: Cross Section and Longitudinal Profile of Head-Cut #8 - Rattlesnake Creek Reach 3.

The Bridge at the Reach 3/Reach 4 Boundary is currently at risk of failure, and is causing undesired channel modification and stream bank erosion both upstream and downstream of the structure (Photo 7). A stream bank stabilization structure on the right stream bank has failed, and is collapsing into the channel (Photo 8), deflecting the force of the stream into the support pilings on the left bank. The cross-sectional area of the stream channel under the bridge is severely reduced, and may result in complete failure of the structure in the near future. A cross-section of the current channel conditions and a facet slope profile of the channel beneath the bridge are shown in Chart 6 below.

It is recommended that the stream bank stabilization structure be removed from the bank, and a boulder cross vane installed immediately upstream of the bridge to protect the bridge foundations and direct the stream thalweg under

the center of the bridge. This will create a new bank full width of the channel of approximately 13 feet. The center of the cross vane should be set to an elevation of approximately 94.5 relative to Left Head Pin 5 (LHP5=100.0), and the bank full elevation is just under 96.0 relative to LHP5. The structure will require approximately 20-25 boulders and should not exceed a volume of 11 - 15 cubic yards below the ordinary high water mark of the stream.

Downstream of the cross-vane, the right bank will be stabilized using either large wood or small boulder for toe-slope stability, and will be revegetated using available willow transplants. There is considerable bank damage and overwidening of the stream channel below the bridge. A mid-channel bar immediately downstream of the bridge will be re-contoured to create a single thread channel, and the vertical, eroding stream banks will be treated with large wood toe-slope / bank full bench treatments described previously. 6 -8 large trees will be required to complete this work.

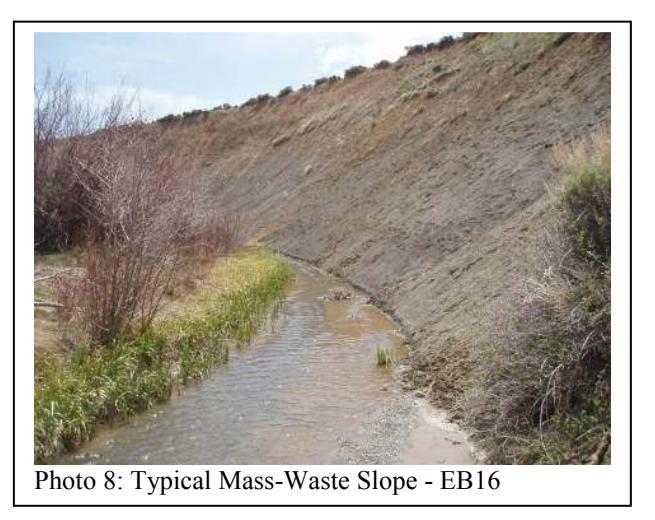
We found three distinct types of actively eroding banks. The first type of unstable bank observed in the reaches is the result of large scale slope failure and mass- wasting along edge of the valley floor. These mass-waste slopes typically exhibit bare banks up to fifty feet high, with toe-slopes consisting of parent bed material and shale. An example of this eroding bank type is shown in Photo 8. While this eroding bank type continues to contribute sediment to the stream, much of the material entering the stream consists of shale fragments approximately 1/2" to 2" in diameter. Fine particle (<1/4") sedimentation in pools downstream of these slopes does not appear to be excessive, and given the cost to treat this bank type, it is recommended that these areas continue to be

monitored through photo-points to determine if vegetative cover is increasing or decreasing on the bank slope. This eroding bank type is the least common found in the reach, and were mapped using GPS (shown as a Yellow Flag on Map 3)

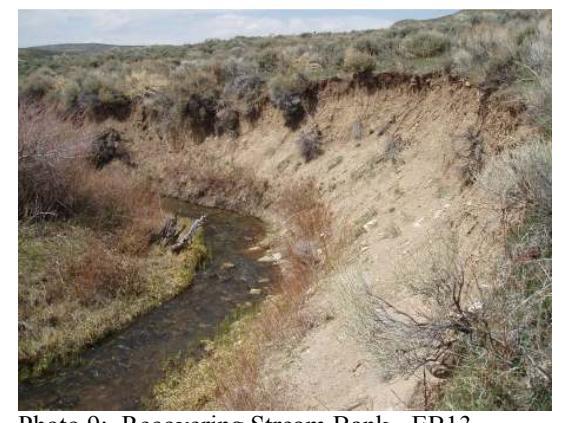
Photo 9: Recovering Stream Bank - EB13

The second type of eroding stream bank observed exhibit some new vegetative growth along the bank full edge of the stream channel, and appear to be healing reasonably well of their own accord. An example of this eroding stream bank is shown in Photo 9. These stream banks were mapped using GPS (shown with a Blue Flag on Map 3) and should continue to be periodically monitored using photo-points to ensure that they continue to heal.

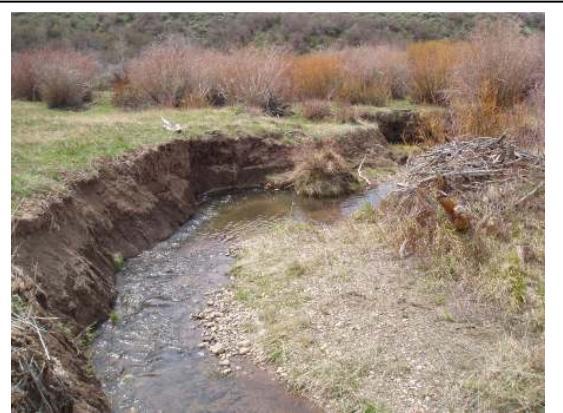
Photo 10: Actively Eroding Bank - EB18

The third type of eroding bank observed are extremely unstable, lacking any riparian vegetation along the bank full edge of the bank, and are actively contributing fine sediment to the stream. These eroding banks were mapped using GPS (shown with a Red Flag in Map 3), and the length of unstable bank was visually estimated. Left untreated, these banks will most likely become more unstable, and may contribute to undesirable lateral instability within the flood plain. These severely eroding banks tend to be associated with some of the head-cuts in the watershed, and on the outside banks of meander bends where the streamside riparian vegetation is less robust or has been disturbed. An example of this eroding stream bank type is shown in Photo 10.
