Halleck Creek
Aquatic Habitat Enhancement Project
Elk Mountain Ranch
Carbon County, WY
Prepared by

FIN-UP Habitat Consultants, Inc.

Halleck Creek
Aquatic Habitat Enhancement Project
Elk Mountain Ranch
Carbon County, WY

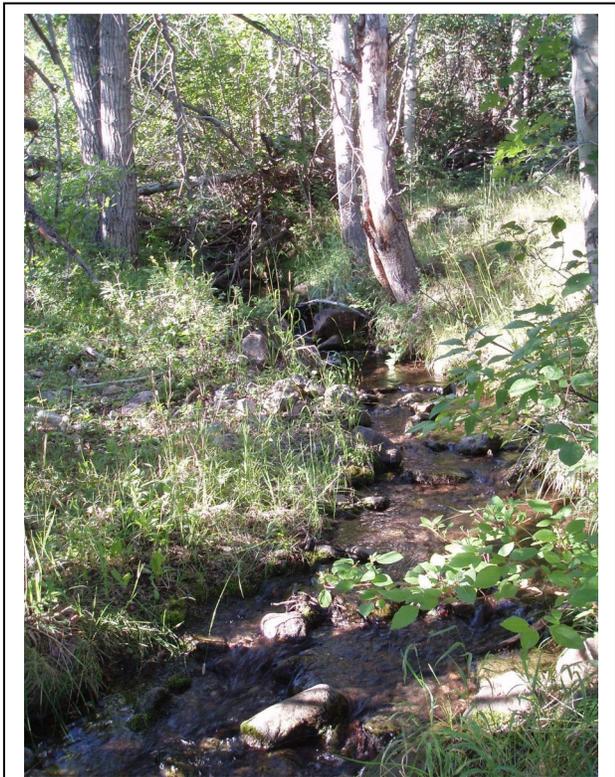
Halleck Creek Reach 6 extends from the Ranch Headquarters (Palm Ranch) upstream to a waterfall barrier at the obvious rock outcrop in the steep canyon above the ranch headquarters. Halleck Creek throughout Reach 6 flows through an alluvial fan at the base of the steep headwater canyon on the northern flank of Elk Mountain. There is evidence of considerable historic lateral migration of the channel across the alluvial plain in this reach, and old abandoned channels may be observed throughout the area. Near the center of the reach, there are a series of diversion points which feed irrigation ditches leading to the pastures below. These diversions present significant barriers to fish passage, and may dramatically alter the natural flow regime in the segment downstream, likely limiting the reach in terms of quality aquatic habitat and depth (Photo 1). Upstream of these diversions, extensive historic logging operations have disturbed the stream channel in many locations, altering channel morphology and mobilizing stream substrates. An old logging road parallels the stream channel on the east bank from a point a few hundred feet upstream of the uppermost diversion point to the rocky waterfall at the upstream boundary of the reach. Large stumps (3-4' DBH) between this road and the stream lend evidence to extensive logging occurring down to the waters edge, and may partially explain the frequent lateral migration of the channel and generally poor pool habitat conditions observed in the reach. The waterfall at the top of the reach is an impenetrable barrier to fish migration upstream, and may account for no fish being observed in any of the reaches upstream on Elk Mountain.

Photo 1: Low flows on Reach 6 below ditch.

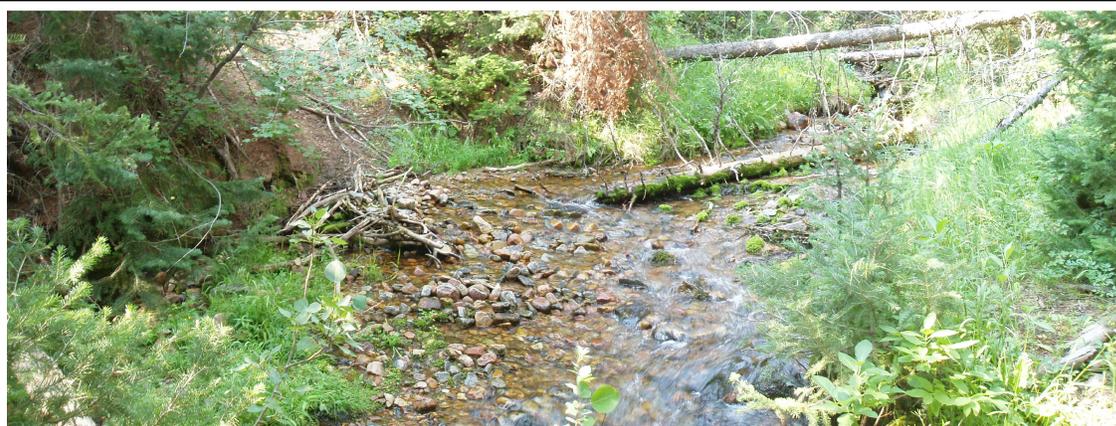
Photo 3: Treatment Site ACCESS_2 on Halleck Creek - looking upstream.

A boulder cross vane will be installed at the upstream boundary of the treatment site to create a new large plunge pool. Cobble armoring the channel at this new pool site will be excavated to maximum depth of 2 ft and a residual pool depth of 1.3 - 1.6 ft. It is estimated that the cross vane will require from 8 to 12 boulders to complete.

An existing piece of large wood in the stream channel will be re-positioned in order to create a new bank-full bench on the west side of the stream channel. Additional wood may be added to redefine a new narrower channel through the old skid trail crossing. Areas behind these large wood bank features will be revegetated using sedge mats, willows and alder harvested from nearby areas. Wood and willows for this segment of the work will be harvested from an area along the skid trail to the west of the treatment site.

Two medium sized trees (DBH = 14" - 16") will be directionally felled into the stream channel at the constriction downstream of the skid trail crossing to create a new woody debris dam pool. These trees will be dropped into the channel with their root-wads intact, to ensure that these features do not move during peak spring run-off flows. Disturbed areas around the base of the trees will be contoured and revegetated to prevent bank erosion at these points. Gradual accumulation of woody debris in this debris jam should create a new dam pool approximately 2 -2.5 feet deep and approximately 20 feet long.

Upon completion of the channel and bank stabilization work, the skid trail approaches on either side of the stream will be obliterated and re-seeded. The steeper east side approach will require one or two water-bars be installed to ensure that the skid trail and adjacent logging road are effectively disconnected from the stream.

The in-channel and bank stabilization work in Access_2 will require 16 - 20 boulders and up to 5 trees to complete. Estimated fill below the ordinary high water mark of the stream is 4 to 6 yd³ each for the cross vane structure and woody debris dam pool, and 0.2 yd³/linear ft for the log toe slope stabilization (4 yd³ total).

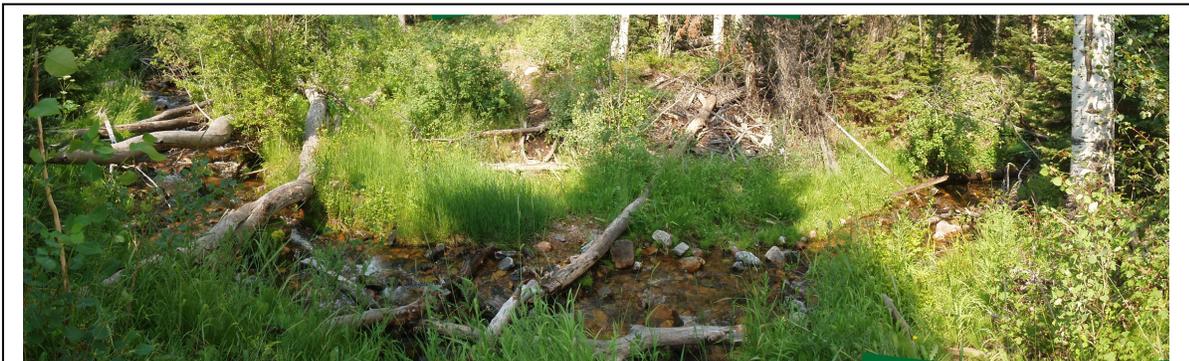
Photo 4: Treatment Site ACCESS_3 on Halleck Creek - from the left stream bank.

A large log vane will be installed near the bottom of the site to create a new dam pool. Some small cobble will be removed from upstream of this feature to create additional depth in the pool. The new maximum depth of the pool will be 2.0 ft. Cobble removed from this habitat will be used to harden the skid trail crossing described below.

A boulder cross-vane will be installed immediately downstream of the skid trail crossing in order to maintain the channel grade at the crossing. A new plunge pool will be excavated immediately downstream of the structure. The maximum depth of the pool will be 1.5 - 1.7 ft, and the RPD will be 1.0 to 1.2 ft. Suitable materials from this excavation will be used to harden the crossing and approach slopes. Any excess materials will be completely removed from the site. Channel width at the crossing will be less than 12 ft in order to maintain adequate depth along the crossing during low flow to allow for fish passage. Another boulder cross-vane and new plunge will be installed at Cross-section #2, approximately 15 ft upstream of the skid trail crossing. The new pool will be 1.7 - 2.0 ft deep with a RPD of 1.3 - 1.5. Excavated cobble will be removed from the site.

A double log cross-vane and new plunge pool will be installed downstream of the split channel in the middle of the site. The logs will be placed so that each vane ties into the mid-channel island immediately upstream. The new pool will be excavated to 1.7 - 2.0 ft deep with a RPD of 1.3 - 1.5. Small boulder clusters will be installed at the head of each of the split channels in order to stabilize the log-jam pool upstream, and to provide pocket water features within this high gradient riffle habitat. The boulders will be placed in a manner that will form step pools to allow for fish passage at low flows. The existing pool upstream of the log-jam will be deepened to 1.5 ft by excavating cobble from along the right bank. This will also create some under-cut combination cover along the well vegetated stream bank.

The existing pool at Cross-section #1 will be enlarged and enhanced by removing cobble armoring the bottom of the pool to obtain a maximum depth of 1.5 - 1.7 ft. At the upstream boundary of the site, a new pool will be constructed by re-aligning existing boulders in the stream channel into a boulder cross-vane structure. The new pool will be 1.7 - 2.0 ft deep with a RPD of 1.3 - 1.5 ft.

The in-channel and bank stabilization work in Access_3 will require 35 - 40 boulders and up to 3 trees to complete. Estimated fill below the ordinary high water mark of the stream is 4 to 6 yd³ each for the cross vane structure and the double log cross-vane pool, and 2 yd³ for hardening the low water crossing at the existing skid trail.

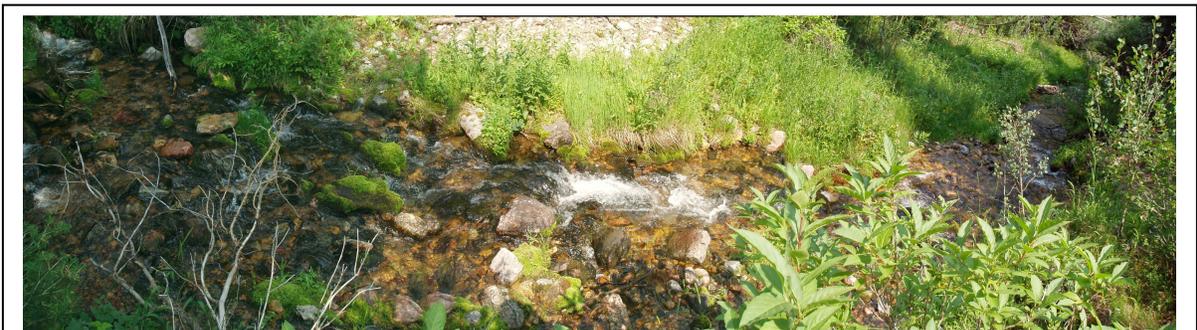
Photo 5: Treatment Site ACCESS_4 on Halleck Creek - from the left stream bank.

The two existing pools at the downstream boundary of the site (BWSHI pools 9 & 10) will be enhanced by excavating cobble armor from the bottom of each pool to create a new maximum depth of 1.7 - 2.0 ft deep with a RPD of 1.3 - 1.5 ft. The large log associated with these habitats will not be disturbed. A new log vane will be installed in the riffle upstream of these pools to form a new log-jam debris dam pool. Some minor excavation of the channel upstream of this log will be necessary to create a pool.

A boulder cross-vane will be installed immediately downstream of the skid trail crossing in order to maintain the channel grade at the crossing. A new plunge pool will be excavated immediately downstream of the structure. The maximum depth of the pool will be 1.5 - 1.7 ft, and the RPD will be 1.0 to 1.2 ft. Excavated material will be completely removed from the site. The skid trail approach slopes will be ripped and revegetated, and the stream banks at the crossing will be planted with willow and alder. If necessary, log toe-slope bank stabilization structures may be used at the crossing to provide adequate foundation for re-establishing vegetation.

Pocket water cover will be created in the riffle upstream of the skid trail crossing by manipulating existing boulders into small micro-vortex boulder clusters. Up to three of these cover features may be installed in the site.

A new full-channel boulder cross-vane and plunge pool will be constructed at the upstream boundary of Access_4. This structure will be located immediately downstream of a multiple-thread boulder cascade, at a brief, low gradient transition in the stream channel. Cobble armoring the channel below the cross-vane will be excavated and removed from the site. Additionally, small boulders in the habitat will be re-positioned to create a new, slightly higher riffle crest to further deepen and enhance the new pool. The new pool will have a targeted maximum depth of 1.7 - 2.0 ft deep with a RPD of 1.3 - 1.5 ft.

The in-channel and bank stabilization work in Access_4 will require 20 - 25 boulders and up to 3 trees to complete. Estimated fill below the ordinary high water mark of the stream is 4 to 6 yd³ each for the cross vane structures and the log-vane pool, and 0.2 yd³/linear ft for the log toe slope stabilization (4 yd³ total).

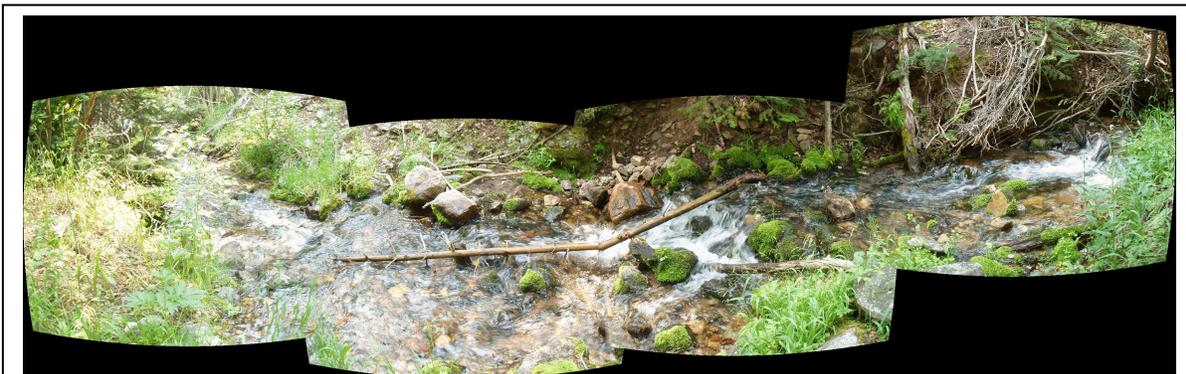
Photo 6: Treatment Site ACCESS_5 on Halleck Creek - from the right stream bank.

Two medium sized trees (DBH = 14" - 16") will be directionally felled into the stream channel at the constriction at the downstream boundary of Access_5 to create a new woody debris dam pool. These trees will be pushed down into the channel with their root-wads intact, to ensure that these features do not move during peak spring run-off flows. Disturbed areas around the base of the trees will be contoured and revegetated to prevent bank erosion at these points. Gradual accumulation of woody debris in this debris jam should create a new dam pool approximately 2 -2.5 feet deep and approximately 20 feet long.

A boulder cross-vane will be installed immediately downstream of the skid trail crossing by re-aligning existing boulders in the stream channel to form the cross-vane. A new plunge pool will be excavated immediately downstream of this structure. The maximum depth of the pool will be 1.5 -1,7 ft, and the RPD will be 1.0 to 1.2 ft. Excavated material will be completely removed from the site. The skid trail approach slopes will be ripped and revegetated, and the stream banks at the crossing will be planted with willow and alder. If necessary, log toe-slope bank stabilization structures may be used at the crossing to provide adequate foundation for re-establishing vegetation.

Pocket water cover will be created in the riffle upstream of the skid trail crossing by manipulating existing boulders into small micro-vortex boulder clusters. Up to three of these cover features may be installed in the site.

A new full-channel boulder cross-vane and plunge pool will be constructed at the upstream boundary of Access_5, at a brief, low gradient transition in the stream channel. Cobble armoring the channel below the cross-vane will be excavated and removed from the site. The new pool will have a targeted maximum depth of 1.7 - 2.0 ft deep with a RPD of 1.3 -1.5 ft.

The in-channel and bank stabilization work in Access_5 will require 20 - 25 boulders and up to 3 trees to complete. Estimated fill below the ordinary high water mark of the stream is 4 to 6 yd³ each for the two cross vane structures and the woody debris dam pool, and 0.2 yd³/linear ft for the log toe slope stabilization (4 yd³ total).

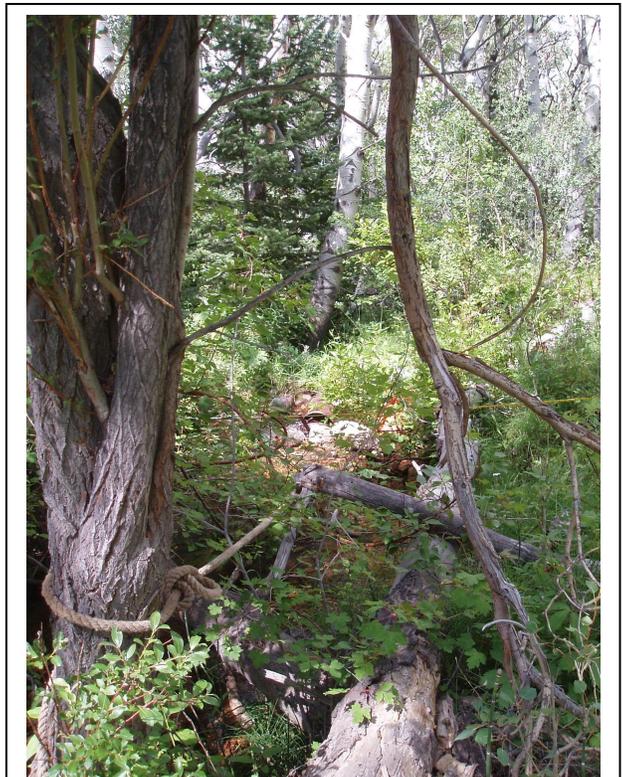
Photo 7: Diversion 2 looking downstream

Treatment Site H6 Diversion 2 is located near the downstream boundary of Halleck Creek Reach 6, and is approached from an ATV access route that parallels the irrigation ditch feeding the pasture lands between the main stem of Halleck Creek and Halleck#4 Creek to the east. H6 Diversion 2 is approximately 450 ft upstream of the east/west ATV access route that defines the downstream boundary of the project area. The existing diversion structure at H6 Diversion 2 consists of a 12" cast iron pipe embedded into an earthen berm consisting mostly of small cobble and gravel. The diversion is at a sharp, 90 degree bend that appears to have been constructed when the diversion was installed. Downstream of this point, there is a brief higher gradient riffle leading to the undisturbed stream channel below. The "head-gate" control on this diversion consists of a steel cap that seals the end of the pipe extending into the stream. In order for the diversion to function, a "come-a-long" block and tackle must be fastened to trees upstream of the pipe, and the cap forced open and held in place (Photo 7).

In addition to being difficult to operate, the diversion at H6 Diversion 2 is at risk of catastrophic failure from high flows breaching the earthen berm creating the artificially tight meander bend. If the existing structure were to be overtopped and fail, there is a high probability that the stream could re-align into the diversion ditch, creating significant problems downstream along the ATV access trail and in the pasture lands below. Additionally, the current structure, as configured, presents a significant barrier to fish and other aquatic organisms moving through the reach.

To reduce the risk of failure and improve the functionality of the diversion, a new 12" culvert and screw-type head-gate will be installed approximately 15 feet upstream of the present diversion point. This culvert and head-gate will be incorporated into a boulder cross vane that will provide sufficient stage at low flow to provide full capacity to the pipe leading to the diversion ditch. Downstream of the new cross-vane diversion structure, the stream channel will be re-aligned to reduce the radius of curvature of the meander bend and create a more consistent channel bed and water surface slope through the pocket water riffle below. Approximately 15 feet of stream channel will need to be re-aligned toward the right bank. Willow and alder vegetation removed along the right bank will be used to create a new bank-full riparian bench on the left bank at the old diversion point. Additionally, the existing earthen berm will be raised and re-enforced to ensure that the stream does not over-top this structure.

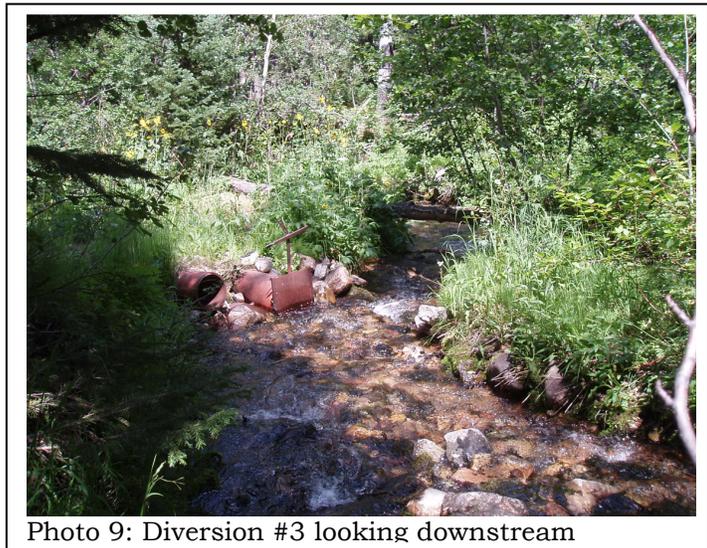
Photo 9: Diversion #3 looking downstream

Treatment Site H6 Diversion 3 is located approximately 450 ft upstream of H6 Diversion 2, and is approached from an ATV access route leading from the intersection of the Main Ranch road and the east / west ATV route defining the downstream boundary of the project area. The existing diversion structure at H6 Diversion 3 consists of two 12" cast iron pipes at differing elevations, embedded into an earthen berm consisting mostly of small cobble and gravel. The diversion is at a natural meander bend that does not appear to have been significantly altered when the diversion was installed. The "head-gate" control on this diversion is similar to H6 Diversion 2, and consists of a steel caps that seal the ends of the pipes extending into the stream. It does not appear necessary to use a block and tackle to keep this diversion open, however, the stream channel does appear to be down-cutting to the point where water may not enter either pipe at low flows.

The diversion at H6 Diversion 3 appears to have a slight risk of catastrophic failure from high flows breaching the earthen berm, possibly resulting in an undesirable stream re-alignment into the diversion ditch. The existing irrigation ditch elevation is considerably lower than the stream channel bed elevation, and failure of the structure would likely create a head-cut that would progress upstream.

To reduce the risk of failure and improve the functionality of the diversion all flows, a new 12" culvert and screw-type head-gate will be installed at the same location as the present diversion point. This culvert and head-gate will be incorporated into a boulder cross vane that will provide sufficient stage at low flow to provide full capacity to the pipe leading to the diversion ditch. The right stream bank forming the outside of the meander bend upstream of the diversion point will be reinforced using boulder and large wood to ensure that the stream cannot re-align into the diversion ditch. The existing earthen berm will be raised and re-enforced at the same time so that the stream does not over-top this structure.

Fish passage through the diversion will be assured by selectively removing cobble armoring the channel bed immediately upstream and downstream of the new boulder cross-vane to create new dam pool and plunge pool habitats both above and below the diversion point.
