Aquatic Habitat Survey
&
Habitat Enhancement Plan
for Bear Creek
Bear Creek Regional Park
El Paso County Parks Department
Colorado Springs, El Paso County
Colorado

FIN-UP Habitat Consultants, Inc.

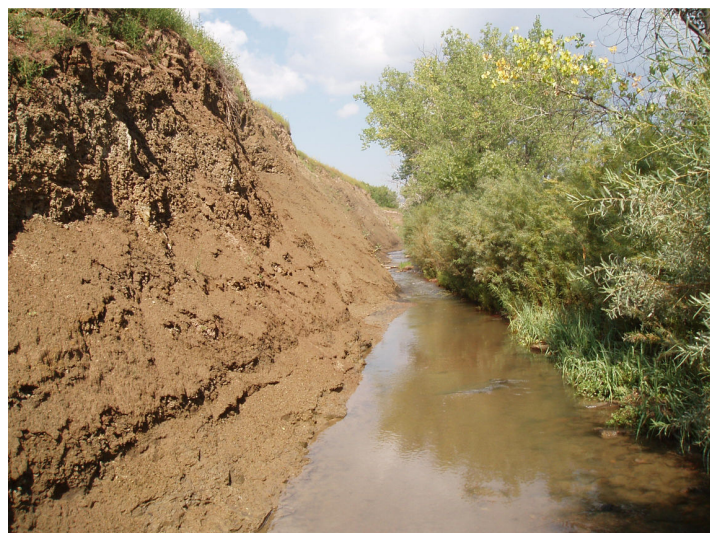
Reach 1 of Bear Creek is severely entrenched, flowing through a ravine that has degraded to bed-rock parent material (Photo 2). This ravine is approximately thirty feet deep in places, with extremely unstable banks subject to frequent toe slope failure and mass wasting into the channel. Aquatic habitat in most of the reach is extremely limited, and no fish were observed except in the upper most portion of the reach, where the entrenchment is not as severe. The geomorphic channel type was determined to be a Rosgen G4 channel in the lower section of the reach, with several segments of G1 where the channel has down-cut to bedrock. The upper-most limit of Reach 1 begins to exhibit characteristics of a B3 channel, with a identifiable floodplain and adjacent riparian zone. "B" channels tend to be somewhat less sinuous and slightly entrenched, and tend to exhibit a higher ratio of riffles to pool habitat. Most of Reach 1 on Bear Creek appears to have been physically altered by the construction of the Penrose Equestrian Center, which is located on the north bank of the stream throughout the reach. Most likely, the stream was straightened and relocated in order to accommodate the parking lots and barns for the center. Due

Photo 2: Ravine and Mass Waste Slope on Bear Creek

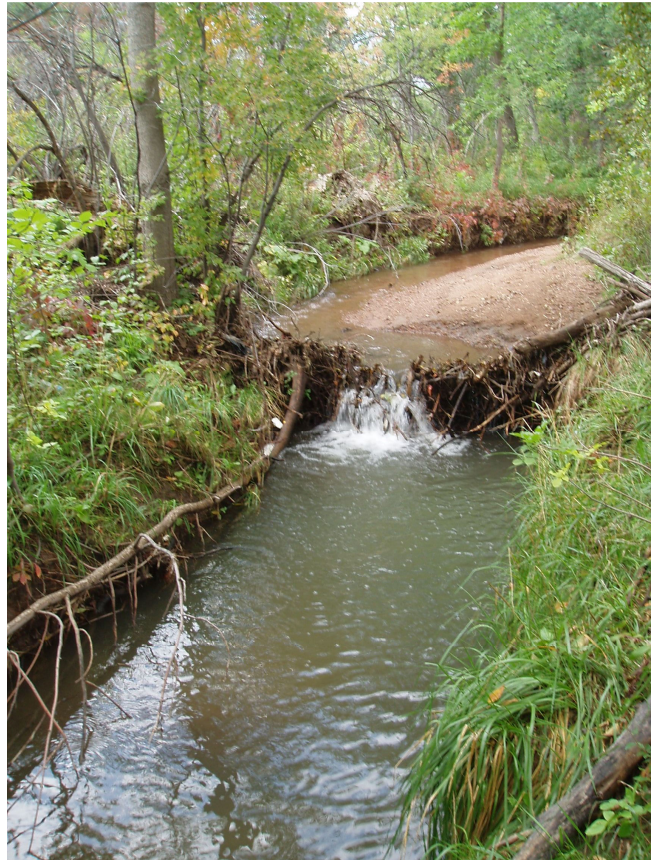
Photo 3: Plunge Pool 12 on Reach 2 - Bear Creek. Note sediment in storage in the channel upstream of the pool.

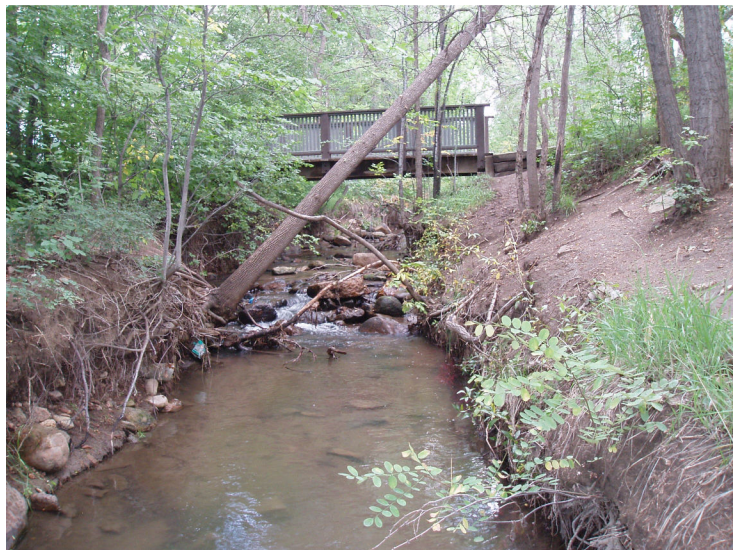
Glide habitat is considerably more extensive in the reach than should be expected for a B channel. Most of the glide habitats observed appeared to be former pools that had been completely in-filled with sediment. The eleven glide habitats observed comprised 282 ft of the length of the river, and tended to be associated with channel disturbances such as head-cuts, bridges and culverts (Photo 4). Cover for trout was extremely limited in these habitats, which tend to provide little protection from flows or predators. The average width of these glide habitats was 6.8 feet.

Photo 4: Poor glide habitat below Footbridge 4 in Bear Creek Reach 3. Note the entrenchment of the channel throughout this area.

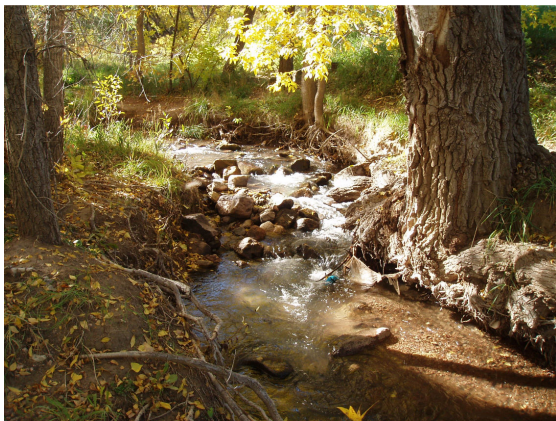
Currently, the greatest threat to aquatic habitat in reach 3 is the down-cutting of the stream channel near the downstream boundary of the reach and upstream of the culverts at Riffle 15. Active head-cuts are currently located near the transition from Riffle 7 and Glide 3, and immediately downstream of Glide 10 (Photos 5 & 6). Below these head-cuts, the channel has down-cut at least three feet, effectively abandoning the adjacent flood-plain and riparian zone (Longitudinal Profile in the Appendix). Left untreated, these head-cuts will continue to migrate upstream until a bedrock control or other hardened point in the channel is reached. Stream banks below the head-cuts are very unstable, with root-systems of adjacent alder and cottonwood exposed. These banks are subject to extreme shear stress during peak flows, and may collapse, resulting in the loss of important and esthetic tree cover and riparian vegetation along the banks. Continued down-cutting will also result in filling of pools downstream with sediment and further loss of critical deep water habitats. This inventory identified stream banks along Reach 3 that are already showing signs of bank failure. Stabilization of vertical channel profile and protection of stream banks downstream of the head-cuts may be enhanced through the strategic placement of rock vanes and full-channel cross-vane structures in the reach, as well as toe slope stabilization using boulder and large wood along the banks below the head-cuts.

Photo 5: Head-cut downstream of Glide 2

As stated earlier, there are two active head-cuts that need to be stabilized as soon as possible. The river will continue to down-cut upstream of these head-cuts as it adjusts to the new channel slope. The downstream head-cut can be repaired by installing a full-channel rock cross vane near the upstream boundary of Riffle 7 (X-Vane 3 on the Project Map in the Appendix). The upstream head-cut may be controlled by installing another full channel rock cross vane immediately downstream of Glide 10 (X-Vane 11). These vanes should be constructed to an elevation of the bank full stage of the old abandoned channel (Photo 7). These vanes should be constructed of large boulders ($3/4\text{ yd}^3$) fit tightly together, with smaller boulders and cobble in-fill, with adequate footer boulders and geo-textile filter cloth between the footers and the upper row of rock. Conceptual drawings and photos of actual cross-vanes may be found in the Appendix.

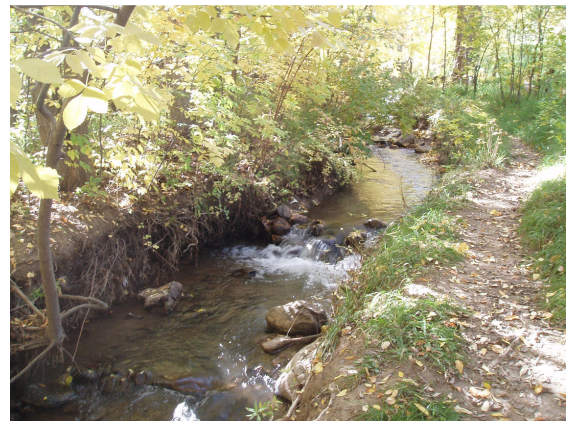
Photo 6: Head-cut downstream of Glide 10

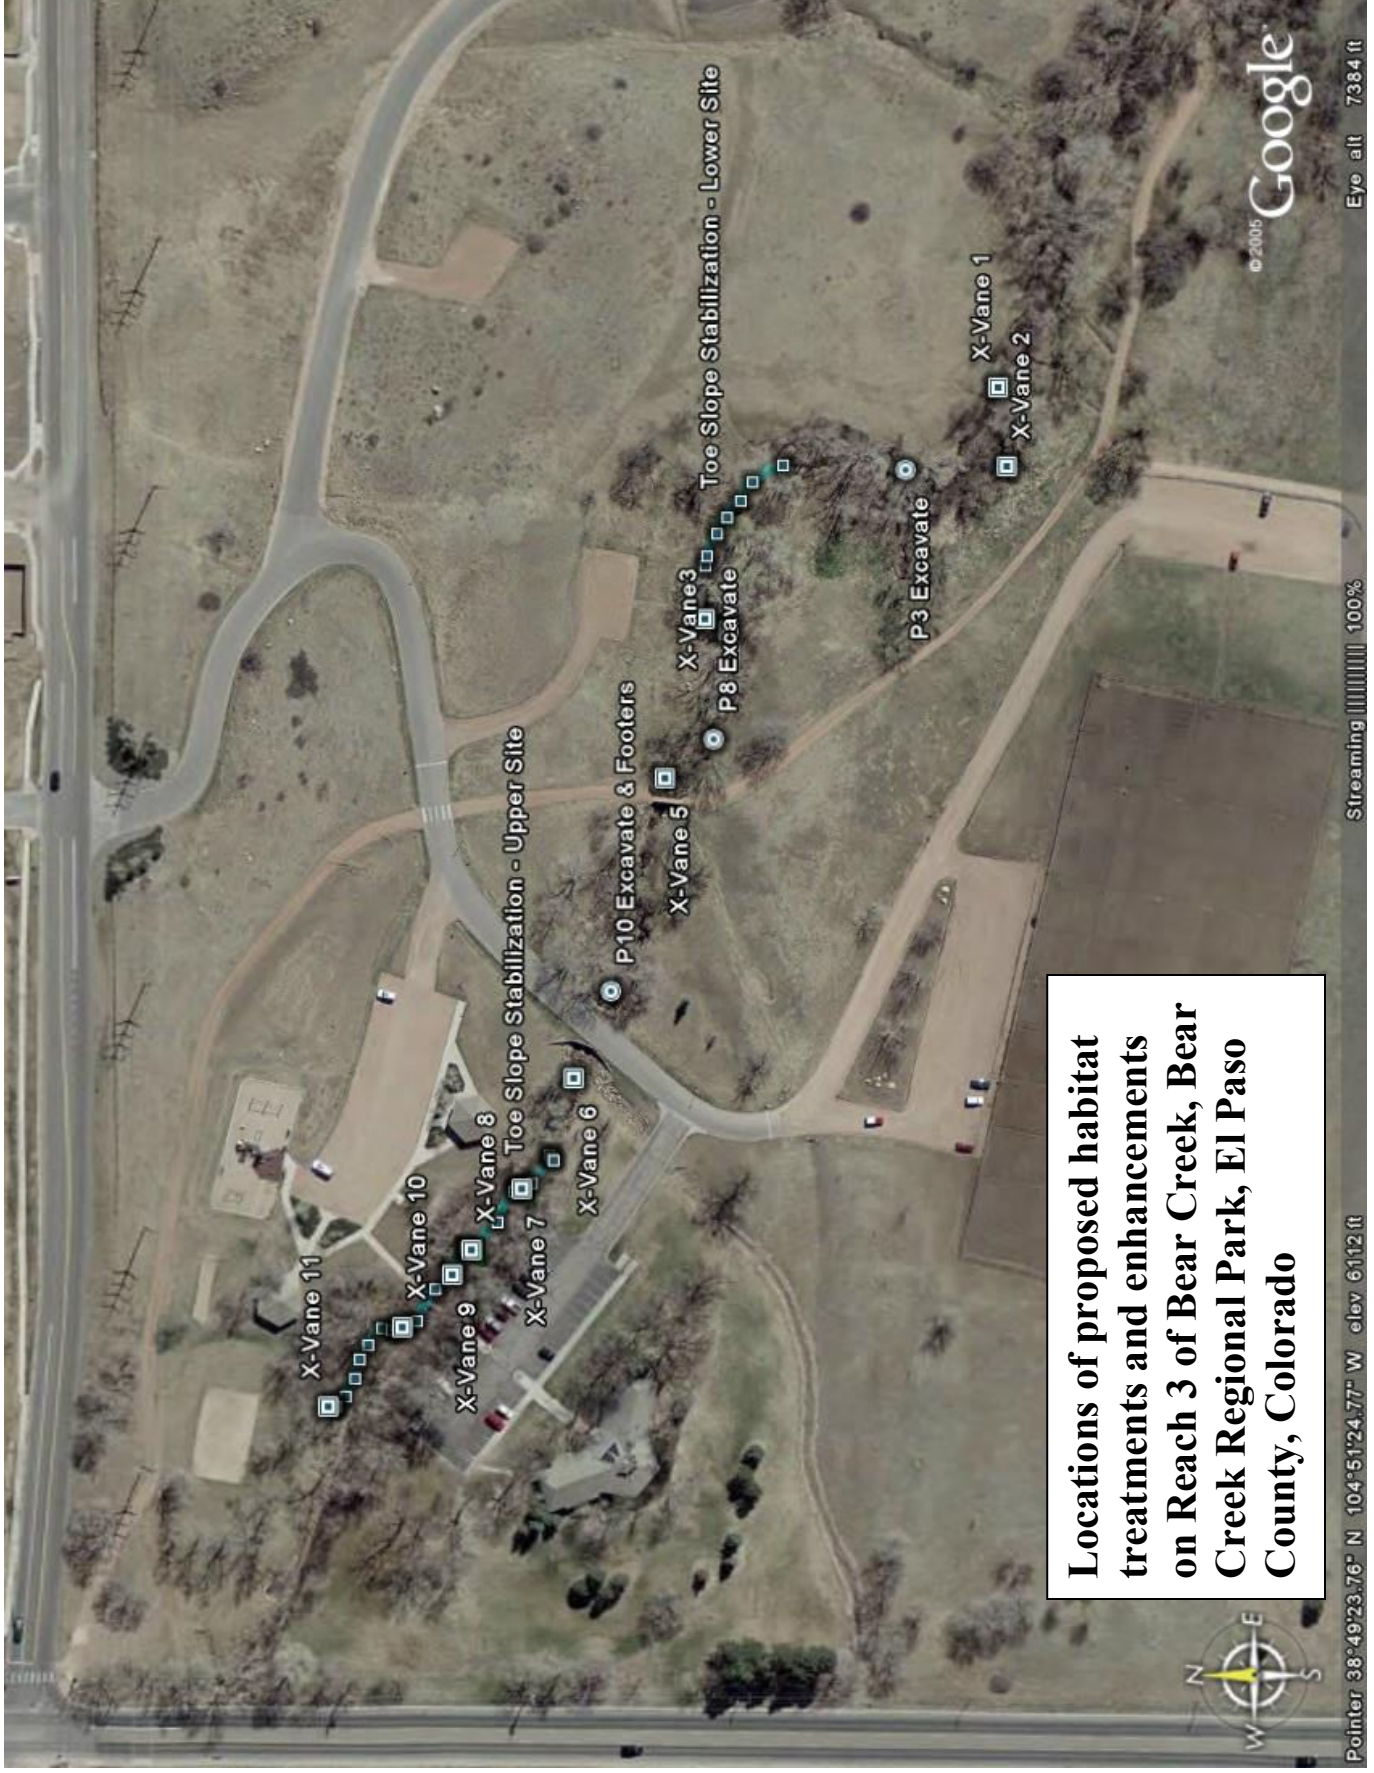
Locations of proposed habitat treatments and enhancements on Reach 3 of Bear Creek, Bear Creek Regional Park, El Paso County, Colorado

1. Construct a cross-vane (X-Vane 1) at the upstream boundary of Glide 1. Excavate Glide 1 down to the buried cobble substrate (approximately 1.5 ft).
2. Construct a cross-vane (X-Vane 2) at the upstream boundary of Glide 2. Excavate Glide 2 down to the buried cobble substrate (approximately 1.5 - 2 ft).

3. Remove two boulders and some cobble armoring the bottom of Pool 3 to allow for enhanced scour.
4. Install toe slope stabilization logs and boulders along 302 feet of stream banks (both sides of the channel) below the downstream head-cut. Re-vegetate stream banks above toe-slope structures using native riparian vegetation transplanted from adjacent areas. This toe slope stabilization begins at Riffle 6, and includes Pool 4, Riffle 7, and Glide 3. See Appendix for conceptual drawings and photographs of similar structures.

5. Construct a cross-vane (X-Vane 4) between Riffle 8 and Glide 4 to create a type 7 dam pool. There is heavy recreation use in this area, and the public has attempted to "create" this habitat by stacking cobbles in the stream. This structure will provide a deep water habitat (1.25 - 1.75ft) while also providing additional vertical stability in the channel.

6. Minor excavation of sediment in Pool 8. Remove approximately 1 ft of sediment from bottom of the pool.
7. Adjust boulders and install additional boulder to create micro vortex pocket water habitats in Riffle 13

8. The culverts forming Pool 10 most likely are barriers to migration of fish and other aquatic organisms. Remove armor from the pools downstream of the culverts to create enough depth so that trout may be able to pass into the culvert and maintain necessary burst speed to pass the 40 foot length. A pool depth of approximately 1 -1.5 feet may be necessary. Footer the culverts with boulders in order to prevent undercutting of these structures.

9. Construct a cross-vane (X-Vane 5) between Riffle 15 and Glide 5 to create a type 7 dam pool. This structure is immediately upstream of the road accessing the Park Headquarters building and may be an appropriate site for interpretation of the project for the public. This structure will provide a deep water habitat (1.25 - 1.75ft) while also providing additional vertical stability in the channel.

10. Install toe slope stabilization logs and boulders along 240 feet of stream banks (both sides of the channel) between Riffle 16 and Glide 7. Re-vegetate stream banks above toe-slope structures using native riparian

- vegetation transplanted from adjacent areas. This toe slope stabilization includes Riffle 17, and Glide 6.
11. Construct a cross-vane (X-Vane 7) at the upstream boundary of Glide 7 to enhance scour and stabilize the vertical channel profile.

12. Construct a cross-vane (X-Vane 8) at the upstream boundary of Riffle 18 to stabilize the vertical channel profile.
 13. Construct a cross-vane (X-Vane 9) at the upstream boundary of Glide 8 to enhance scour and stabilize the vertical channel profile.

14. Install toe slope stabilization logs and boulders along 168 feet of stream banks (both sides of the channel) between Glide 9 and Glide 10. Re-vegetate stream banks above toe-slope structures using native riparian vegetation transplanted from adjacent areas. This toe slope stabilization includes Riffle 20

15. Adjust boulders and install additional boulder to create micro vortex pocket water habitats in Riffle 21
 16. Remove concrete and other materials from a failing retaining wall that is collapsing into the channel within Pool 11.
