Aquatic Assessment & Habitat Enhancement Plan The Cucharas River Cuchara Valley Ranch Huerfano County - Colorado

J. Peter Gallagher 220 Illinois Ave Manitou Springs, CO 80829 (719) 685-9768 (Office) (719) 332-2550 (Cell) <u>pete@fin-up.com</u> September 30, 2008

Table of Contents

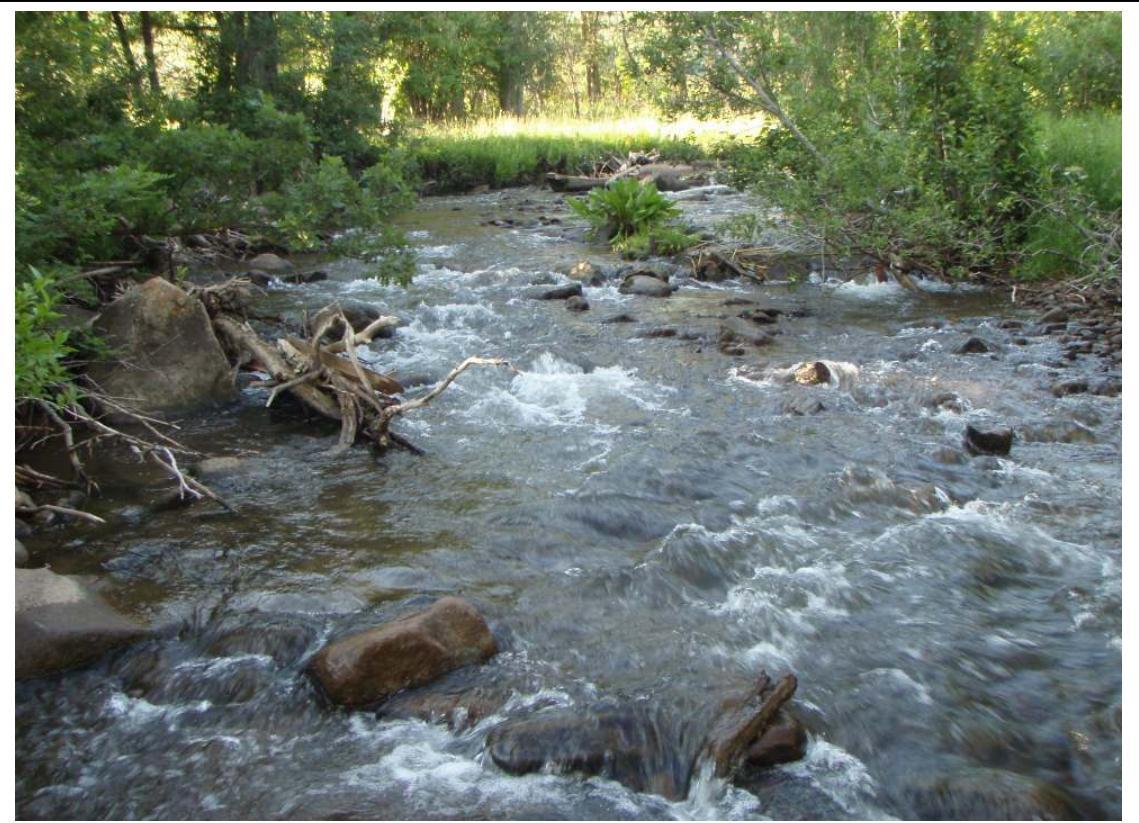
Photo 1: Typical boulder/cobble dominated riffle in Reach 1 of the Cucharas River.

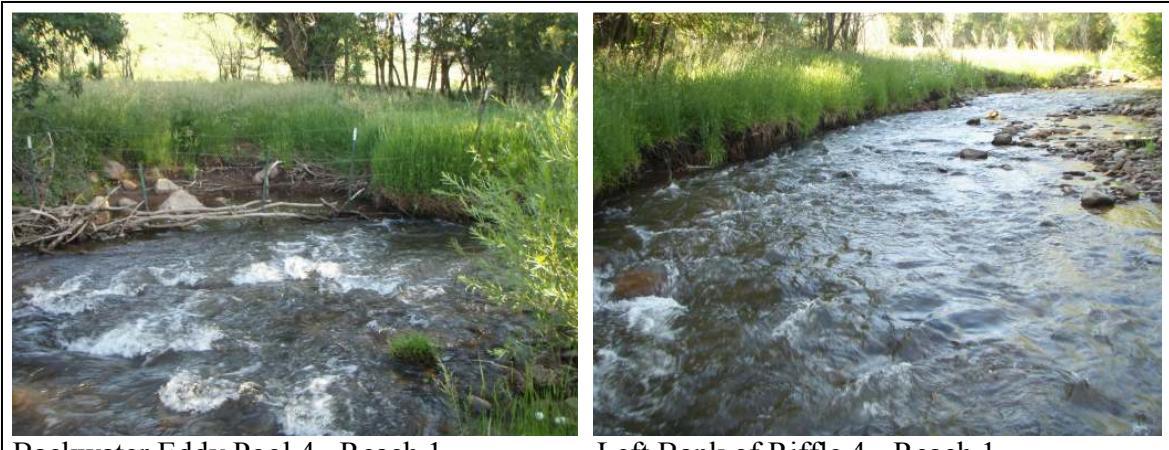
Backwater Eddy Pool 4 – Reach 1.

- One hundred feet of log toe-slope bank full bench, planted with native willow, will be installed along the left bank of Riffle 4 to eliminate an actively eroding bank. Additionally, up to four small rock vanes / groins will be installed at intervals along the treated bank to provide for additional velocity shelter / pocket water for trout in this riffle. Three large cottonwood trees and approximately 14 boulders (0.5 yd³ each) will be required for this work. The estimated amount of fill per linear foot of treated bank is not expected to exceed 0.2 yd³.
- The failed boulder drop structure at Riffle 6 will be removed from the river, and the boulders will be re-used to create a small J-Hook Vane on the left stream bank at this site to reduce shear forces and erosion. No additional fill should be necessary to construct this feature.

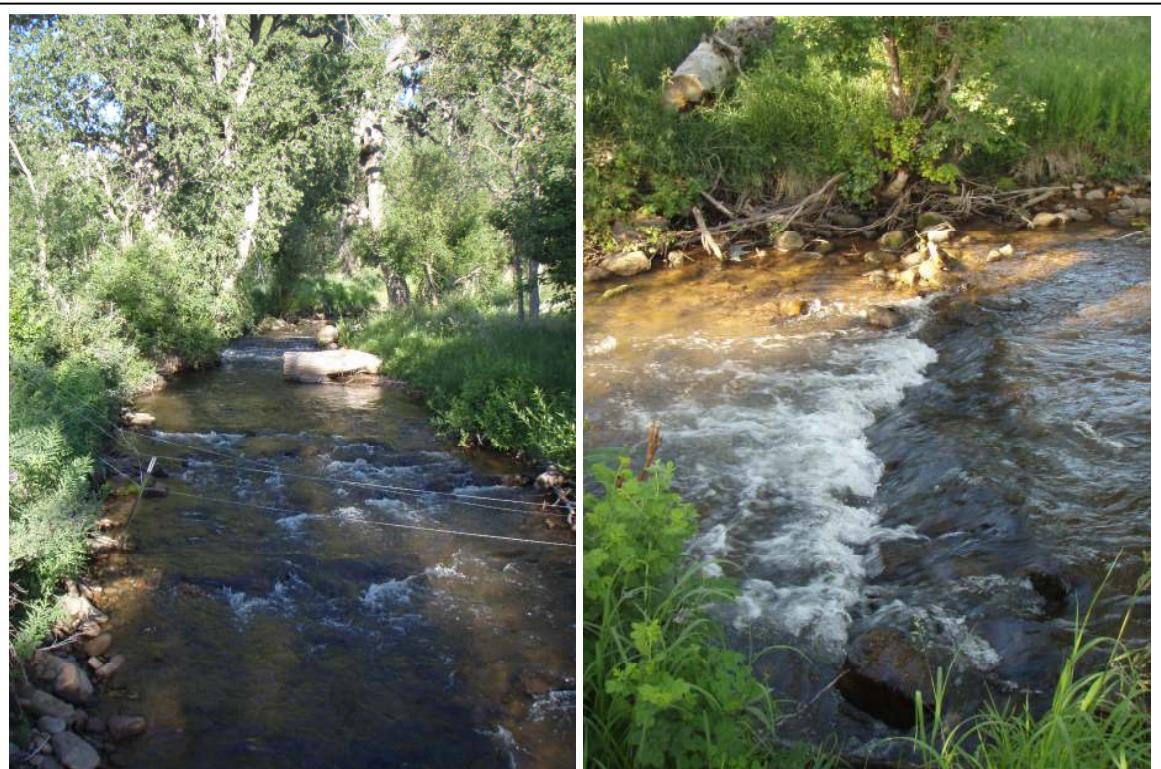
Site of the proposed double log/boulder cross vane at Pool 3 – Reach 2.

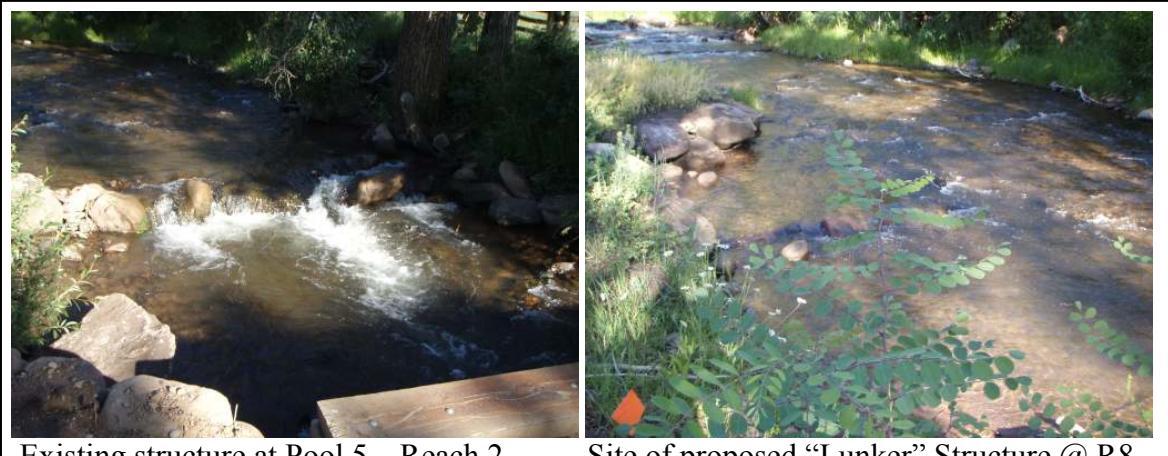
Existing structure at Pool 5 – Reach 2.

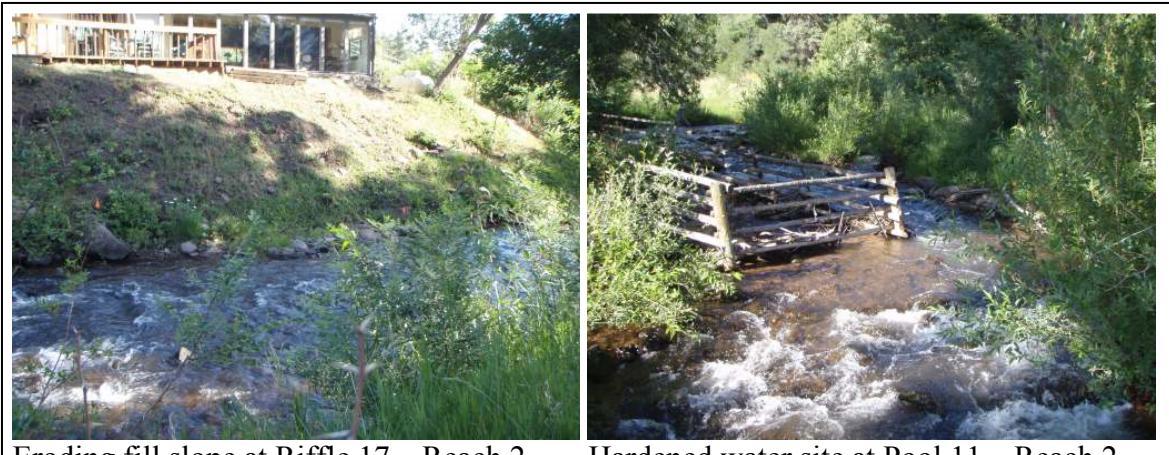
Eroding fill slope at Riffle 17 – Reach 2. Hardened water site at Pool 11 – Reach 2.
