Upper Rattlesnake Creek
Aquatic Habitat Enhancement Project
Elk Mountain Ranch
Carbon County, WY

FIN-UP Habitat Consultants, Inc.

Upper Rattlesnake Creek
Habitat Enhancement Project
Elk Mountain Ranch
Carbon County, WY

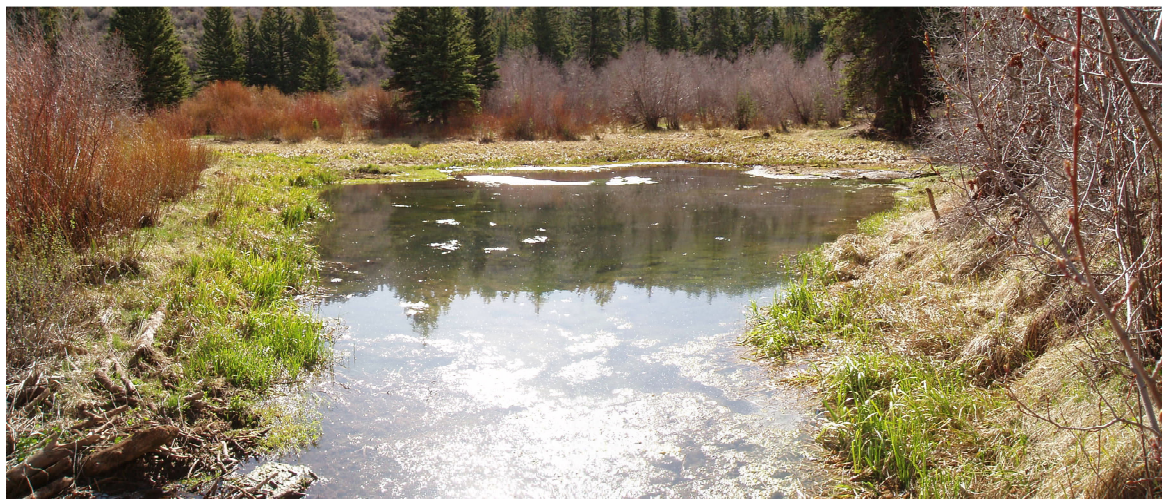
The pond is surrounded along the eastern and southern shorelines, and along the first 75 ft of the feeder channel, by relatively extensive wetland/riparian plant communities, consisting primarily of carex and willow. Riparian vegetation is limited to a narrow green-line along the western shore of the feature, due to the steep topography and encroachment by the Rattlesnake Creek Road. The beaver pond, and the remnants downstream no longer appear to be inhabited by beaver, although there is evidence of several colonies downstream in Reach 2, 3, and 4.

Off-Channel Beaver Pond looking South East adjacent to Reach 6 on Rattlesnake Creek.

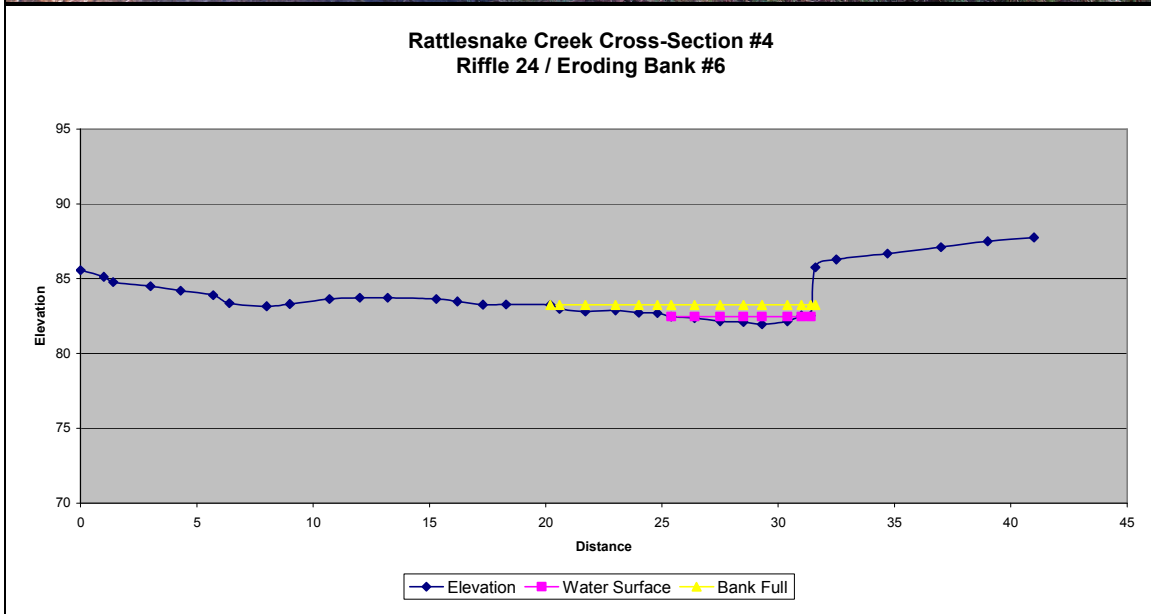
Chart 6: Cross-Section #4 @ R5-EB6 along Reach 5 on Rattlesnake Creek.

The other channel cross-sections indicate that there may be some lateral instability of the reach, with frequent vertical, poorly vegetated stream banks subject to considerable shear stress on the outside of the meander bends (Cross Sections #4 and #6). Cross-Section #4 (Chart 6) is a good example of lateral instability and bank failure occurring in the reach. The stream, though this cross-section, exhibits a tight meander bend, and is rapidly eroding the right bank, which is failing at several points. The width/depth ratio of the channel is currently 15.8 and appears to be gradually increasing. The point bar on the inside of the meander is stable however, and is well vegetated. The vegetation on the right bank however, consists of mostly shallow rooted upland grasses. Left untreated, the stream will continue to erode into the right bank, increasing sedimentation downstream. The photo in the chart above shows the cross-section from upstream, looking downstream at the site.

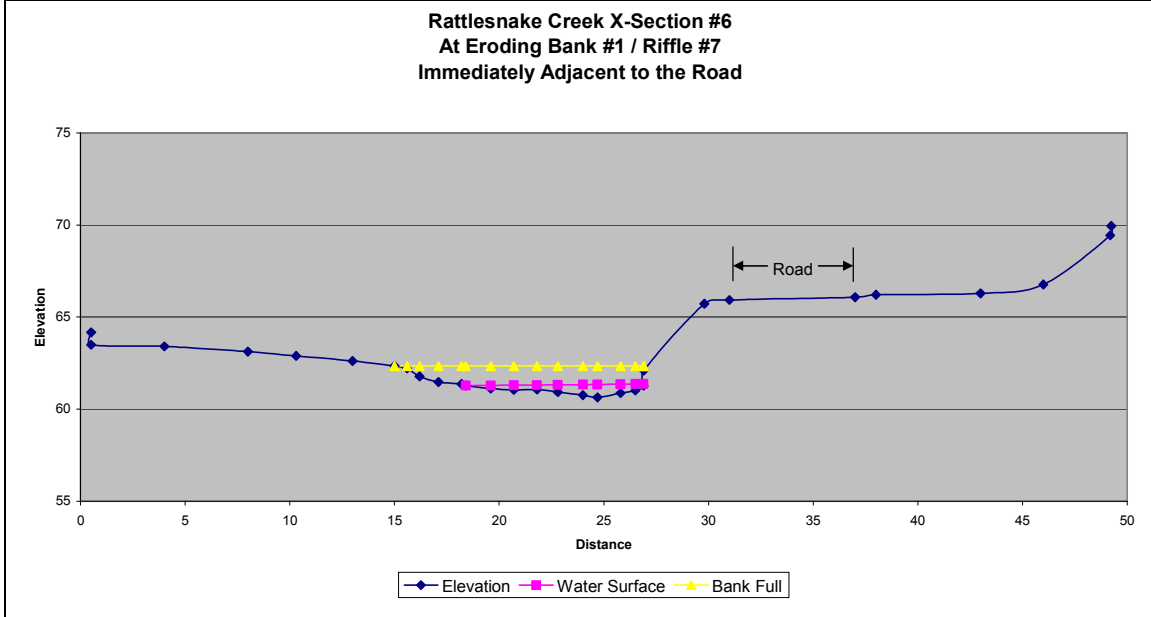
Chart 7: Cross-Section #6 @ R5-EB1 along Reach 5 on Rattlesnake Creek.

Cross-Section #6 is an example of the road/stream interactions occurring within the reach (Chart 7). As is the case with Cross-Section #4, the stream exhibits an extremely tight meander bend at the point where it is immediately adjacent to the road. The road-side stream bank vegetation is shallow rooted and very sparse, and the bank has failed at several points. Left untreated, the stream will eventually erode the bank to the point where the road will be cut-off. The photo in Chart 7 shows the cross-section from upstream of the site, looking downstream.

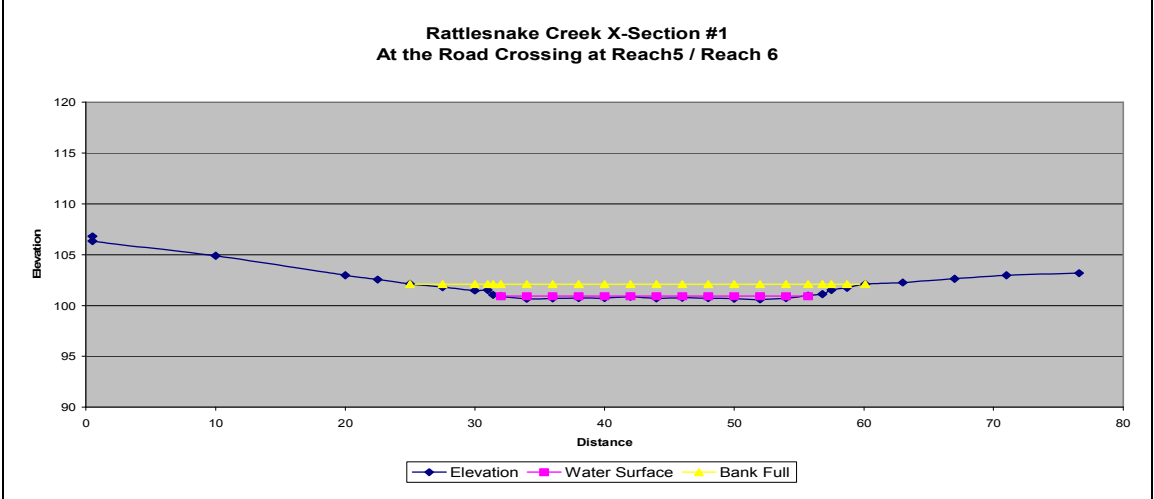
Chart 8: Cross-Section #1 @ the R5/R6 Reach Boundary on Rattlesnake Creek.

Additionally, there are several segments of the reach that exhibit channel width/depth ratios greater than would be expected or desirable in this channel type. Over-wide channels are a significant problem at the Reach 5/Reach 6 road crossing, and immediately downstream of this point (Cross-Section #3, Chart 9), where width/depth ratios range from 13 to over 31. The road crossing (Cross-Section #1, Chart 8) is likely a barrier to fish migration through the reach during the low flows found in late summer and fall, due to lack of depth or defined channel through the crossing. The photographs in each of these charts are taken from downstream of the cross-sections, looking upstream.

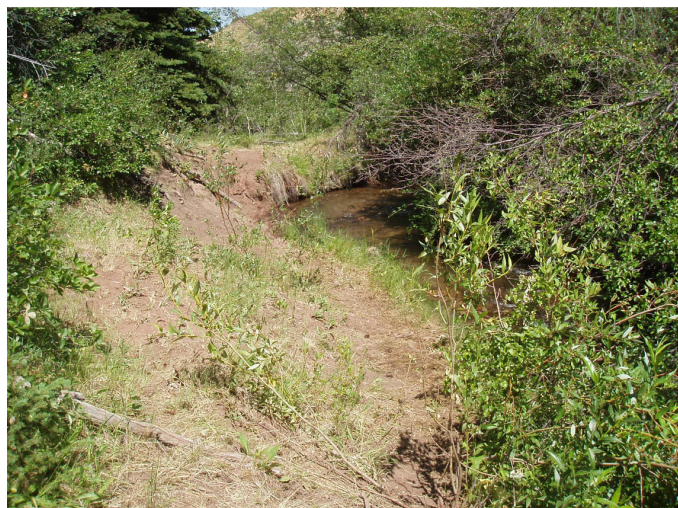
Photo 7 - Site R4-EB1 Downstream

The first treatment site on Reach 4 is designated as GPS point R4-EB1 on the map, and consists of 75 ft. of actively eroding stream bank on the right side of the channel. This segment of the stream lies along a corridor frequently utilized by elk, which has resulted in severe hoof-shear and collapse of the bank. Additional pressure from grazing cattle has resulted in banks that are nearly devoid of vegetation and actively contributing sediment to habitats downstream. Two pools exist along the 75 ft length, and could be further enhanced at the same time as the bank stabilization. The segment is shown in Photos 7 and 8, looking downstream and upstream respectively. Recommended treatment includes installing 3 log toe-slope structures along the right bank, and transplanting willow behind these structures. The channel throughout this segment is not overly wide, therefore the logs will be installed flush against the existing stream bank, creating a bench on which to transplant willow harvested from the riparian area beyond the left bank. A short segment of the right and left banks immediately downstream of Pool 3 will be armored with small cobble in order to provide a hardened crossing for elk. Two log/boulder J-hook vanes will be installed on the right bank adjacent to the existing pool habitats, to further protect the right bank and to enhance scour in these habitats. A total of 5 pieces of large wood, 8 to 10 boulders (0.5 yd³ each), and 1.5 yd³ of cobble will be required for this site. Fill below the ordinary high water mark of the stream for the log/boulder J-hook vane structures is estimated to be approximately 2.5 to 3.5 yd³ for each structure. Bank stabilization fill below the ordinary high water mark is expected to be approximately 0.1 yd³ per linear foot of bank for the log-toe-slope structures, and 0.2 yd³ per linear foot for the cobble hardened crossing. Total fill for the site is estimated not to exceed 15.5 yd³. Good access is available to the site along the elk / cattle path leading to the stream, therefore no wetlands will be effected in the course of this work.

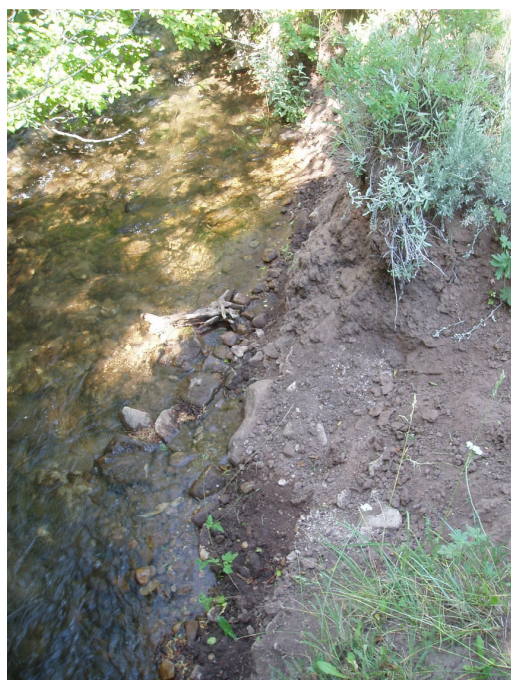
Photo 9 - Site R4-EB2 Left Bank

The next treatment site is designated as R4-EB2, and consists of a short segment of collapsing stream bank that can be easily treated with a single log toe-slope structure and willow transplant (Photo 9). The log will be installed flush with the existing bank, and anchored with two small boulders and willow transplants. Total fill below the ordinary high watermark of the stream channel should not exceed 0.2 yd³/linear foot of stream bank treated. Total fill is expected to be less than 3 yd³. The site is easily accessible from the Rattlesnake Creek road, and no wetlands will be affected.

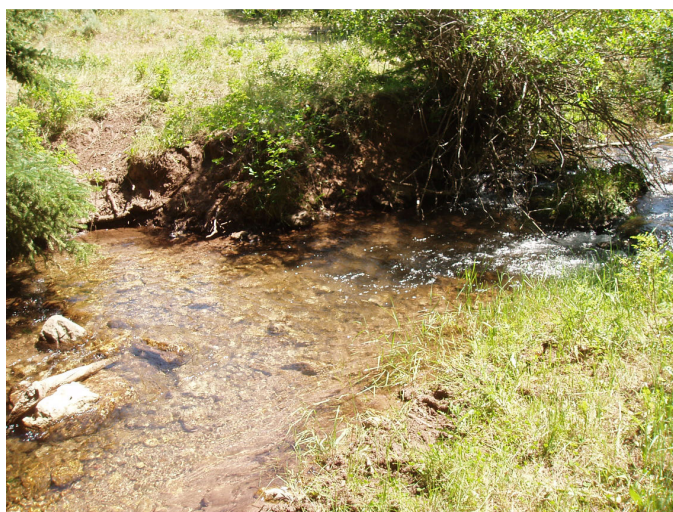
Photo 10 - Site R4-EB3 From Right Bank

Treatment site R4-EB3 is immediately adjacent to the Rattlesnake Creek road and consists of approximately 15 feet of eroding left bank with a very shallow pool near the upper end of the site (Photo 10). The eroding stream bank will be treated using a single log toe-slope structure (0.2 yd³/linear foot - 3 yd³ cumulative). The pool may be enhanced by removing some of the larger cobble and small boulders that are limiting scour in this feature. Any large rock removed from the pool will be used to anchor the ends of the log toe-slope structure on the left bank.

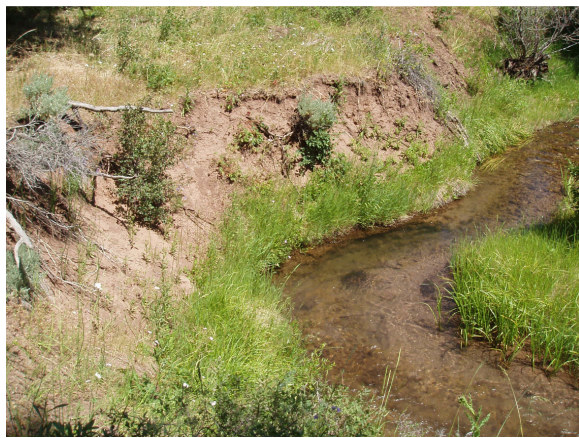
Photo 11 - Site R4-EB4 Downstream

The eroding bank at R4-EB4 is not easily accessible to equipment, and therefore will not be treated under this project. The unstable bank is approximately 70 ft long, and appears to be gradually healing, as evidenced by the line of riparian sedges that have become established along the toe-slope of

the stream bank (Photo 11). This bank should continue to be monitored to ensure that it continues this trend.

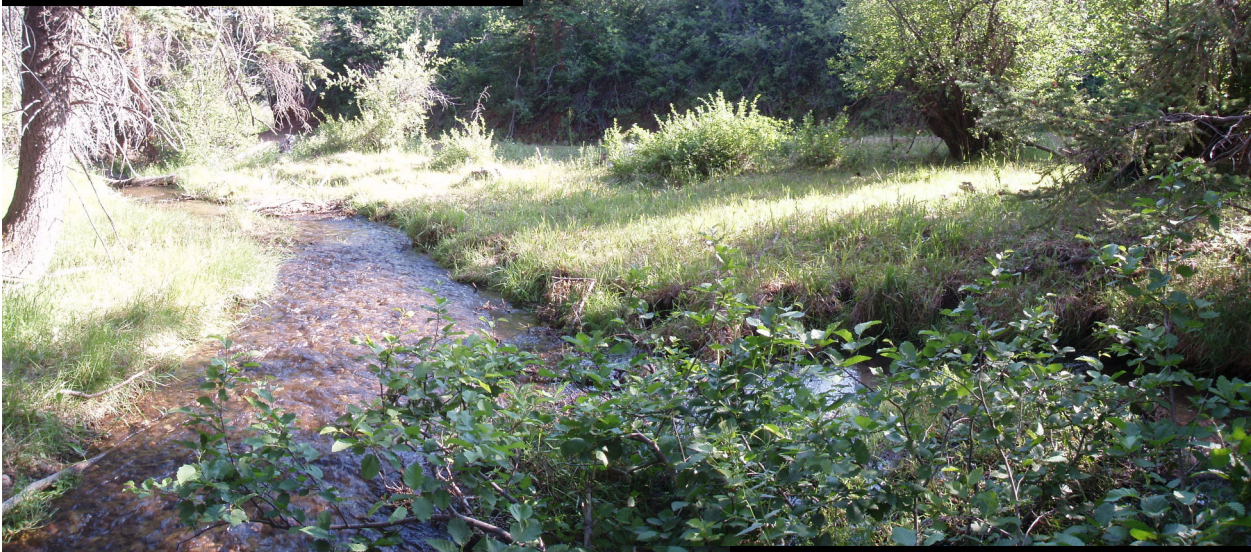
Photo 14 - Site R5-EB2 Looking Downstream

Treatment site R5-EB2 (Photo 14) corresponds with Riffle 10 in the BWSHI, and consists of 40 ft of unstable left stream bank, and a somewhat over-wide stream channel due to the formation of a mid-channel bar in the upstream boundary of the site. Treatments will include installing a large tree along the left stream bank, and revegetating the bank with sedges harvested from the mid-channel bar. A small log/boulder vane will be installed at the downstream boundary of this site to enhance scour and cover in Pool 8. Two pieces of large wood, and 4 - 5 boulders (0.5 yd^3 each) will be required for this site. Fill below the ordinary high water mark of the stream for the log/boulder vane is estimated to be approximately 2.5 to 3.5 yd^3 . Bank stabilization fill below the ordinary high water mark is expected to be approximately 0.2 yd^3 per linear foot of bank for the log-toe-slope structure. Total fill for the site is estimated not to exceed 10.5 yd^3 .

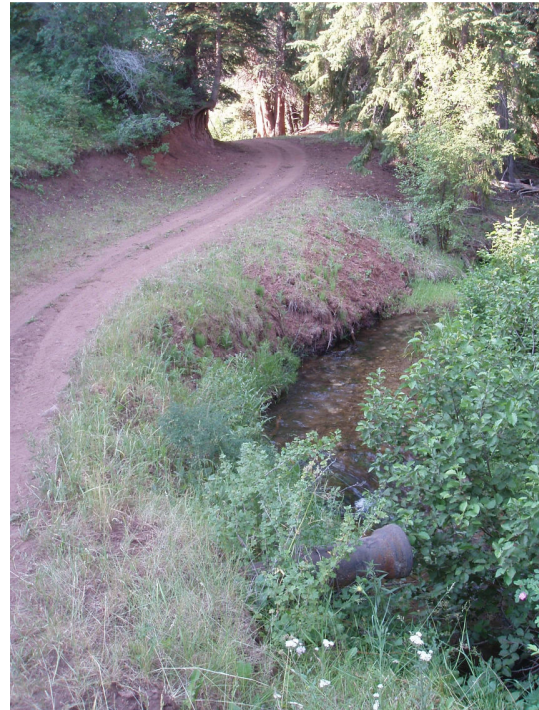
Photo 13 - Site R5-EB1 Looking U/S.

The first eroding stream bank treatment site on Reach 5 is designated as GPS point R5-EB1 on the map, and corresponds with Riffle 7 in the BWSHI and Cross-Section # 6 described in the previous chapter. The site consists of 35 ft. of actively eroding stream bank on the left side of the channel. The road is immediately adjacent to the stream channel at this site, and is at risk of collapsing into the stream (Photo 13). The road will need to be moved approximately 8 ft to the east, away from the stream. There is adequate width between the stream and the steep hill slope to allow for this re-location. The collapsing left bank will be stabilized using two log toe-slope bank structures placed flush against the existing stream bank. These toe-slope structures will be anchored using small boulder vanes extending $1/3$ of the distance into the channel, at an angle not to exceed 30° from the bank. These structures will further reduce the sheer stress along the outside of this meander bend, as well as providing additional in-stream cover within Riffle 7. The existing vertical bank will be sloped back to the edge of the newly relocated road and will be revegetated using native willow and sedges transplanted from the point bar on the inside of the meander bend. A total of 2 pieces of large wood, and 12 to 14 boulders (0.5 yd^3 each) will be required for this site. Fill below the ordinary high water mark of the stream for the boulder vanes is estimated to be approximately 2.5 to 3.5 yd^3 for each structure. Bank stabilization fill below the ordinary high water mark is expected to be approximately 0.1 yd^3 per linear foot of bank for the log-toe-slope structures. Total fill for the site is estimated not to exceed 10 yd^3 .

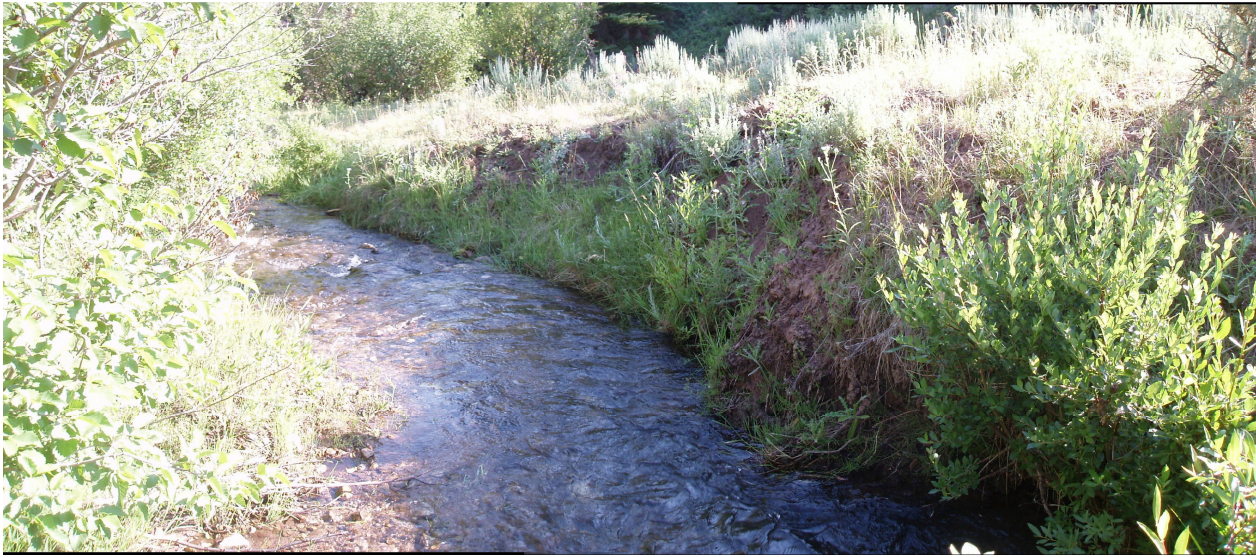
Photo 17 - Site R5-EB4 Looking Downstream at left bank.

Site R5-EB4 (Photo 17) corresponds with Riffle 21 in the BWSHI and consists of 120 ft of relatively unstable and steep stream bank on the left side of the channel, including 25 ft of actively eroding stream bank contributing sediment to the channel. Three logs will be installed flush with the left bank, and revegetated using native willow available on the other side of the stream. Additionally, two pools (Pool 21 and 22) will be enhanced by installing log/boulder vanes to improve scour and depth, as well as reducing sheer on the unstable left bank between the pools. Five pieces of large wood, and 8 boulders (0.5 yd³ each) will be required for this site. Fill below the ordinary high water mark of the stream for the log/boulder vanes is estimated to be approximately 2.5 to 3.5 yd³ per structure. Bank stabilization fill below the ordinary high water mark is expected to be approximately 0.1 yd³ per linear foot of bank for the log-toe-slope structure. Total fill for the site is estimated not to exceed 19 yd³.

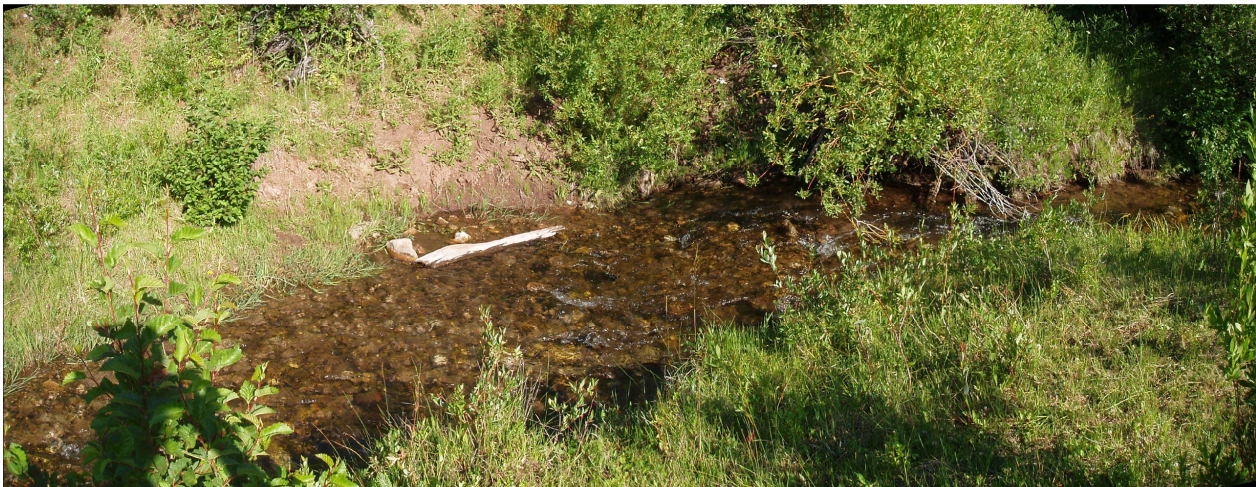
Photo 18 - Site R5-EB5 Looking Downstream at left bank.

Site R5-EB5 (Photos 18) corresponds with Pool 24 and Riffle 23 in the BWSHI and consists of 20 ft of actively eroding stream bank contributing sediment to the channel. Treatment will include installing a tree along the right stream bank, and revegetating the bank with willow harvested from the point bar on the inside of the meander bend. A small log/boulder vane will be installed at the downstream boundary of the toe slope structure to enhance scour and cover in Pool 24. Two pieces of large wood, and 4 - 5 boulders (0.5 yd³ each) will be required for this site. Fill below the ordinary high water mark of the stream for the log/boulder vane is estimated to be approximately 2.5 to 3.5 yd³. Bank stabilization fill below the ordinary high water mark is expected to be approximately 0.1 yd³ per linear foot of bank for the log-toe-slope structure. Total fill for the site is estimated not to exceed 5.5 yd³.

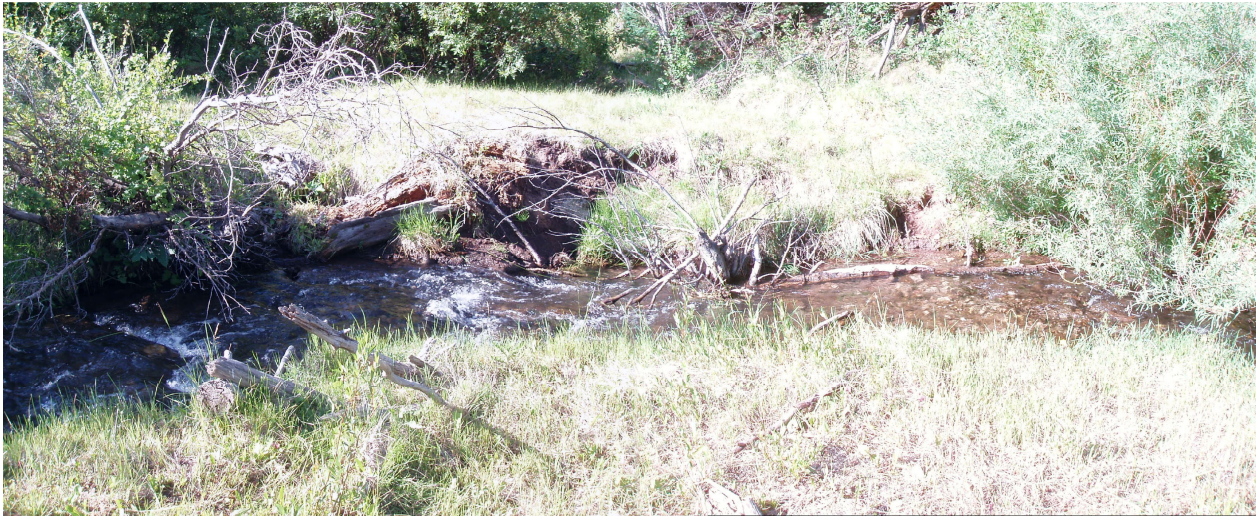
Photo 22 - Site R5-EB8 Looking Across the Channel at Right Bank.

Site R5-EB8 (Photo 22) corresponds with Pool 27 in the BWSHI and consists of 13 ft of generally unstable stream bank on the left side of the channel, with 7 linear feet of the bank actively contributing sediment to the system. Treatment will include installing a tree flush along the right stream bank, and revegetating the bank with willow and sedge harvested from near the site. A small log/boulder vane will be installed at the upstream boundary of the toe slope structure to enhance scour and cover in Pool 27. Additionally, some accumulated sediment will be excavated from the pool and removed from the site. Two pieces of large wood, and 4 - 5 boulders (0.5 yd³ each) will be required for this site. Fill below the ordinary high water mark of the stream for the log/boulder vane is estimated to be approximately 2.5 to 3.5 yd³. Bank stabilization fill below the ordinary high water mark is expected to be approximately 0.1 yd³ per linear foot of bank for the log-toe-slope structure. Total fill for the site is estimated not to exceed 5.5 yd³.

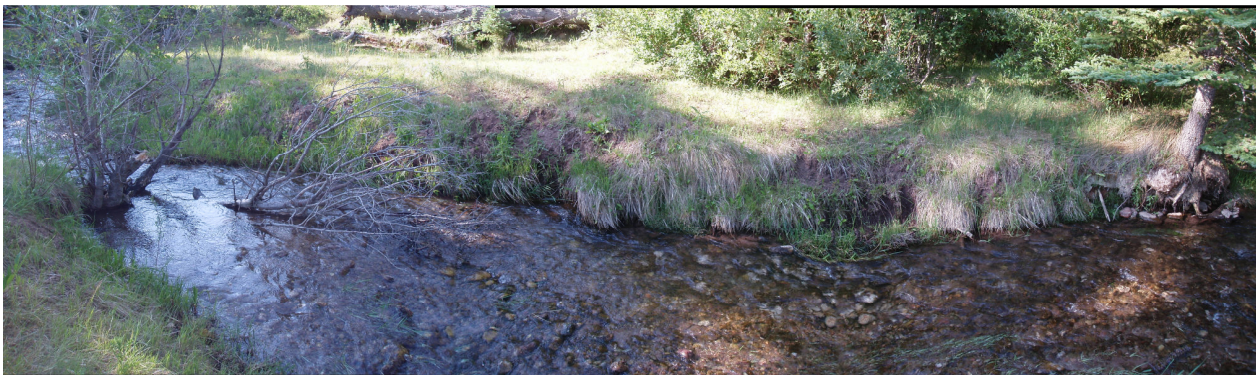
Photo 23 - Site R5-EB9 Looking Across the Channel at the Right Bank.

Site R5-EB9 (Photo 23) corresponds with Riffle 28 and Pool 29 in the BWSHI and is characterized by unstable and poorly vegetated stream banks on the right stream bank. The site is approximately 30ft long. Treatments will include installing a tree flush along thirty feet of the right stream bank, and revegetating the bank with willow and sedge harvested from near the site. A small log/boulder vane will be installed at the tail of Pool 28 in order to increase residual pool depth and cover within this feature. Two pieces of large wood, and 5 - 6 boulders (0.5 yd³ each) will be required for this site. Fill below the ordinary high water mark of the stream for the log/boulder vane is estimated to be approximately 2.5 to 3.5 yd³. Bank stabilization fill below the ordinary high water mark is expected to be approximately 0.1 yd³ per linear foot of bank for the log-toe-slope structure. Total fill for the site is estimated not to exceed 6 yd³.

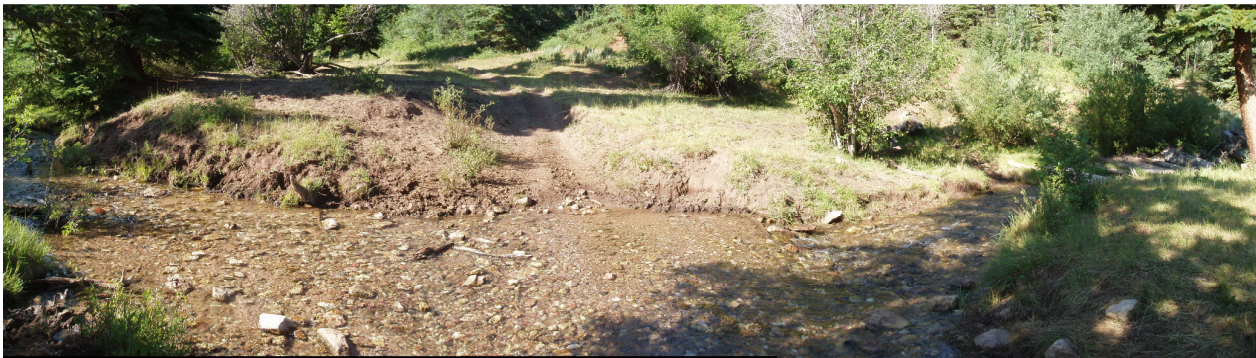
Photo 28 - Site R5-EB11/R6EB1 Looking Across the Channel at the Right Bank.

Site R5-EB11 and R6-EB1 (Photos 26, 27 and 28) correspond with the low water road crossing at the upstream Reach 5/Reach 6 boundary, and Cross-Sections #1 and #2 in the preceding chapter. R5-EB11 and R6-EB 1 are immediately adjacent, and have been combined into one project site for the purposes of this description. The channel throughout this site is characterized by high width/depth ratios, unstable and poorly vegetated stream banks, and severely limited habitat for trout. During low flows in the late summer and fall, the site is likely a barrier to migration of fall spawning brown trout. The site is approximately 100 ft long, with most of the banks actively contributing sediment to the channel. A schematic of the proposed work is shown in Diagram 1 and in the appendix.

Large wood toe-slope structures and transplanted willow will be utilized to define the stream banks throughout the site. These structures will be installed so as to reduce the width/depth ratio of the channel along Cross-Section to a W/D of 12 - 15 from the current W/D of 31. The areas behind these bank structures will be filled with transplanted willow and sedge mats harvested from areas nearby the site. A boulder cross vane will be installed immediately downstream of the low water crossing, in order to maintain the grade at the crossing, as well as to providing additional pool habitat and depth necessary for trout to maximize burst speed necessary to pass the low water crossing during low flows. Additionally, another cross vane will be installed at the upstream boundary of the site to create an additional new pool in Reach 6, as well as anchor the tree toe-slope treatments. This pool will provide additional velocity shelter and refugia for trout migrating upstream through the crossing during spawning. The road approaches to the low water crossing will be hardened using large gravel and cobble imported to the site. The gravel/cobble armoring of the approaches will extend down to the ordinary high water mark of the channel, but not below this elevation. Additionally, water-bars will be constructed on the southern approach to the crossing in order to deflect run-off from the road away from the creek. Benefits of this work will include eliminating the hydrologic connection between the road and the stream, eliminating a potential barrier to migration, and providing the ranch with a

potential hardened watering site for cattle when the pasture is grazed., Seven pieces of large wood, and 30 - 32 boulders (0.5 yd³ each) and approximately 22 yd³ of cobble will be required for this site. Fill below the ordinary high water mark of the stream for each cross-vane is estimated to be approximately 8 yd³. Bank stabilization fill below the ordinary high water mark is expected to be approximately 0.1 yd³ per linear foot of bank for the log-toe-slope structure. Additionally, up to 7 yd³ of transplanted willow and sedge mats may be used to re-vegetate the areas behind the log toe-slope structures. Total fill, including boulder, willow/sedge transplants and large wood for the site is estimated not to exceed 43 yd³.
