Aquatic Assessment
&
Habitat Enhancement Plan
Fountain Creek - Memorial and Mansions Park
City of Manitou Springs
El Paso County - Colorado

In January 2009, FIN-UP Habitat Consultants, Inc. was contracted by the City of Manitou Springs to conduct an aquatic habitat analysis and habitat enhancement strategy for a segment of Fountain Creek within Memorial and Mansions Park, in the center of the city. The stream within the park is approximately 1,500 feet in length, consisting of a moderately entrenched channel flowing through a cottonwood and alder dominated floodplain in Memorial Park, and a severely confined channel bounded by concrete retaining walls and building foundations through Mansions Park. An aquatic assessment was conducted within the project area during the 1st week of February, 2009, and the results of this study are summarized in this document.

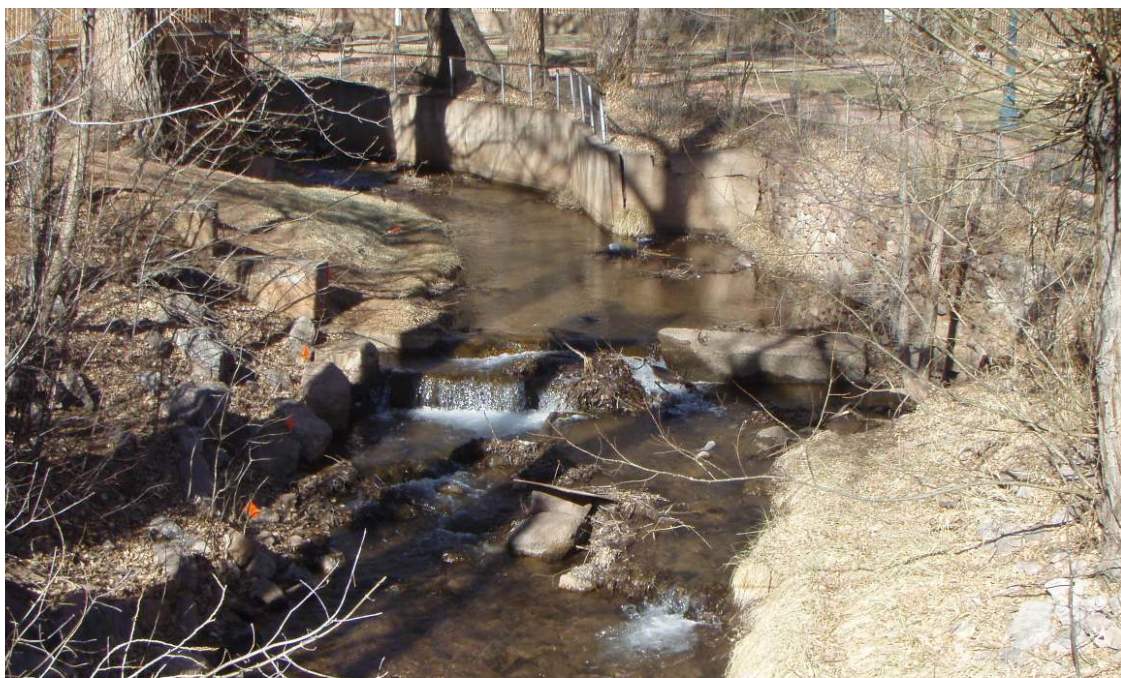
Photo 3: Concrete block drop structure - Mansions Park behind City Hall.

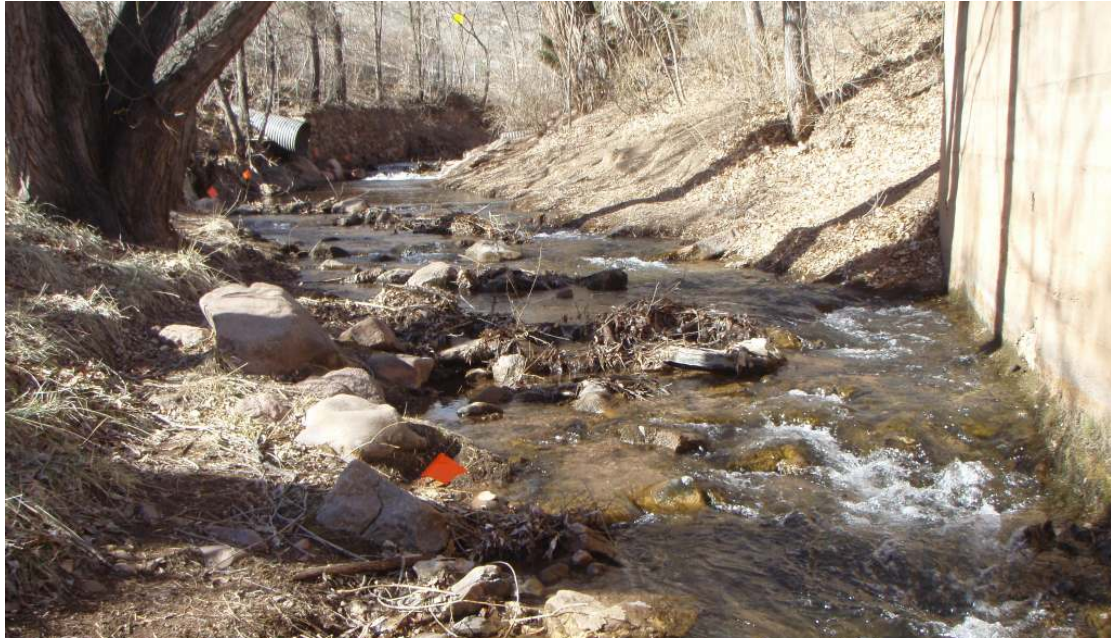
Photo 4: Lower half of Memorial and Mansions Park project reach, looking upstream.

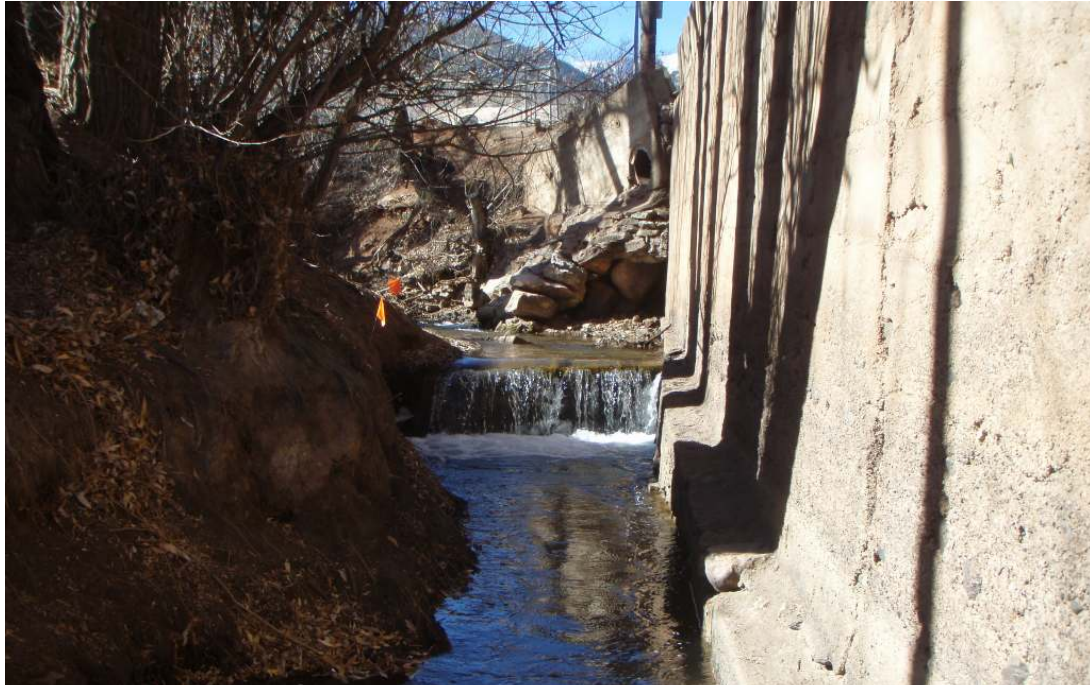
Photo 5: Upper barrier adjacent to Lover's Lane – Fountain Creek Reach 7.

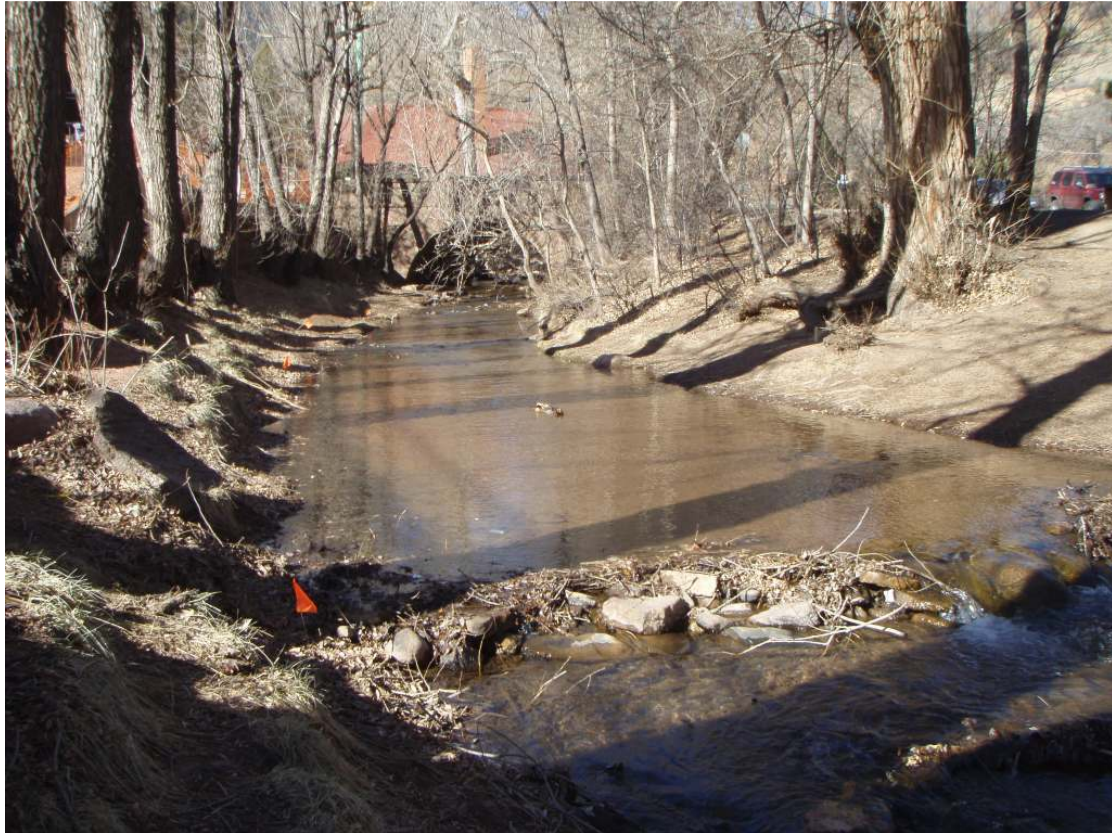
Photo 6: Over-wide glide habitat resulting from an un-authorized hand made dam structure along the Memorial Park segment of Reach 7.

A considerable number of glides were observed, comprising 20% of the reach. Glide habitat appeared to be the result of excessive sediment inputs upstream. Most of the glide habitats observed appeared to be former pools that had been completely in-filled with gravel and smaller diameter materials. Cover for trout was extremely limited in these habitats, which are characterized by laminar flow profiles and tend to provide little velocity shelter or protection from predators. Aggradation of sediment in the glides is resulting in a gradual over-widening of the bank full channel in these meso habitat forms. The average width of the glides observed in Reach 7 was 13.5 feet.

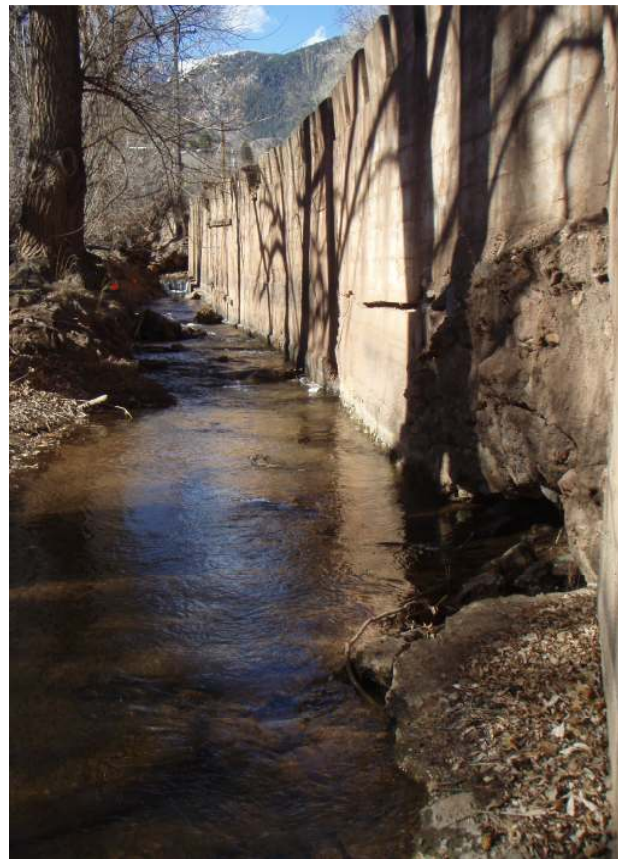
Photo 7: Unusual combination cover formed by failing concrete retaining wall footings - Lover's Lane retaining wall - Reach 7.

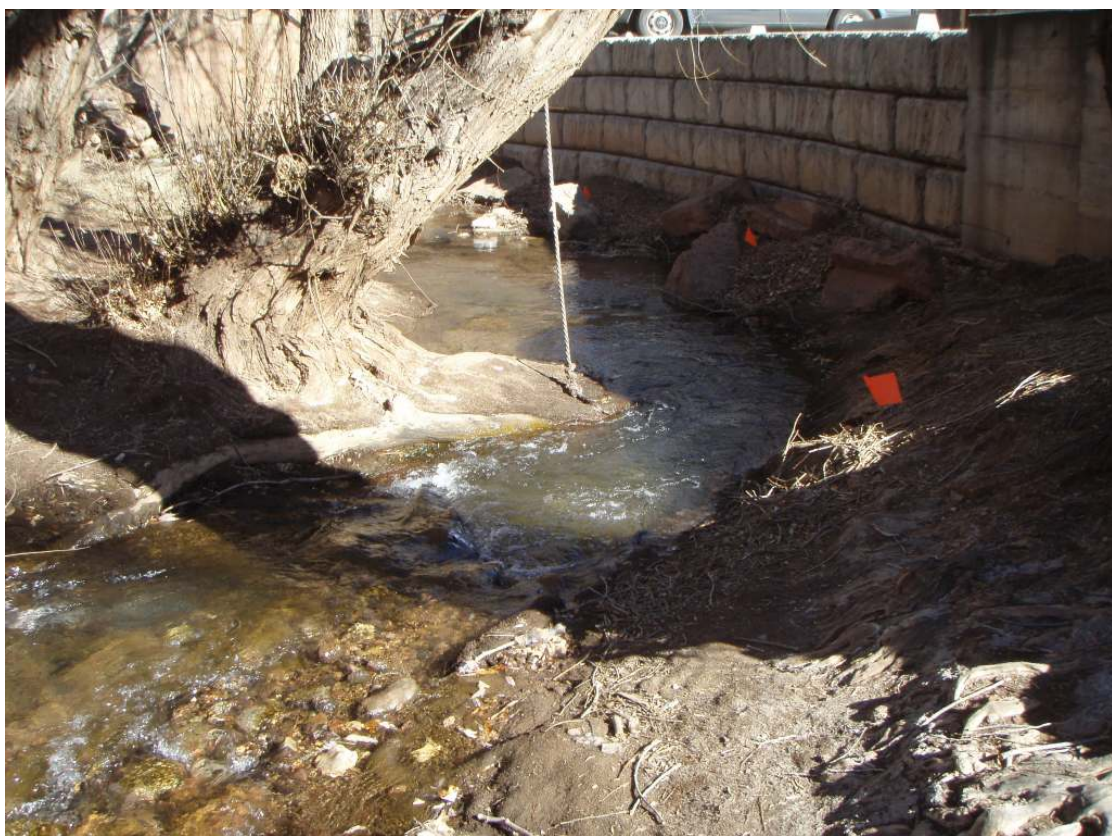
Photo 8: Two trench pools (Pool #15 and Pool #16) formed by a large cottonwood tree forming a constriction in the channel near the upstream boundary of Reach 7. Both of these pools exhibited efficient scour of sediment, acceptable residual pool depths, and maximum pool depth in excess of 1.5 feet.

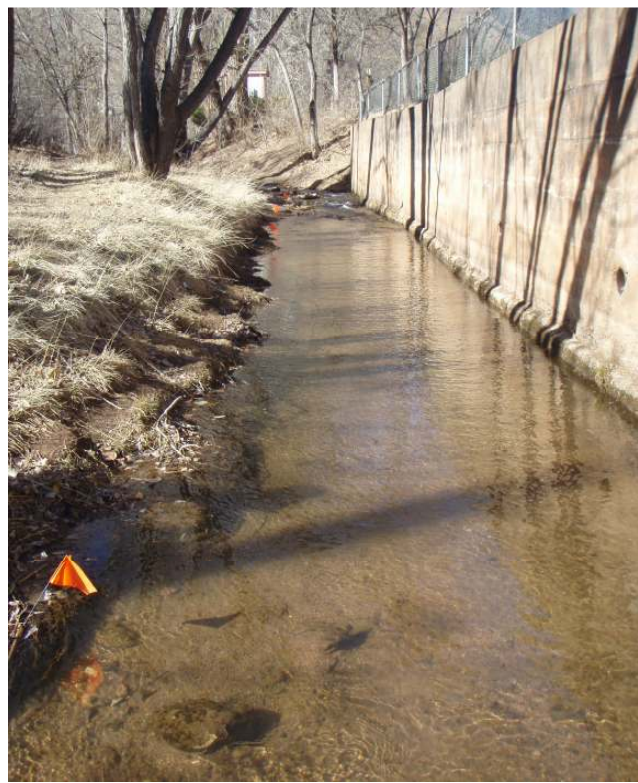
Photo 10: Glide 1, Pool 2, and Riffle 2 on Reach 7, looking upstream.

Approximately 100 feet of the right stream bank, from the end of the retaining wall at Riffle 2 to Riffle 5 will be re-vegetated using volunteers from the Rocky Mountain Field Institute. Several stone retaining walls will need to be constructed in the area adjacent to the pump house, in order to provide a stable terrace for vegetation to take hold. The existing 30 ft segment of boulder rip-rap on

the left bank of Pool 3 will be re-aligned in order to provide velocity shelter for trout as well as bank armoring and protection from shear. The existing creek access trail on the left bank will be repaired, with stone steps leading down to Pool 3. Additionally, a new stone stairway will be constructed on the right bank leading to the stream, immediately downstream of the pump house.

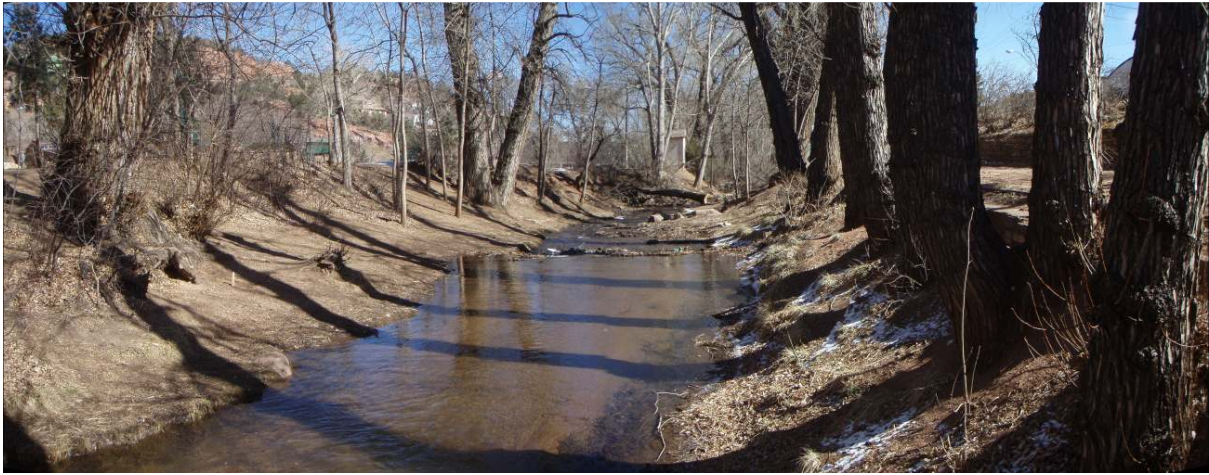
Photo 11: Over-wide segment of Fountain Creek in Memorial Park, looking downstream.

Upstream of the pump-house, the stream begins to exhibit excessive over-widening, due to sedimentation, bank damage from heavy recreational use, and the construction of an un-authorized dam perpendicular to the direction of flow that has resulted in bank failure and lateral migration of the channel. This hand constructed dam will be removed from the channel, and a large boulder cross-vane will be installed at Pool 5 to significantly improve the scour and depth of the pool and downstream glide habitat. The stream channel throughout this segment will be narrowed and re-defined using large wood toe-slope structures and bank-full riparian benches on both sides of the stream to reduce the width/depth ratio of the channel and improve sediment transport within the segment. The target bank-full width of the new channel will be 22 feet. Additional sinuosity will be built into this segment by building a slight meander into the newly defined channel. A total of 300 feet of these treatments will be necessary, split approximately evenly on each side of the channel. Narrowing the channel and improving sediment transport through this segment will allow us to increase and improve pocket water habitats within the riffles by adjusting the elevations and facet slopes of existing boulders in the riffles, and by adding additional boulder micro-vortex structures in appropriate locations throughout these riffle habitats. Up to twelve of these features may be added to Riffles 7 & 8.

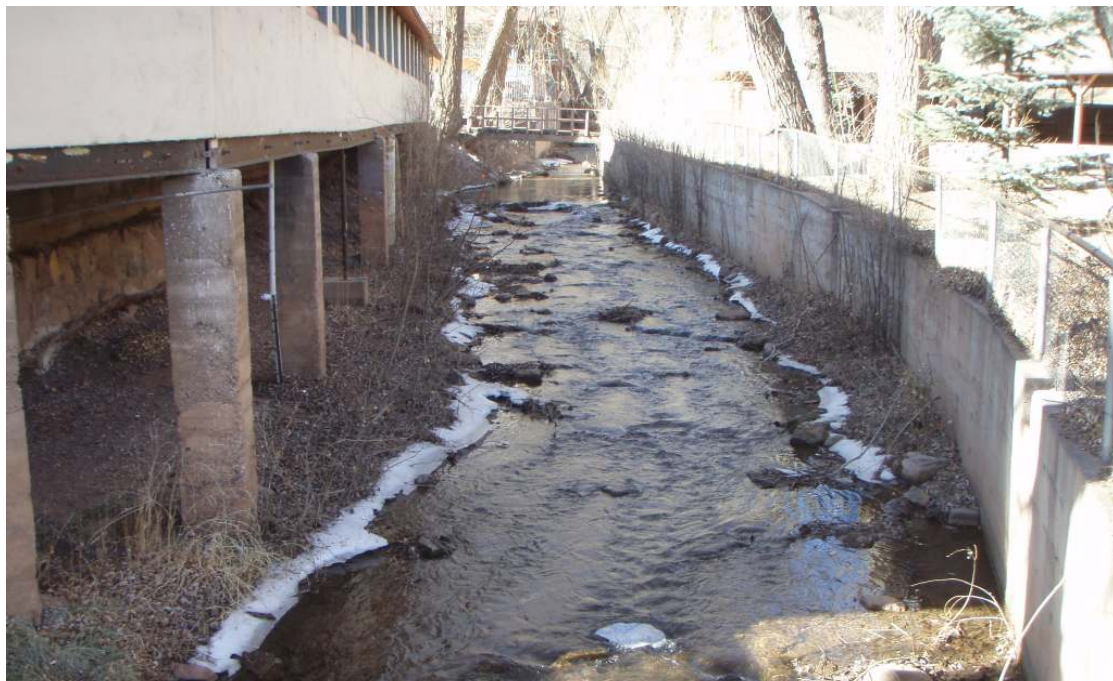
Riffle 12, Pool 8, and Glide 9 are confined by a concrete retaining wall on the north bank, and by the foundation walls of Manitou Springs City Hall on the south. The City Hall building overhangs the creek by 10 feet throughout this segment (see Cross-Section 5). Periodic high flows have begun to undermine a significant section of the building foundation on the north east corner of the building, and if not quickly addressed, could result in undesirable structural changes to the building. A thin line of riparian alder and

Photo 14: Fountain Creek adjacent to City Hall, looking upstream. The eroding foundation can be seen on the left side of the photograph.

willow has become established between the creek and the edge of the building, and we would like to further enhance this protective feature by installing log/boulder toe slope structures and riparian bank full benches along the entire south stream bank adjacent to the building. Behind these bank full bench features, boulder vanes may be installed underneath the building, extending at an angle of no greater than 30 degrees, from the foundation wall upstream to the concrete columns supporting the outer edge of the building. The spaces between these vanes could then be filled with smaller 8" – 12" rip-rap by the volunteer hand crews organized by the Rocky Mountain Field Institute.

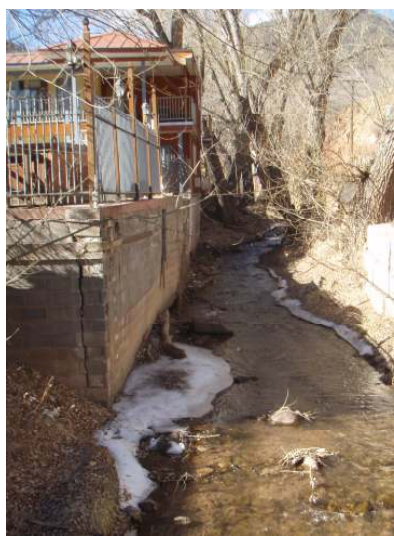
Photo 15: Pikes Peak Inn

appear to be in perilous condition, and might fail in a significant flood event, blocking the channel with debris and subsequently causing greater flood damage downstream. We recommend that the City contact the owners of the Pikes Peak Inn, and work with them to repair or remove this wall.

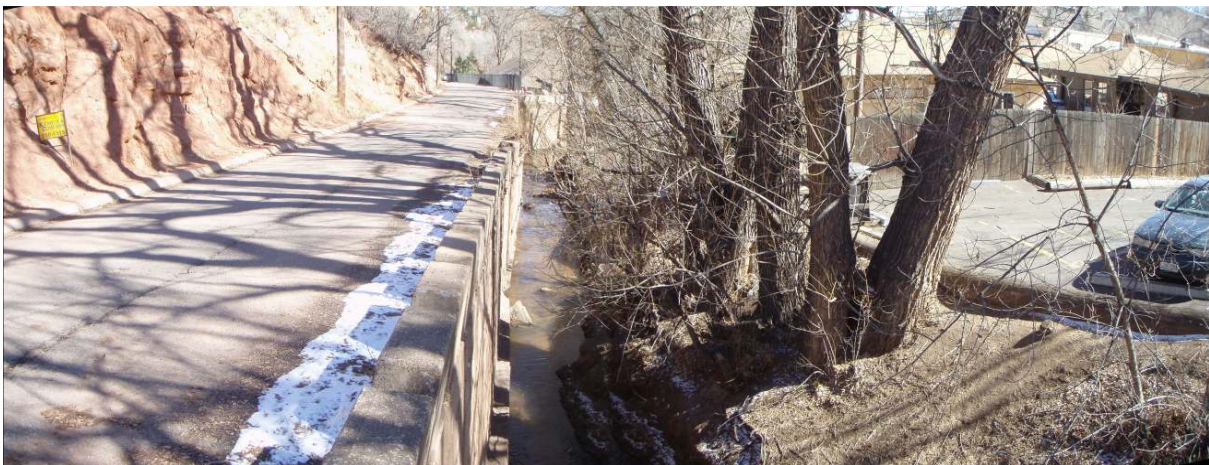
Photo 18: The severely confined segment of Fountain Creek adjacent to Lover's Lane.

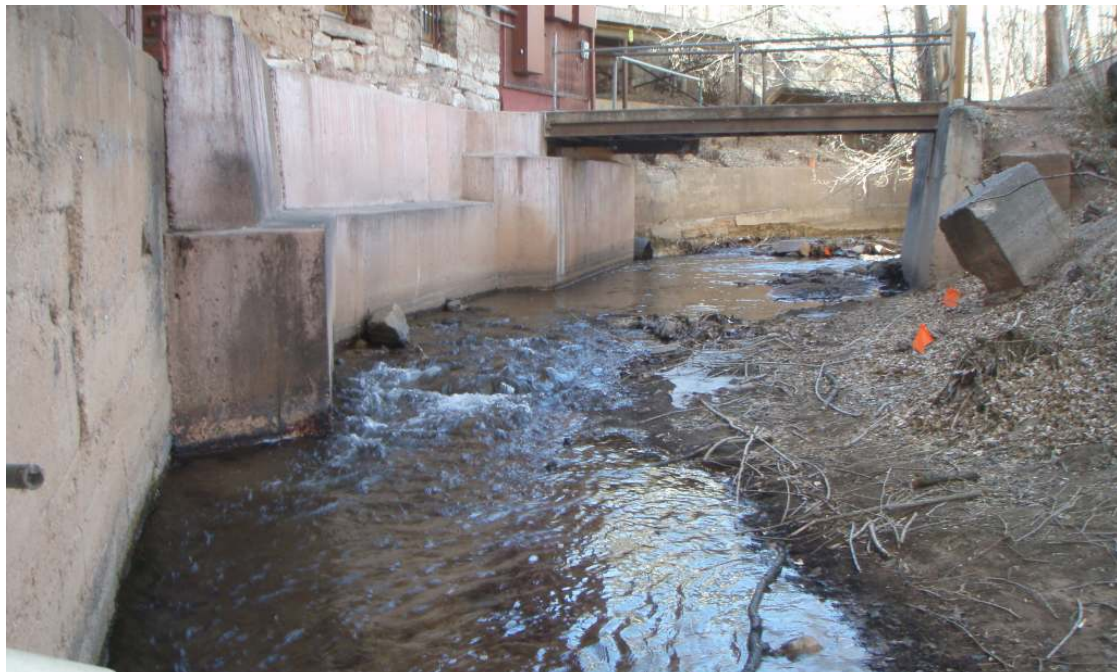
Photo 19: Fountain Creek adjacent to the Stage Coach Inn, looking upstream.

Pocket water cover in Riffles 19, 20 and 21 will be increased and enhanced using the same techniques employed downstream; adjusting existing boulders as necessary and installing up to ten boulder micro-vortex structures. Two boulder rock vanes will be installed along the foundation wall of the Stage Coach Inn, where a lateral scour pool has begun to form immediately adjacent to the foundation footings. These boulder vanes will reduce shear forces along the foundation wall during high flows, as well as provide velocity shelter and fish viewing opportunities for guests dining on the deck of the restaurant immediately above this pool.

While the stream banks are mostly in relatively good condition in this segment, bare and eroded areas adjacent to the right stream bank, below the Wichita Parking Area, will be re-vegetated by RMFI work crews using transplanted sedge along the stream green-line, and native upland grasses and forbs on the slopes leading up to the parking area. Up to two access paths to the stream, with stone steps, will be constructed to allow public access to the stream along this segment.
