## Photographic Representations of Treatment Types

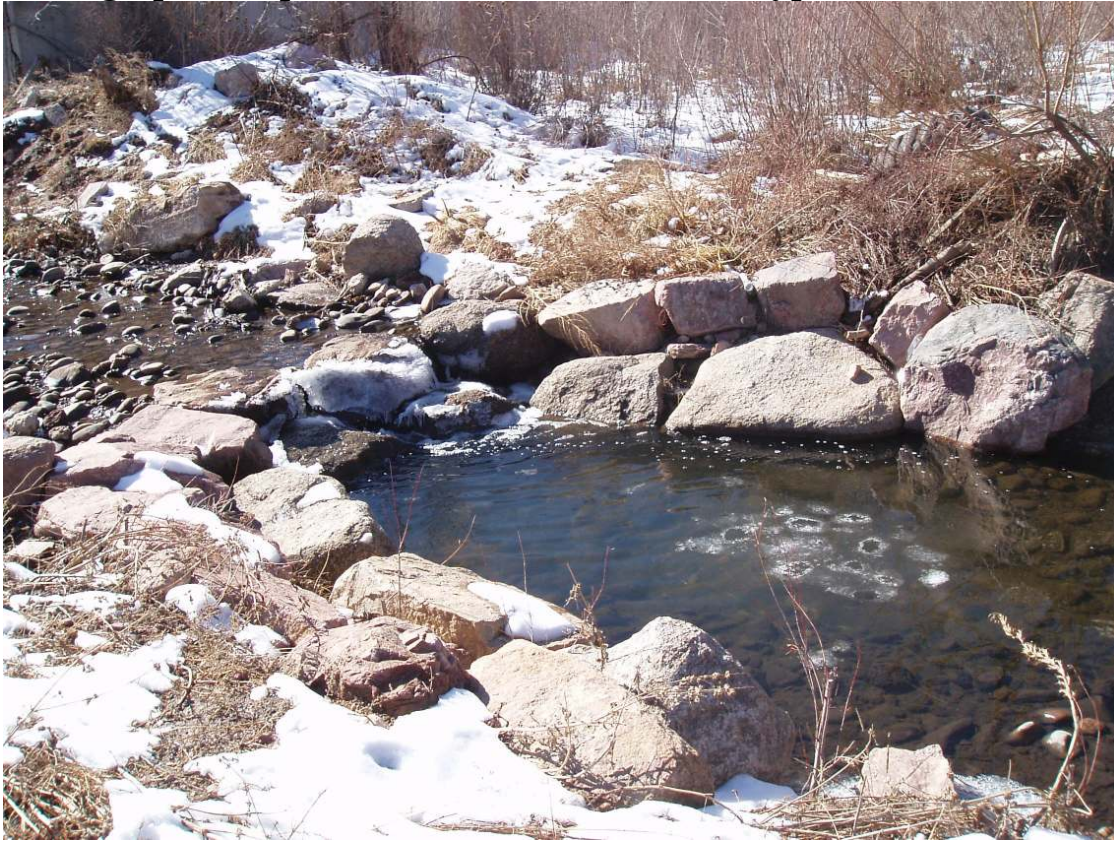
Cross Vane Structure on Cheyenne Creek below I-25 Overpass. Colorado Springs, El Paso County, Colorado

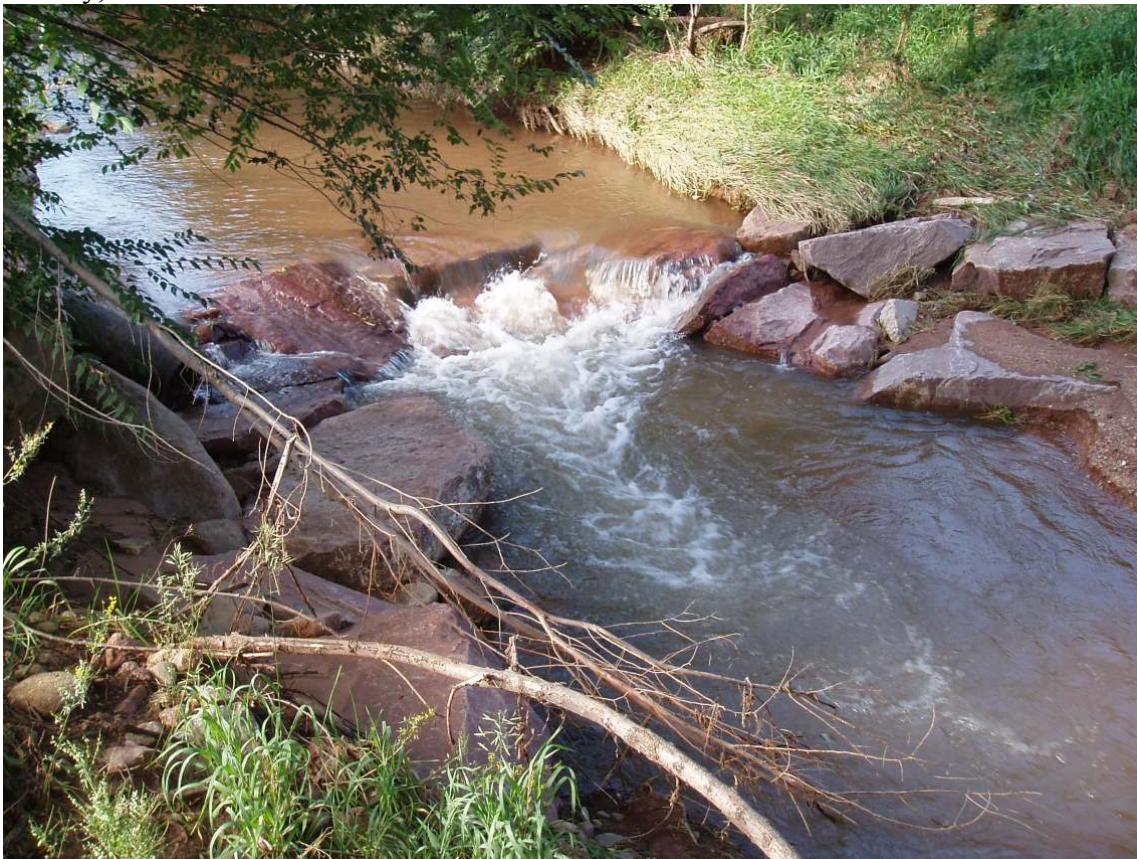
Cross Vane Structure on Fountain Creek below 21<sup>st</sup> Street Bridge, El Paso County, CO.

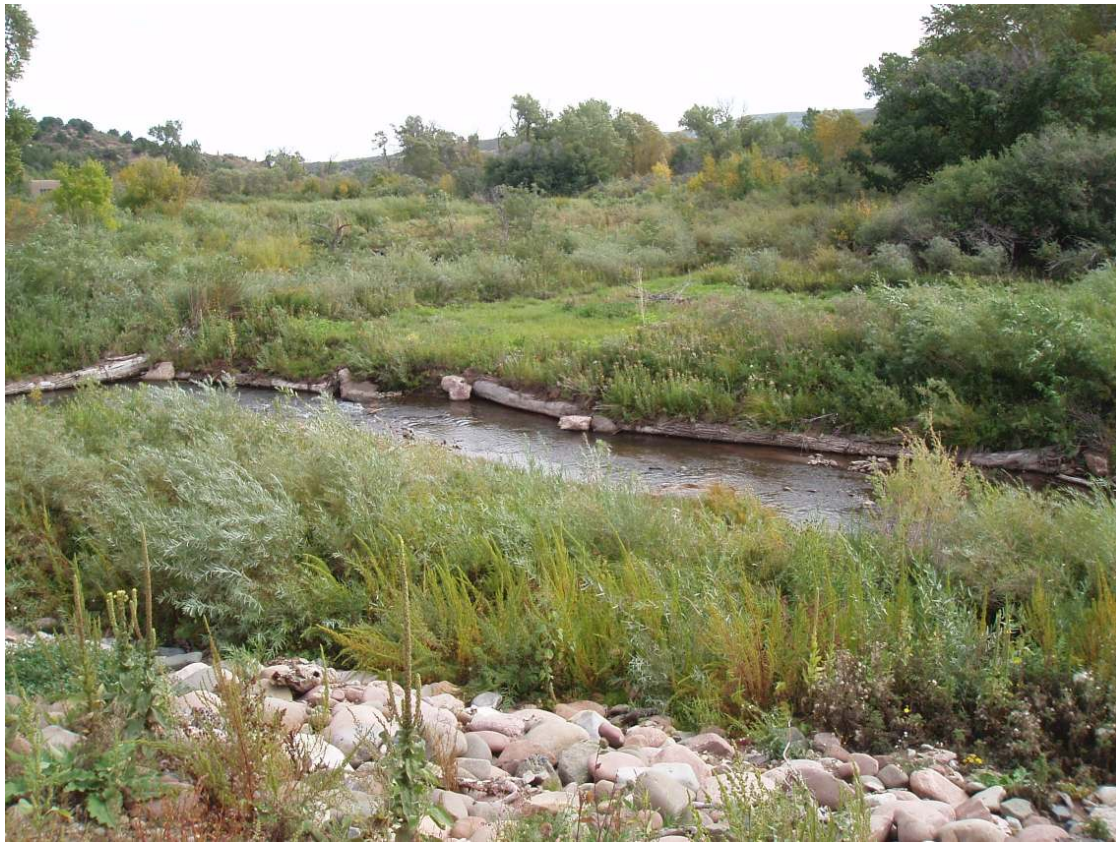
Cottonwood trees used as toe-slope stabilization with riparian benches. Cucharas Creek, Huerfano County, Colorado.

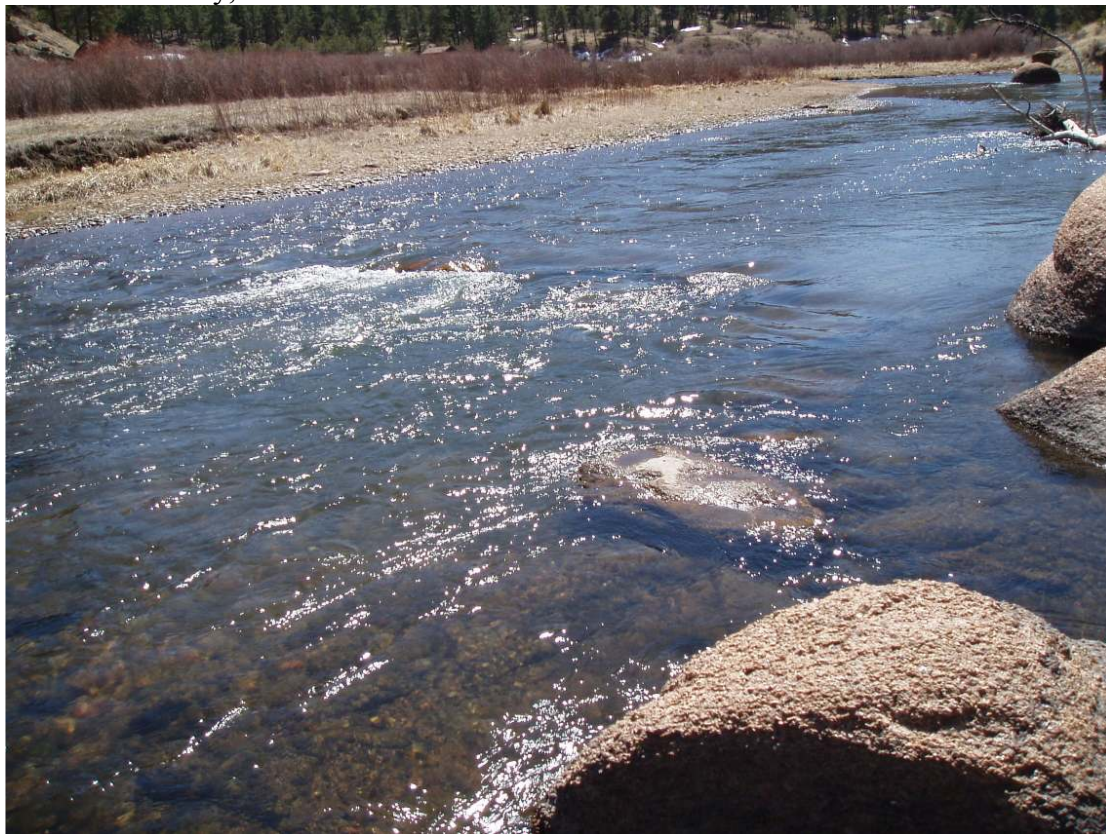
Boulders placed in clusters to create pocket water micro vortex habitats. South Platte River, Park County, CO.

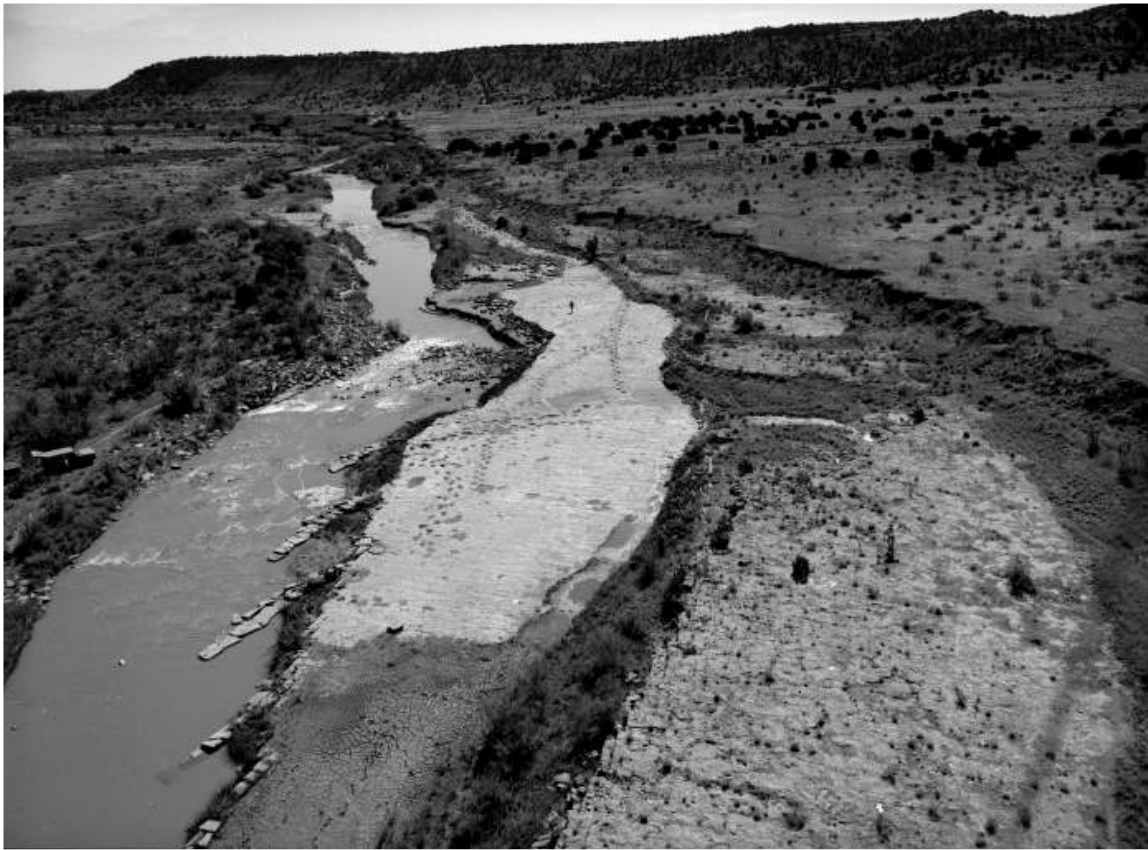
Picketwire Canyonlands, SE Colorado - Rock vanes used to protect dinosaur trackway. These structures were installed in 1998, and survived a 100 year event the following spring. Note the deposition and new willow vegetation taking hold in between the structures. The photo below shows the Project nine years later.

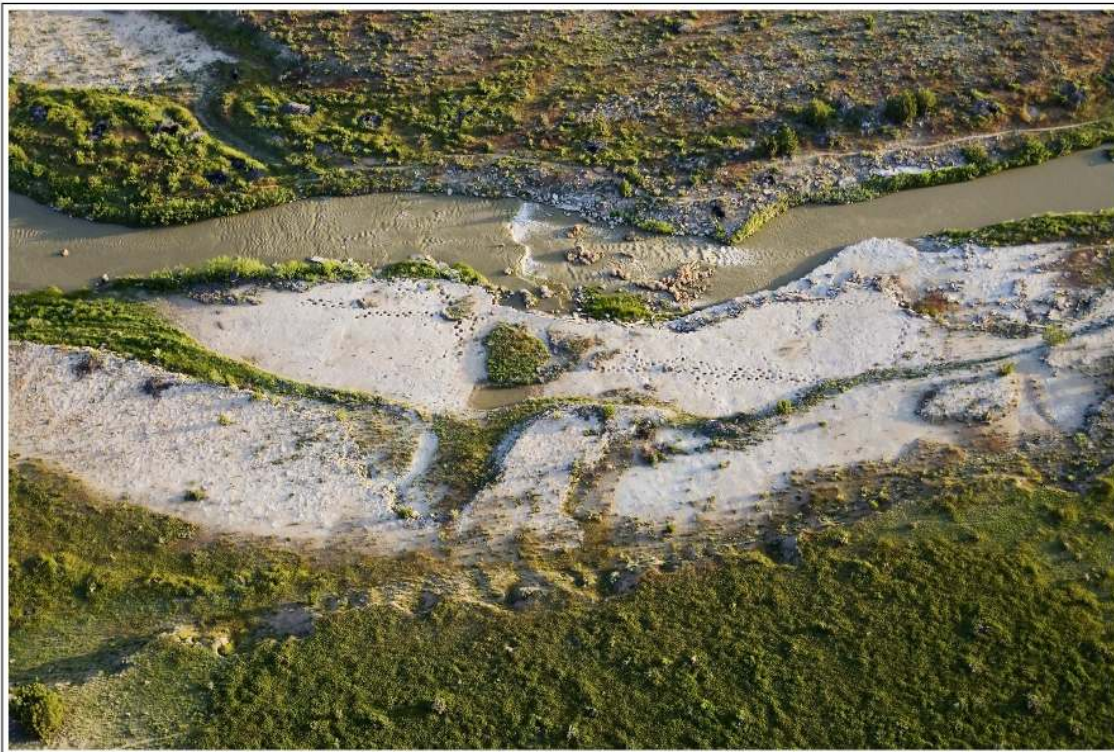
Aerial of Dinosaur Tracks along Purgatoire River  
 Picket Wire Canyonlands, Comanche National Grassland, southeastern Colorado  
 Copyright 2007 Wendy Shattil/Bob Rozinski [www.dancingpelican.com](http://www.dancingpelican.com)  
 Permission of USDA Forest Service

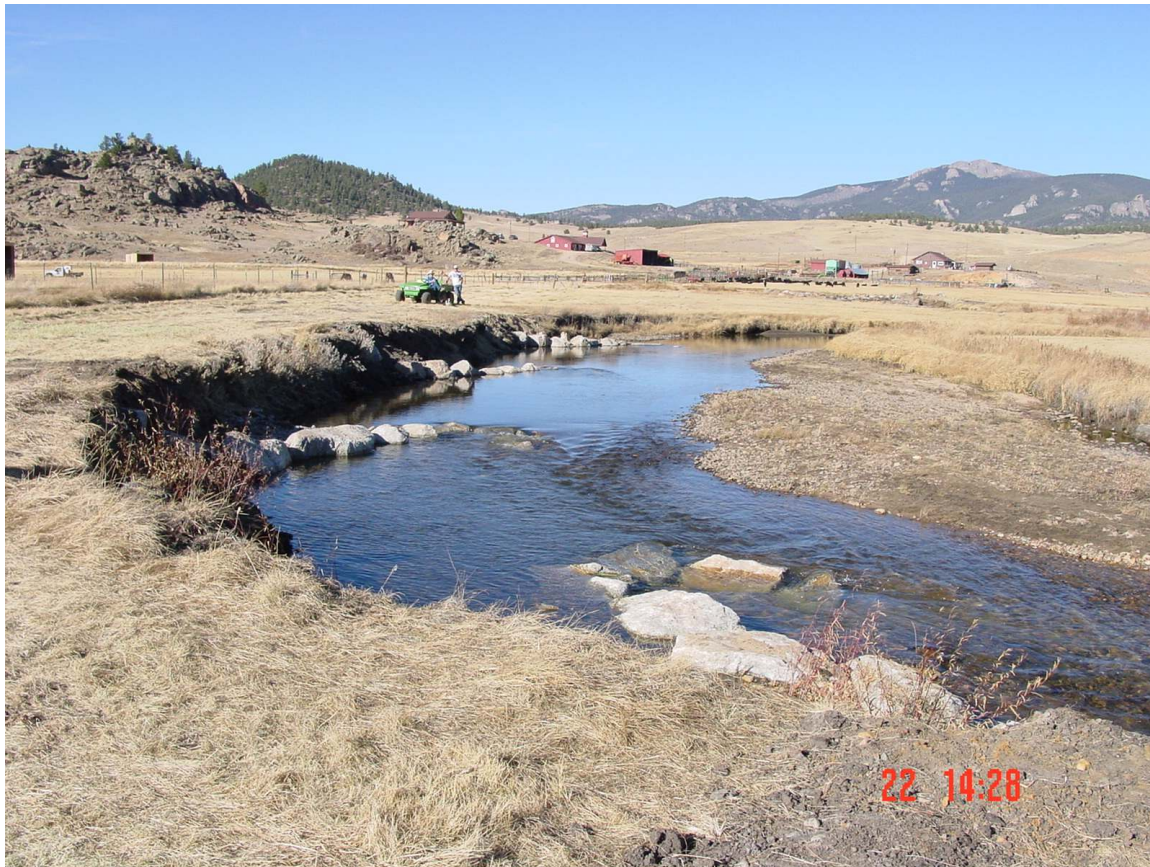
Eagle Rock Ranch - Rock J-Hook Vanes installed to protect stream banks and adjacent road,, 2003.
