Fountain Creek - Manitou Springs, CO Shryver Park Reach and Pond Restoration Project

A Project of the Fountain Creek Restoration Committee & the Pikes Peak Community Foundation

# **Final Report**

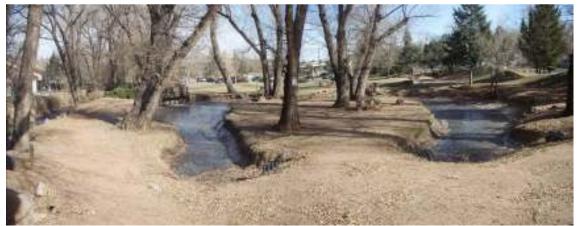
Pre-project Shryver Pond, showing the fill on the west side of the impoundment.

were able to remove a substantial amount of accumulated debris, and approximately 150 cubic yards of material were dredged from the pond and hauled to the City Cemetery for use as fill material for a renovation and enlargement project. Additionally, the pond was enlarged by excavating the entire western side of the pond at the location of the proposed new foot bridge. Average depth of the pond was increased from less than 3 feet to approximately 5 feet, and the maximum depth, near the outlet structure, was increased to greater than six feet.

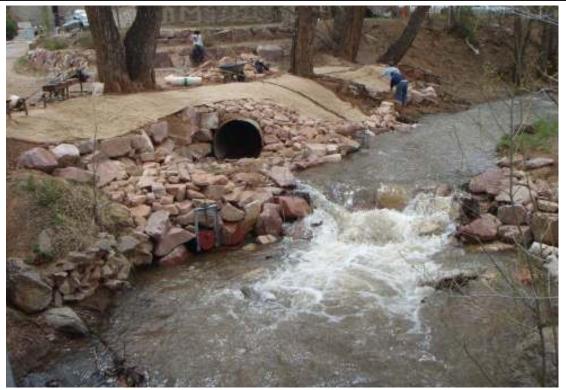
Post-project pond Dual Head-gate diversion structure with 48" storm water culvert.

Concurrent with the construction of the new inlet works, work began on reconstructing the old diversion structure in Fountain Creek. The existing structure consisted of four telephone poles installed as a drop structure perpendicular to the stream channel, with the un-controlled pond inlet pipe extending upstream into the channel. This configuration was covered by a 48" storm water culvert extending over the inlet pipe and "shot-gunned" approximately 6 ft into the stream channel. The storm water culvert was cut approximately 10 ft back, exposing the old inlet pipe, which was removed from the site. The new custom catch-basin, with a dual head-gate clean-out assembly, was installed, and a large boulder cross-vane was constructed around the inlet works and tied into the existing drop structure. A small pool was constructed below the cross vane to provide fish passage through the diversion structure. Additionally, a hardened channel was constructed from the end of the storm water culvert to the stream channel convey run-off, protect the inlet pipe, and prevent head-cutting underneath of the culvert. The new diversion structure and inlet works required two days to complete construction.

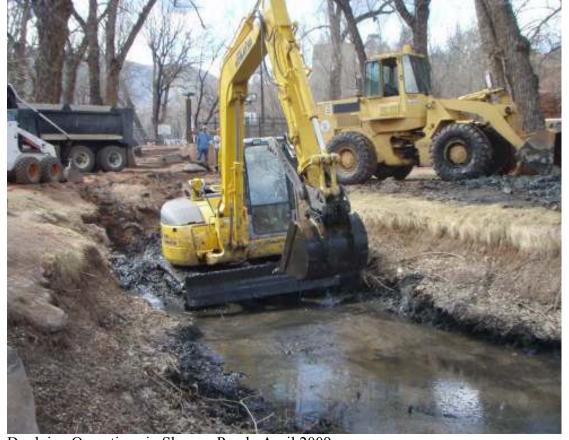
Dredging Operations in Shyrver Pond. April 2009.

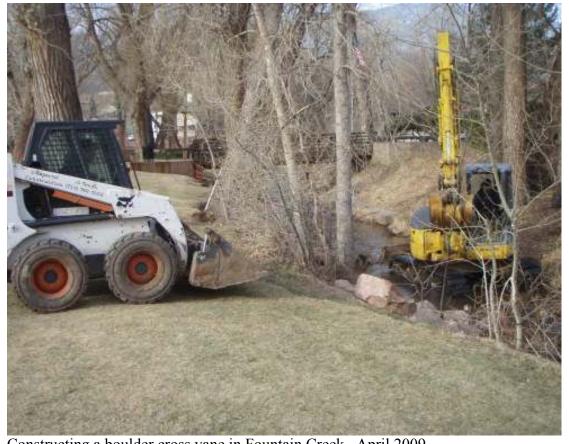
Constructing a boulder cross vane in Fountain Creek. April 2009.

Following the pond dredging, work commenced on the stream habitat enhancement portion of the project, beginning at the upstream boundary of the project reach. Boulder cross-vanes and micro-vortex in-channel object cover structures were installed at strategic locations along the stream, with boulder stream bank toe-slope structures installed to provide a foundation to support the later re-vegetation efforts. A total of fourteen pools were constructed or enhanced, and twenty-four in-channel object cover features were created along the reach. Detailed "as built" drawings of the stream work are included in the appendix to this document. Work on the in-channel structures and toe-slope features, continued downstream to the project boundary at the Garden of the Gods Place bridge, downstream of the Aquatics Center, and was completed by the afternoon of April 13, 2009. The following day, Chaparral LLC demobilized their equipment from the project site, ending the heavy equipment construction phase of the project.

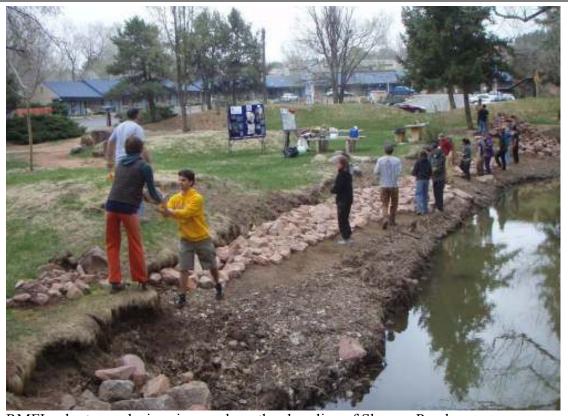
RMFI volunteers placing rip-rap along the shoreline of Shyrver Pond.

coir erosion control matting was then applied over the reseeded areas. To reduce erosion along the banks of the pond, volunteers moved over 16 tons of rock to cobble the banks and provide stability. A 6 foot long and 5 foot high retaining wall was also constructed along a section of the pond bank that was severely eroding. The retaining wall is now providing a stable platform that in the future is planned to be modified into a handicapped accessible fishing spot. RMFI also aided the youth volunteers who were working with Concrete Couch in the construction of rock "wing walls" to help protect the new bridge joining the park's island to the park's trail system.

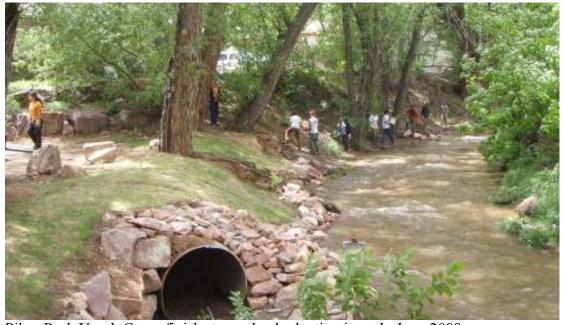
Pikes Peak Youth Corps finish stream bank planting in early June 2009.

The final phase of the project for RMFI was completed in one day on June 4th. RMFI's Pikes Peak Corps program for youth was utilized for this part of the project. The Pikes Peak Corps crew rehabilitated 3,600 square feet of denuded surfaces within the park utilizing the same "low grow" seed mix and erosion control matting as the earlier work days. To help stabilize the banks along the creek, 106 sedge transplants were collected and placed along a 340' reach. In addition, 9.5 tons of rock was placed to provide an access route for stocking trucks to restock the pond with trout. Overall the team contributed an additional 80 hours to the project.

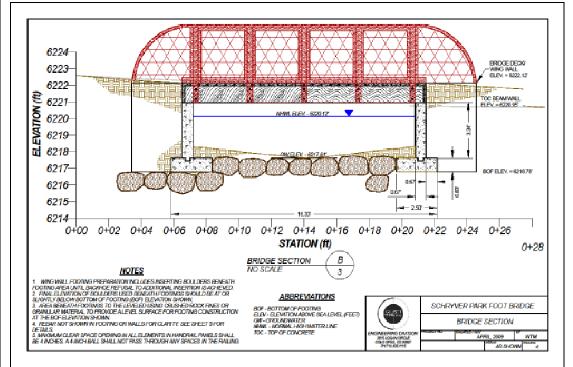
Engineers Drawing of the proposed new footbridge at Shryver Pond.

Concrete Couch, a local 501(c)3 not-for-profit community arts organization, worked with local teenagers, craftsmen, builders, and the City of Manitou Springs to build the new 14 foot pedestrian bridge on the west side of Shryver Pond in Shryver Park, Manitou Springs. We were very fortunate to be able to secure the professional services of a State licensed engineer for no cost. Without this expertise and assistance, it is highly unlikely that we could have succeeded in this effort. Detailed engineering drawings of the footbridge are included in the appendix to this document.

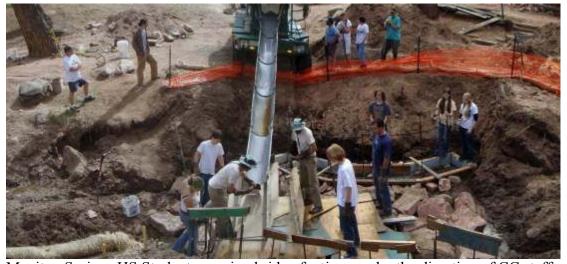
Manitou Springs HS Students pouring bridge footings under the direction of CC staff.

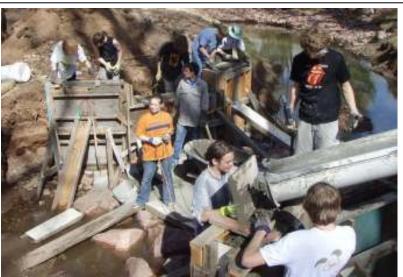
Pouring the Bridge Foundation Wing Walls.

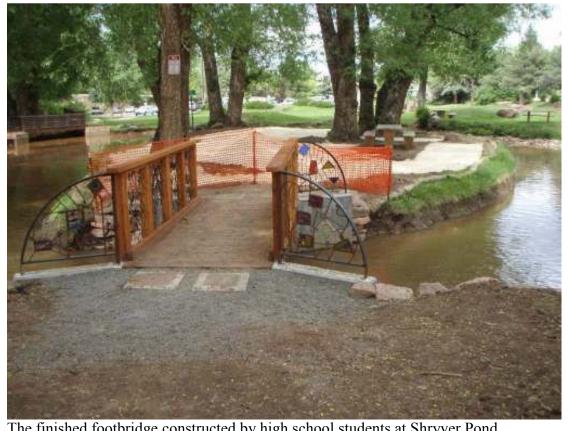
The finished footbridge constructed by high school students at Shryver Pond.

This public-private partnership, coupled with the educational component, made the project a short and long term success: the bridge is structurally sound and beautiful, and a generation of Manitou kids have a new source of pride in themselves and their community for years to come.

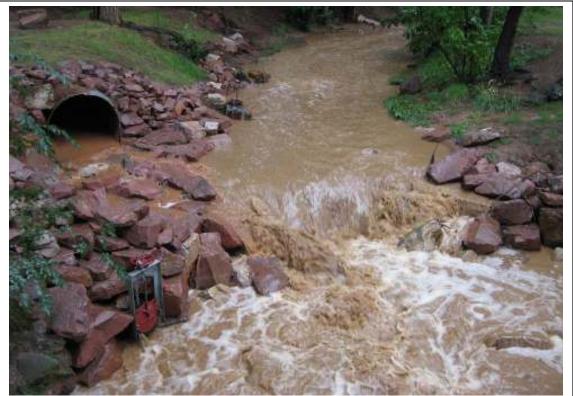
Shryver Pond Diversion Structure during the Sept 16, 2009 flood event.

Since the completion of the restoration effort last spring, the project reach has experienced at least three flood events greater than the bank full design flow, including one event that was greater in excess of 270 cfs (approximately 3 times bank-full stage). We are generally pleased with the performance of the project during these flood flows, with the exception of the new diversion structure for the Shryver Pond inlet. While this structure is structurally sound and performing the function of getting water to the pond, we are not satisfied with the "fish-passage" aspects of this feature, and will be modifying future fish passage structures in our project reaches to function more effectively. Depending on the results of our monitoring of the new design, scheduled to be demonstrated in the Fields Park project in 2010, we may desire to revisit this diversion structure and implement the new modifications.

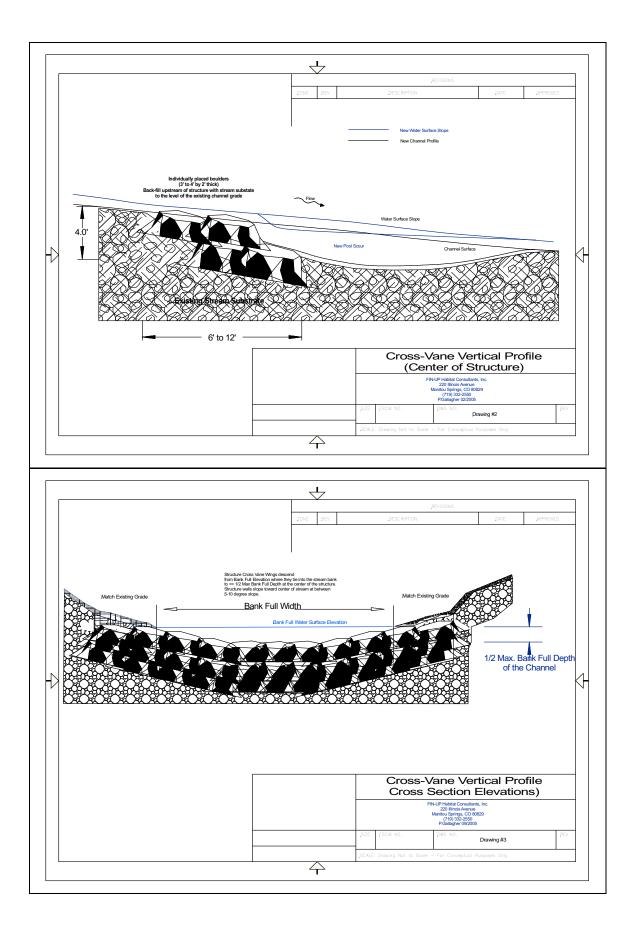
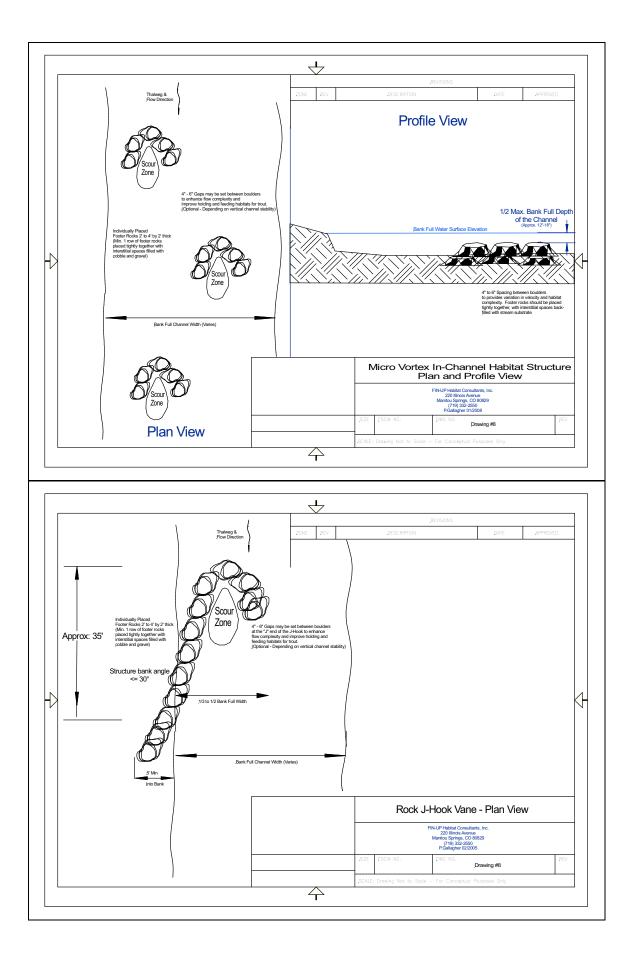
# **Drawings of Treatment Types**

# +In Bank Profile Existing Stream Bank Profile $\left| \right\rangle$ Bank Full Elevation Sedge Mats and Willow Plantings Create a New Bank-Full Bench Boulder Provides Toe-Slope Stability \_ Channel Scour Provides Increased Pool Cover and Reduces W/D Ratio 11.51 Bank-Full Bench / Toe-Slope Stabilization Vertical Profile View FIN-UP Habitat Consultants, Ini 220 Illinois Avenue Manitou Springs, CO 80829 (719) 332-2550 P.Gallagher 01/2006 Drawing #10 $\mathbf{A}$ $\checkmark$ Structure bank angle <= 30° $\left| \right\rangle$ ╞ Poøí Scour Zøne Cross-Vane Plan View ou Springs, CO 80829 (719) 332-2550 Drawing #1 $\widehat{}$

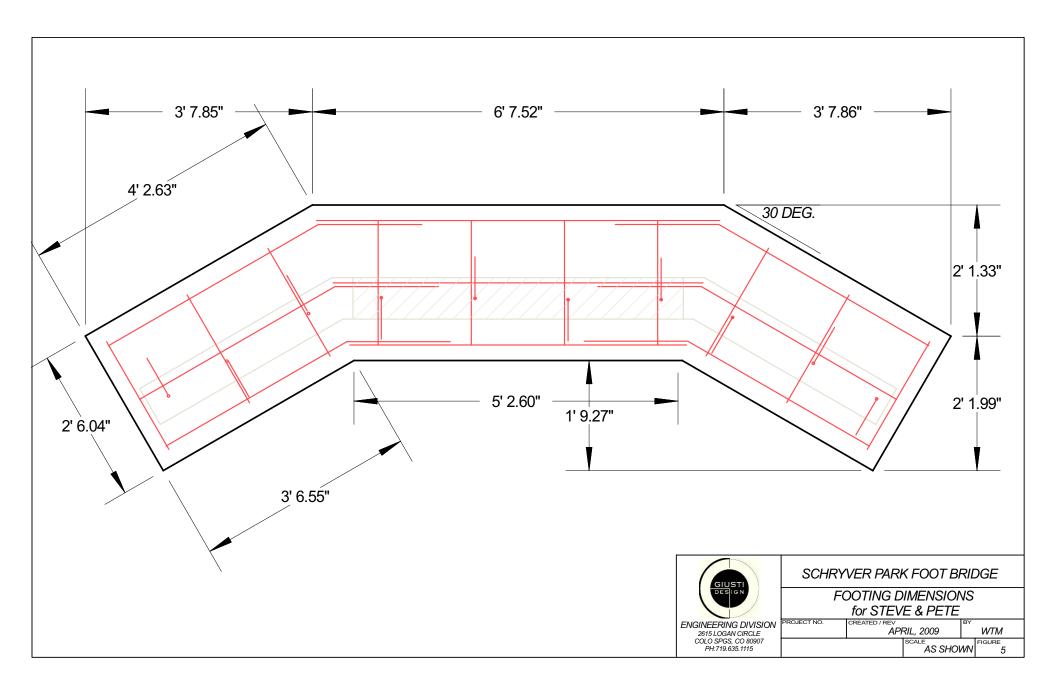
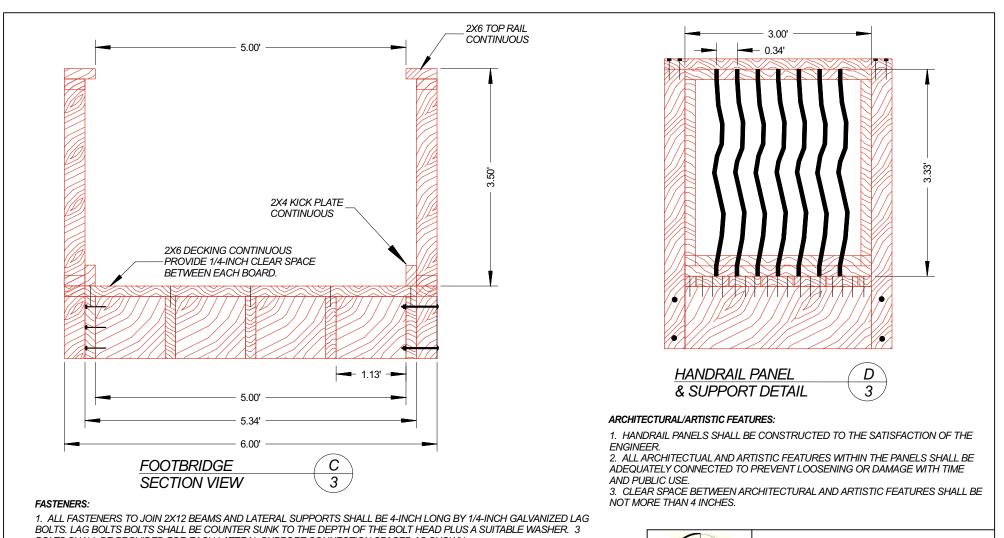
SCHRYVER PARK FOOT BRIDGE

BRIDGE BEAMS, DECK& RAILING

SECTIONS AND DETAILS

BOLTS SHALL BE PROVIDED FOR EACH LATERAL SUPPORT CONNECTION SPACED AS SHOWN. 2. FASTENERS TO ATTACH HANDRAIL POSTS TO THE OUTSIDE BRIDGE BEAMS SHALL BE 7-INCH LONG 3/8-INCH DIAMETER GALVANIZED CARRIAGE BOLTS. THREADED END OF CONNECTION SHALL BE ON THE INSIDE OF THE BEAM AS SHOWN.

3. FASTENERS TO ATTACH TOP HANDRAIL TO HANDRAIL POSTS SHAL BE 4-INCH LONG BY 1/4-INCH GALVANIZED LAG BOLTS. LAG BOLTS BOLTS SHALL BE COUNTER SUNK TO THE DEPTH OF THE BOLT HEAD PLUS A SUITABLE WASHER. 2 BOLTS SHALL BE PROVIDED FOR EACH TOPRAIL CONNECTION SPACED AS SHOWN.
