Aquatic Assessment
&
Habitat Enhancement Plan
Fountain Creek - Soda Springs Park
City of Manitou Springs
El Paso County - Colorado

FIN-UP Habitat Consultants, Inc.

In February 2007, FIN-UP Habitat Consultants, Inc. was contracted by the City of Manitou Springs to conduct an aquatic habitat analysis and habitat enhancement strategy for a segment of Fountain Creek within Soda Springs Park, immediately west of the downtown business district. The stream within the park is approximately 700 feet in length, and is mostly confined by concrete retaining walls and a moderately entrenched natural channel throughout its length. An aquatic assessment was conducted within the project area during the 2nd week of March, 2007, and the results of this work are summarized in this document.

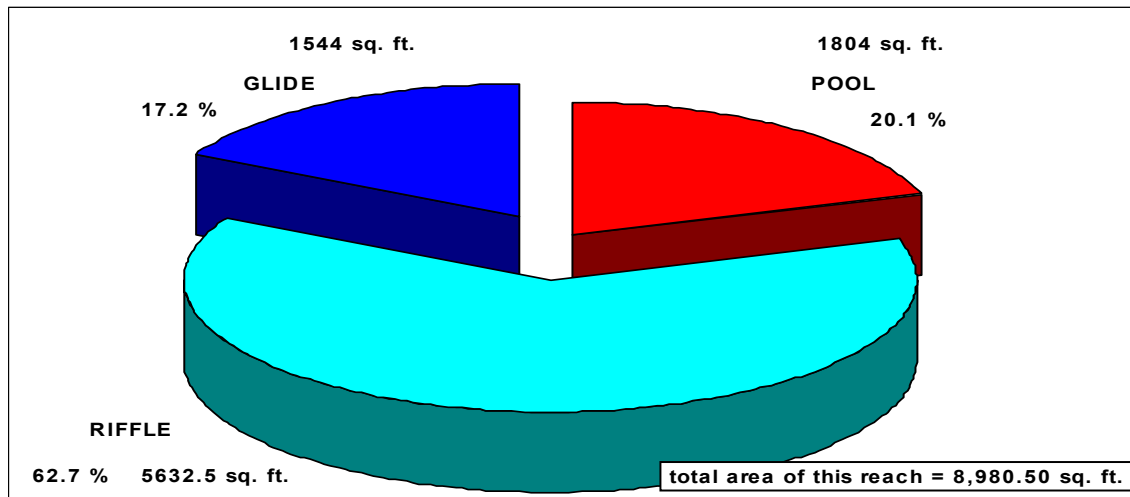
Chart 1 - Distribution of Pool, Riffle and Glide habitats in Reach 11 of Fountain Creek.

There were 27 individual meso-habitats measured in the reach (10 pools, 12 riffles and 5 glides), along a length of 765 feet of stream, and comprising a total wetted area of 8,980ft². The total area of the reach consisted of 63% riffles and 17% glides, with the remaining 20% consisting of pool habitat (Chart 1). The average wetted width of the stream was 11.2 feet throughout the reach. Due to the presence of the concrete retaining walls, approximately 80% of the stream banks were found to be stable. Stream bank stability outside of the segments confined by retaining walls was exceptionally poor, consisting mostly of bare slopes comprised of sand and gravel sized fragments. There were 225 feet of actively eroding stream banks contributing sediment directly into the stream. This accounted for slightly more than 15% of the total length of banks in the study reach.

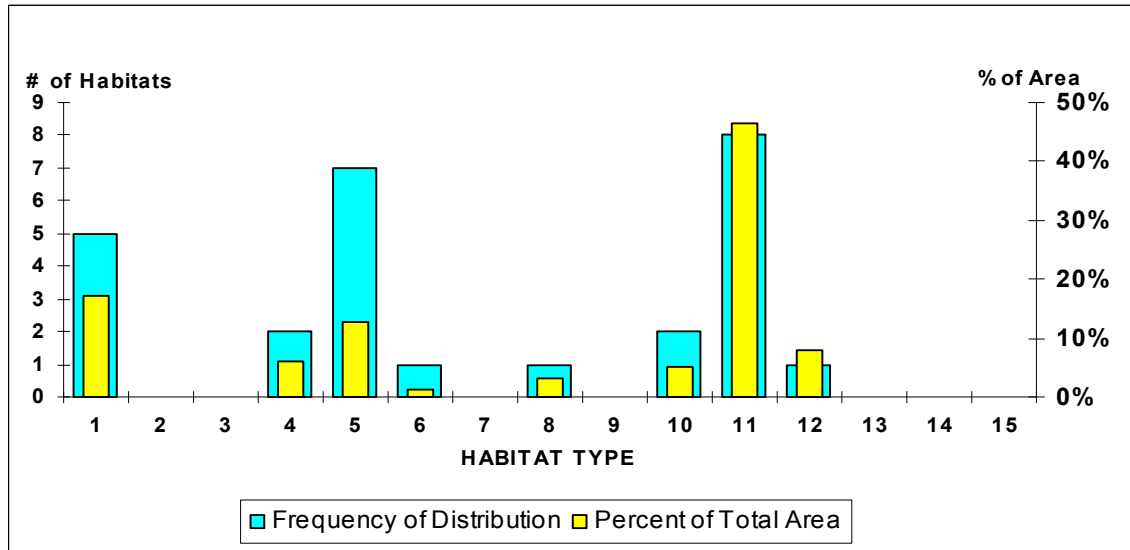
Chart 2 - Distribution of Meso-Habitat Types as a percentage of # of habitats and as a percentage of wetted perimeter of Reach 11 on Fountain Creek.

Low gradient cobble riffles were the most common habitat type in terms of numbers and area, accounting for 46% of the total reach area (Chart 2). Low gradient riffles can provide good spawning habitat, but are somewhat limited in terms of cover from high flows and predators. Two higher gradient, pocket water dominated riffle types were observed in the reach. Overall, very little cover for trout was observed in the riffles, amounting to less than 0.6% (20 ft²) of the total wetted area of these habitat types. The average width of all the riffles observed in the reach was 11.5 feet.

Pool habitat is very limited in the reach, with plunge pools being the most abundant (Chart 2). The plunge pools in the reach are principally associated with log-drop structures and boulder, and comprised 13% of the total wetted area of the reach. One lateral scour pool and two trench pools were observed, but these habitats accounted for less than 6% of the total reach. All of the pools exhibited some degree of in-filling of sediment, mostly consisting of smaller particles of decomposed granite. Due to this in-filling of fines, the average pool depth in Reach 11 was barely more than 1/2 foot. Residual pool depth (RPD) in Reach 11 was found to range from 0.5 to 1.6 feet, with an

average of 1.0 foot throughout the reach. RPD in the reach is relatively poor, and may limit adequate over-wintering habitat for salmonids and other native species in this reach. Cover for trout accounted for 8% of the total wetted area of the pools, which is quite poor for a stream of this size. The average wetted width of all pool types found within the reach was 11.2 feet.

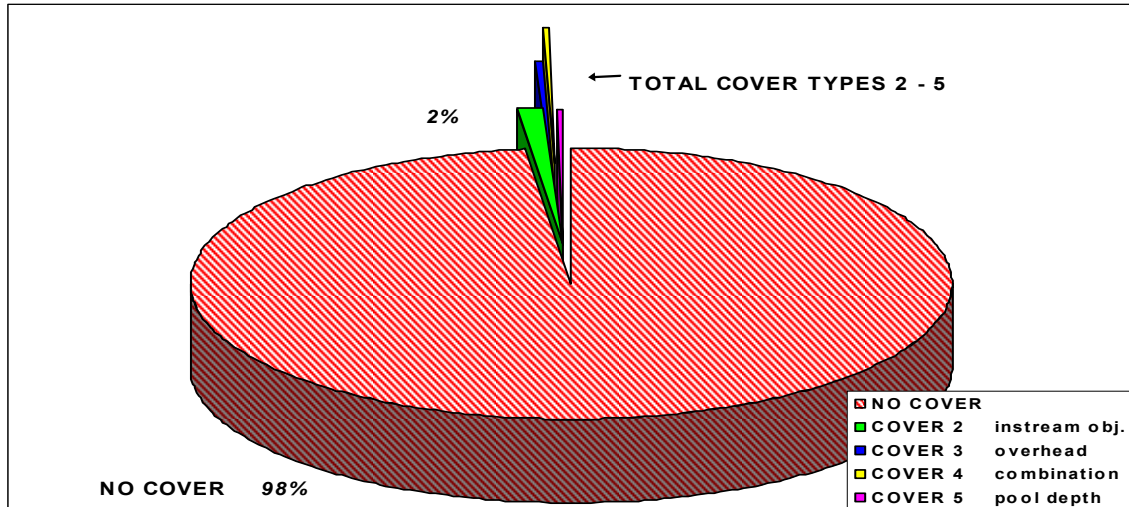
Chart 3 - Percentage of cover for trout to the total wetted perimeter Reach 11 on Fountain Creek.

Cover for adult trout accounted for fewer than 2% of the reach (Chart 3). Available cover appears to be a severely limiting factor to the health of the fishery, and will be addressed in the Habitat Enhancement Plan. Instream object cover (Cover Type 2 - >1' deep) was the dominant type observed in the reach, and was typically associated with the pool habitats. Pool cover (Cover Type 5 - >1.5'deep) was very limited in the reach, and comprised only 2% of the wetted area of the pools and 0.4% of the total reach area. Pool cover is an important indicator for determining the available over-wintering capacity of the stream reach, and appeared to be severely limited in this reach. Combination and overhead cover were the least abundant cover types, due to the lack of streamside vegetation and poor stability of the stream banks. Instream cover could be enhanced in the riffle habitats by adding structure and velocity shelters along the stream banks with strategically placed boulders and large wood. Pool cover may be increased by improving scour in existing pools as well as creating new pool habitats. Overhead and combination cover may be improved throughout the reach through stabilizing and revegetating the eroding stream banks.

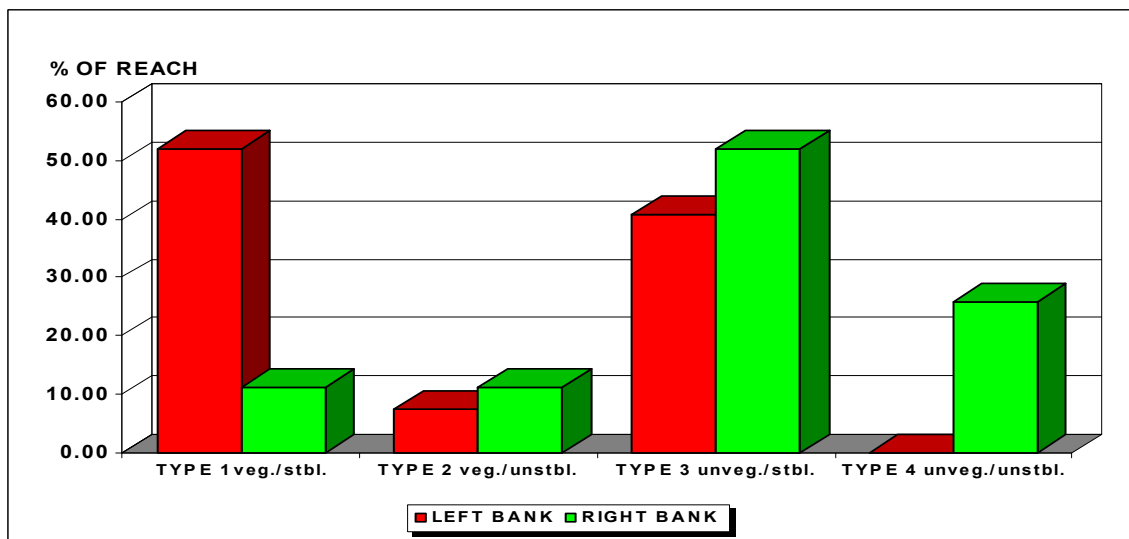
Chart 4 - Percentage of stable banks to unstable banks in Reach 11 on Fountain Creek.

In the segments not confined by concrete retaining walls, stream bank stability was generally poor, primarily due to lack of vegetation on the steep banks resulting from heavy recreational use. In segments of the reach where access is more difficult, such as the left bank at the steel foot bridge, the stream banks were generally in good condition. Deeply rooted, streamside riparian vegetation is a critical component in maintaining the integrity of stream banks during runoff and other high flow events. Fifty-two percent of the left bank and 11% of the right bank were found to be vegetated and stable. 41% of the left bank and 52% of the right banks were confined by concrete retaining walls. The remaining 7% of the left bank and 37% of the right bank were found to be unstable. (Chart 4). Bank rock content consisted either of concrete (Type 2) or mostly of sand and smaller fragments (Type 7), with small accretions of larger material and rip-rap (Chart 5).

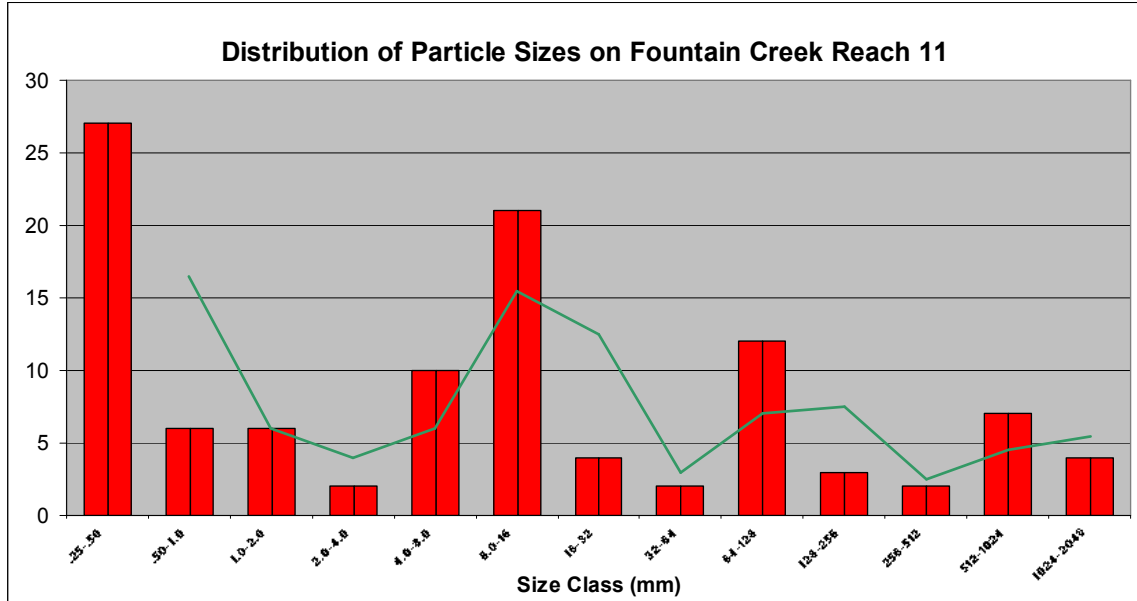
Chart 6 - Distribution of particle size classes distribution of sand and larger cobbles and boulder in Reach 11 on Fountain Creek.

The general reach substrate was calculated using a Wolman pebble Count (Beverger, 1997) and the results are shown in Table 2. A tri-modal distribution of smaller particles (fines) small gravel, and larger boulder is apparent in the pebble count data (Chart 6), and suggests that sediment inputs to the stream may exceed the capacity of the stream to move the material. Large wood (>4" diameter and > 3' long) is somewhat scarce in the reach, with only six pieces being observed. All of these pieces were associated with log-drop structures. Large wood is an important habitat forming component for rivers in the Rocky Mountains, and provides cover and complexity to the aquatic ecosystem, but may not be desirable for use in an urban environment such as Reach 11.

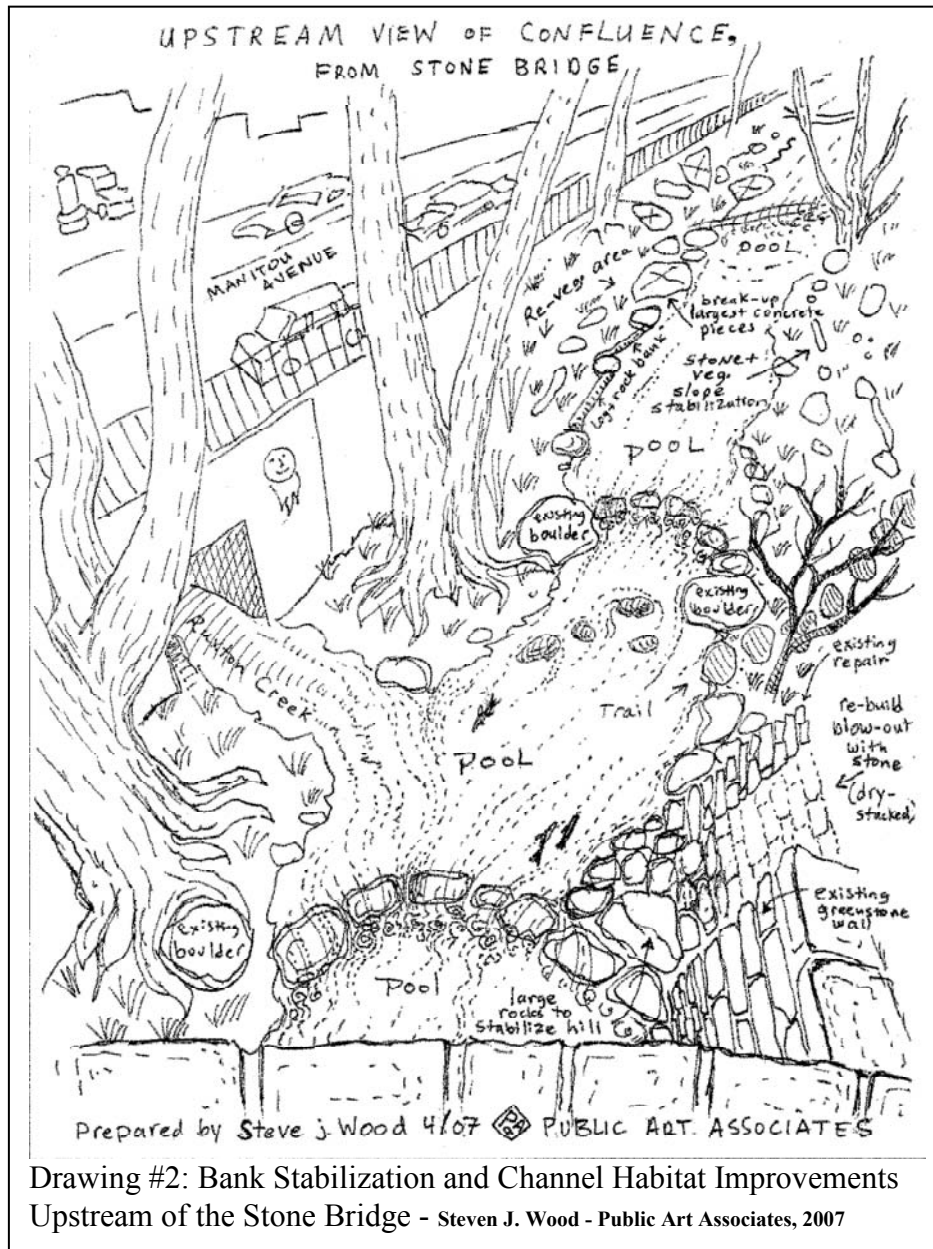
Drawing #2: Bank Stabilization and Channel Habitat Improvements
Upstream of the Stone Bridge - Steven J. Wood - Public Art Associates, 2007

In addition to the stream bank restoration on the right side of the channel, a small segment of the left bank between Pool #6 and Pool #7 will require similar toe-slope stabilization and bank revegetation. This segment of the bank is currently layered with large slabs of concrete rip-rap. It is recommended that this concrete be removed from the bank, or broken into smaller pieces that can be embedded into the bank and planted over with native vegetation. Additionally, a small portion of the old stone retaining wall on the right bank immediately upstream of the stone bridge (Pool #4) has collapsed, and will need to be repaired.

The assessment has identified excess sedimentation and lack of cover as severely limiting the available habitat for trout in Reach 11. Boulder associated plunge pools in the vicinity of the stone bridge have become filled with sediment. Several log drop structures upstream are currently providing limited pool habitat in the reach, but due to

the inherent tendency of this structure type to over-widen the stream channel, these habitats occupy only a very small length along the stream channel. Additionally, one of these log drop structures currently protects a partially exposed utility pipe crossing the stream channel. The log drop structure immediately downstream of this structure has failed, causing the channel to head-cut back to this log drop structure. At present, the log drop is undercut approximately one foot, and is at risk of failure.

the failed drop log structure at Glide #3 will need to be reconstructed, as well as possibly another cross vane in Riffle #9, in order to create a stable, pocket water associated cascade between Riffle #10 and Glide #3. This work will not only protect the utility crossing, but will convert Glide #3 to pool habitat, and eliminate a potential migration barrier at the Pool #9 log-drop structure.

8. Reconstruct the failed log drop structure at Glide #3 through installation of a boulder cross vane. Excavate accumulated sediment from the pool and remove from the site.

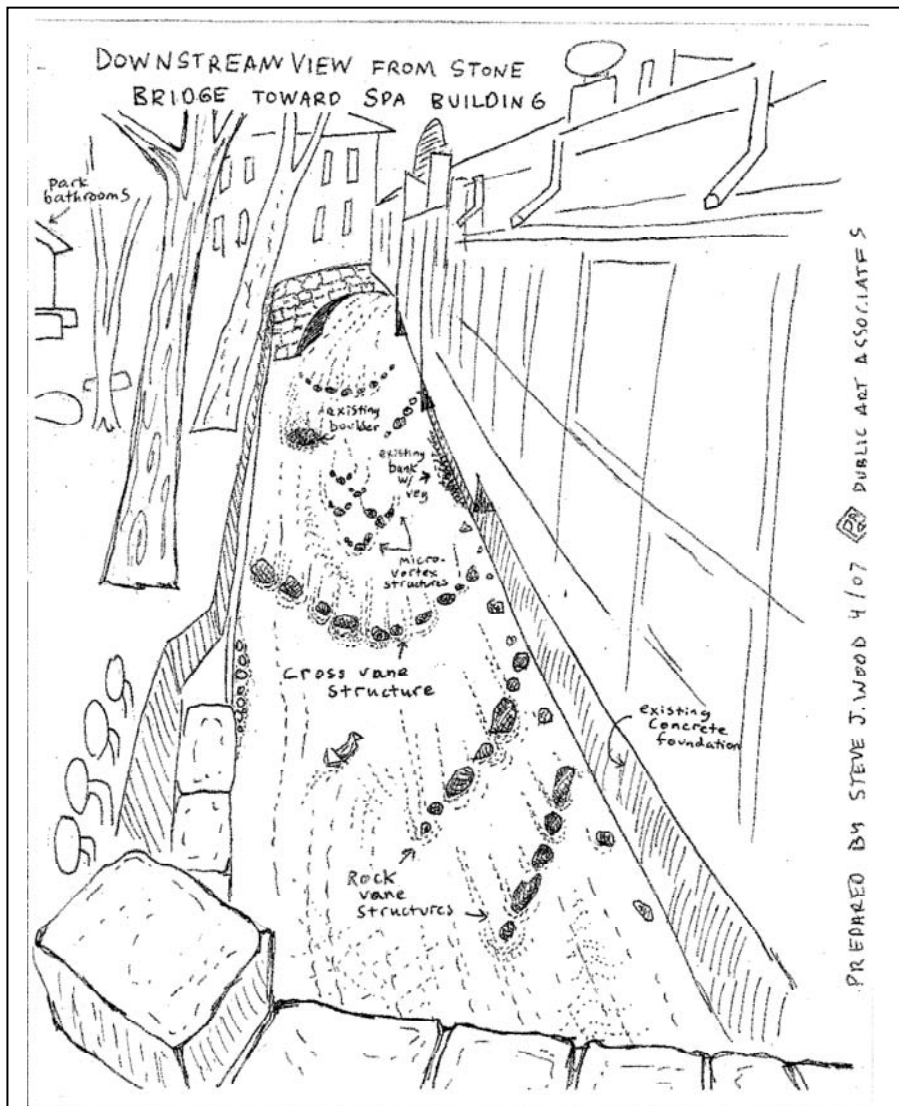
Drawing #3: Channel Habitat Improvements and Foundation Protection Downstream of the Stone Bridge
 Steven J. Wood - Public Art Associates, 2007

Improvements in this segment of the reach represent the greatest challenge for aquatic enhancement in Soda Springs Park. The stream has been straightened and channelized by concrete retaining walls on either side of the channel (Photo 6). Useable aquatic habitat is extremely limited in this segment, and the foundations of several of the buildings overhanging the channel on the left bank appear to be threatened by high flow shear stress. Enhancing the stream through this segment may help reduce some of the foundation erosion risk along the left bank, and provide a unique fish-viewing experience for customers of businesses such as Kinfolks, the Ancient Mariner, and Mate Factor, where the windows in the back of these establishments look directly down on the stream. While there is somewhat greater risk in working in this segment, the potential benefits may warrant consideration in implementing this portion of the enhancement project.

Work in this segment will require a very small piece of equipment and an experienced operator to perform the work without damaging the buildings overhanging the stream channel on the left side of the stream. Equipment will need to be walked into the site

1. Install a full channel cross vane at Glide #1, integrating the structure into the existing large boulder in the stream channel. Perform minor excavation of accumulated sediment downstream of the structure and remove from the site. This structure will provide important vertical profile stability in the channel, protecting the utility crossing upstream at Pool #1, and the foundation on the left bank, as well as providing fish viewing opportunities from Kinfolks.

2. Install rock vane along the left bank of Pool #1 to further protect foundation wall and utility crossing.
3. Install several micro-vortex boulder clusters along Riffle #3
4. Install a full channel cross vane near the upstream boundary of Riffle #3. This structure will provide additional vertical profile stability in the channel, as well as increasing overall pool habitat in the reach. This structure should be visible from dining tables along the windows in the back of the Ancient Mariner.
5. Install two J-hook rock vanes along Riffle #4 to protect foundation on the left side of the stream from direct pressure from thalweg as it emerges from the pool under the stone bridge.
