Lower Rattlesnake Creek Head-Cut and Bank Stabilization Project Elk Mountain Ranch Carbon County, WY

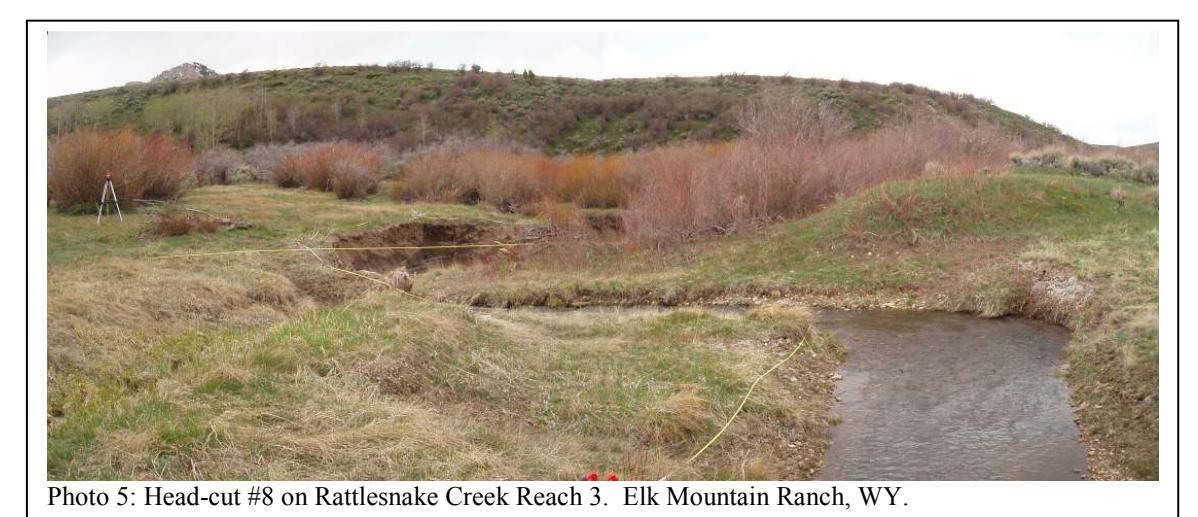
Chart 5: Cross Section and Longitudinal Profile of Head-Cut #8 - Rattlesnake Creek Reach 3.

Head-cut #8 is found approximately 250 feet upstream of the boundary of the Rattlesnake Ranch on Rattlesnake Creek, near the downstream boundary of Reach 3. The head-cut was determined to be moderately severe, and the treatment priority is high, with a large beaver pond complex containing an irrigation diversion structure immediately upstream of the head-cut being at risk. Once this head-cut migrates into the first beaver pond, it will rapidly continue upstream through the fine sediments accumulated in the ponds, resulting in significant sedimentation to habitats downstream A cross section and longitudinal profile of the 116 foot channel segment containing the cut were collected during the survey and are shown in Chart 5 below.

A boulder cross vane may be constructed at the top of the head-cut. The bank full width of the channel at the cross-vane is approximately 14.1 feet. The center of the cross-vane should be set to an elevation of 94.5, relative to the Left Head Pin 6 (LHP6 = 100.0). The elevation of the legs of the cross-vane, at the point where they intersect the stream bank, should be at the bank full stage, at approximately 96.0 relative to LHP6. The legs of the cross vane will be firmly anchored into the stream bank by extending the structure at least 5-7 feet into each bank. These extensions should not exceed the bank full elevation referenced above, and will be buried and revegetated. The structure should be constructed of large flat boulders approximately 0.5 - 0.75 cubic yards in volume. It is estimated that approximately 28 - 30 boulders, including footers, will be required for the structure. Total estimated fill volume for this structure is approximately 11 -15 cubic yards within the bank full stage of the stream.

Once the structure is installed, it is recommended to treat the vertical, collapsing left stream banks downstream of the site be treated using the same toe-slope stabilization technique described for Head-cut #1. These areas will require 3 -4 pieces of large wood to create a stable toe and bank full bench on the bank, then the upper portion of the bank may sloped back and revegetated. The bank full bench can be revegetated using locally available willow and sedge mats harvested from areas nearby the site. Estimated fill below the bank full

stage for this structure type is estimated to be less than 0.1 cubic yard / linear foot of stream bank.
