Halleck Creek
Aquatic Habitat Enhancement Project
Elk Mountain Ranch
Carbon County, WY
Prepared by

FIN-UP Habitat Consultants, Inc.

Halleck Creek
Aquatic Habitat Enhancement Project
Elk Mountain Ranch
Carbon County, WY

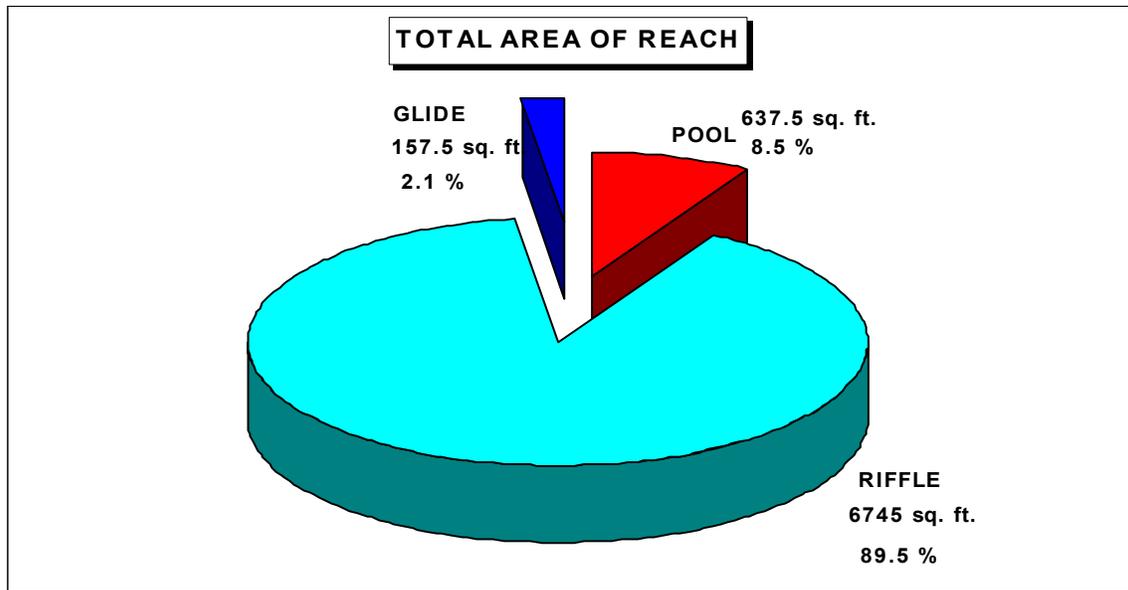
Chart 1: Distribution of Pool, Riffle, & Glide Habitats in Reach 6 on Halleck Creek.

A total of thirty-seven separate meso-habitats were identified in the study segment. These were composed of eleven pools, twenty-four riffles, and two glide habitats (Chart 1). The average width of the stream was 7.9 feet and the average depth was 0.4 feet. Channel substrate was predominately gravel and cobble, with considerable accumulations of boulders. Sand and silt was limited in all habitat types, and in-filling of depositional areas such as the bottom of pools was relatively insignificant. There are considerable accumulations of large wood in the representative segment, with 87 individual pieces counted during the survey. Large wood provided important velocity shelter and cover, and was a significant contributor to habitat creation and scour. Stream banks were generally vegetated and stable throughout the reach, and the bank rock particle size (BRC) consisted mostly of larger cobble providing good armoring of the banks. Only forty-two feet of active eroding banks were measured in the study segment, and were primarily associated with old skid trails crossing the channel.

Pools were principally formed by water plunging over boulders, logs and woody debris obstructions in the channel. Pool habitats comprised approximately 8.5% of the total wetted area of the study segment. The average depth of all of the pools measured was 0.7 ft., with maximum pool depths ranging from 1.0 to 1.4 feet. Residual pool depth (RPD) was found to range from 0.5 to 1.1 feet, with an average of 0.6 feet throughout the reach. RPD and maximum pool depth was found to be generally poor in the reach, and may limit over-wintering capacity for brook trout at this elevation.

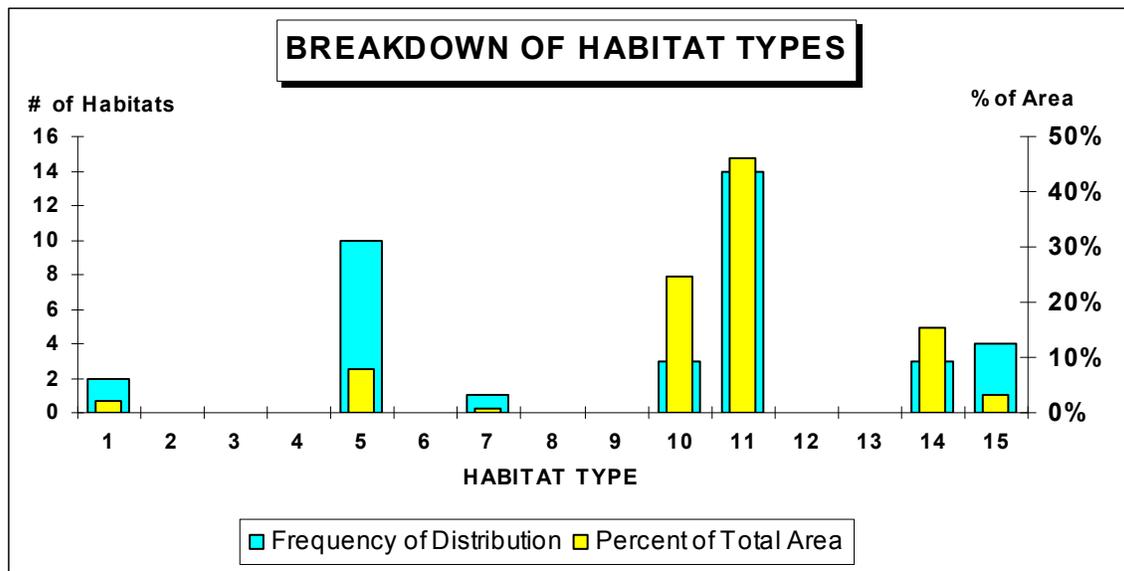
Chart 2: Percentage distribution of Pool, Riffle, & Glide Habitat forms in Reach 6.

High-gradient, pocket water dominated cobble and boulder riffles were the most abundant habitat type, in terms of both numbers and area, in the study segment, comprising more than 89% of the wetted area (Chart 2). These riffles typically dominate A and B channel types, and depending on depth and substrate structure, may provide important holding and feeding habitats for trout, as well as critical habitat for benthic macro-invertebrates and other aquatic organisms. Pocket water cover for trout was observed in several of the

riffles, but totaled only 24 ft², comprising less than 1% of the wetted perimeter of these habitats. Overhead cover was present, to a limited degree, totaling 21 ft² in the riffle habitats. Riffles in the study segment did appear to provide adequate spawning habitat for brook trout.

Two glides was observed in the reach. Glides are not typically encountered in A and steeper B channels, unless they are due to some form of disturbance. These glides were associated with old skid trail crossings along the creek. Glide habitats tended to be over-wide (~9 ft) and shallow to the point creating barriers to migration at lower flows. These habitats accounted for approximately 2% of the total wetted area of the reach.

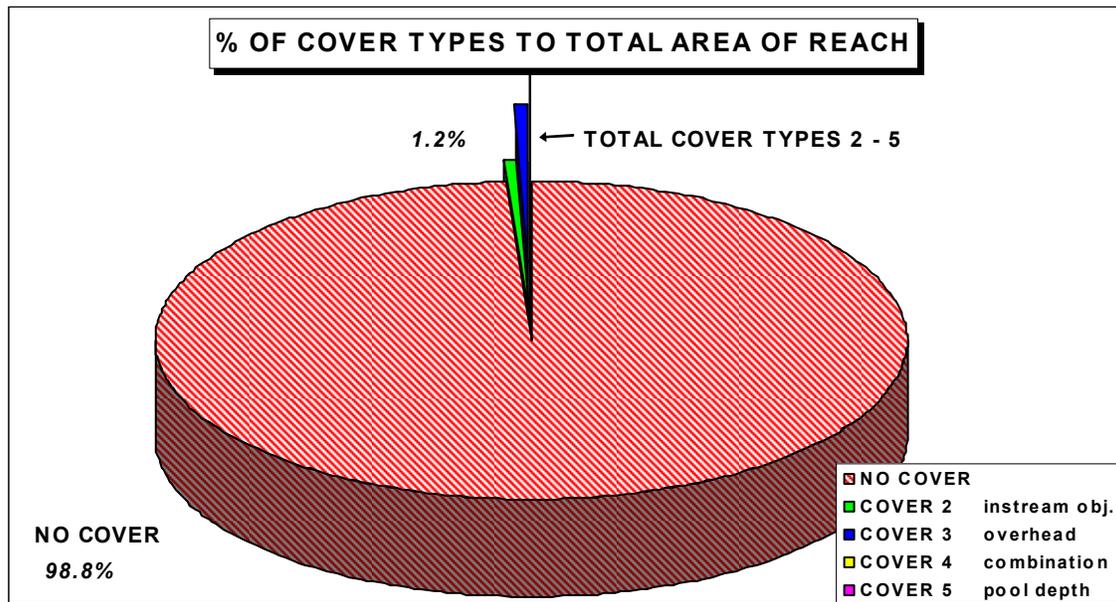
Chart 3: Percentage of Cover Types within Reach 6 on Halleck Creek.

The quantity of suitable cover in the Halleck Creek study segment was very limited (Chart 3), accounting for slightly more than 1% of the total wetted area of the channel. Cover was principally composed of vegetation overhanging the stream providing overhead protection but no velocity shelter. In-channel pocket water cover was the next most dominant type, and was equally distributed between riffle and pool habitats. Combination cover was very limited in the reach, and was typically associated with large wood in the channel. Pool cover, an important metric for determining over-wintering capacity, was not present in the study segment, and is likely a serious limiting factor to the fishery at this time.

The habitat data collected in this segment suggests that Reach 6 may be enhanced to improve the existing brook trout fishery. Pool residual depth and cover appear to be limiting factors in the reach. It may be desirable to enhance pool and pocket water habitats in the reach by removing armor (boulder and cobble) from the bottom of existing pools to enhance scour, improve RPD, and deepen these habitats. This work can be done by back-hoe, small excavator, or by hand.

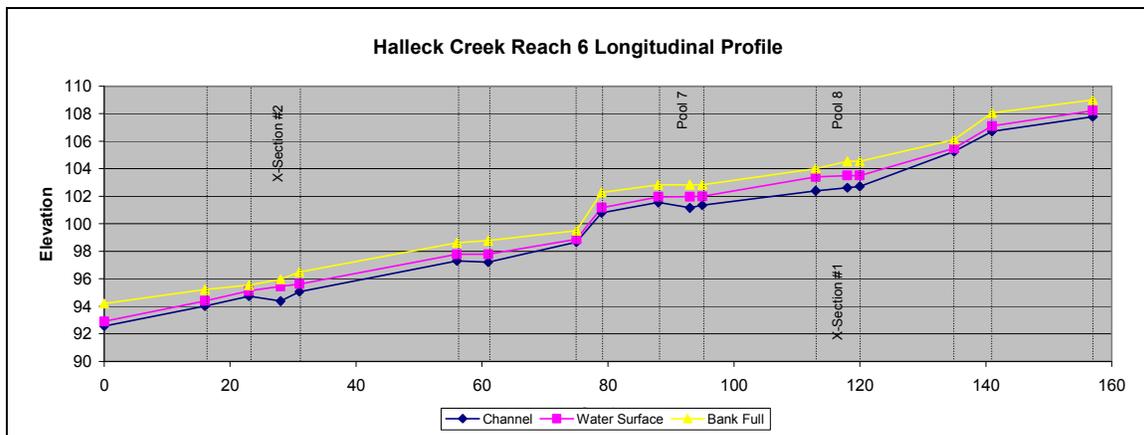
Chart 4: Longitudinal Profile of the representative segment of Reach 6 on Halleck Creek.

The stream channel was slightly entrenched throughout this segment. Stream substrate typically was composed of gravel and smaller cobbles, and did not appear to be significantly embedded. Stream banks were vegetated and stable, and the banks were mostly composed of particles 3" - 6" in diameter, providing some armoring from high flows. The width of the stream throughout the longitudinal profile was typically 6 -7 feet, and considerable large wood was present in the channel, creating scour habitat and cover, as well as channel roughness and complexity. Pool habitats, however, were relatively infrequent and of poor quality throughout the reach. Maximum pool depth was not more than 1.0 foot, and residual pool depths did not exceed 0.5 foot. Over-wintering habitat was exceptionally limited along the longitudinal profile.

A longitudinal profile (Chart 4) of the stream channel and the two cross-sections were established in July 2007. Stream flow was measured at cross-section #1, using a Marsh-McBirney FlowMate 2000 flow meter, and was calculated to be 2 cfs. The longitudinal profile is typical of the steeper Ba channel type, characterized by high gradient and infrequent pool habitat. The

average slope of the channel and the water surface throughout the profile was 9.7%, and the slope of the bank full elevation was 9.4%. Riffle slopes ranged from 8% to 13%, with two transitional areas exhibiting slopes of 4% to 6%. These transitional segments in the riffles are identified for conversion to pool habitat in the habitat enhancement plan. Stream channel sinuosity was low (<1.5) in the representative sub-reach, as would be expected for a Ba type channel.

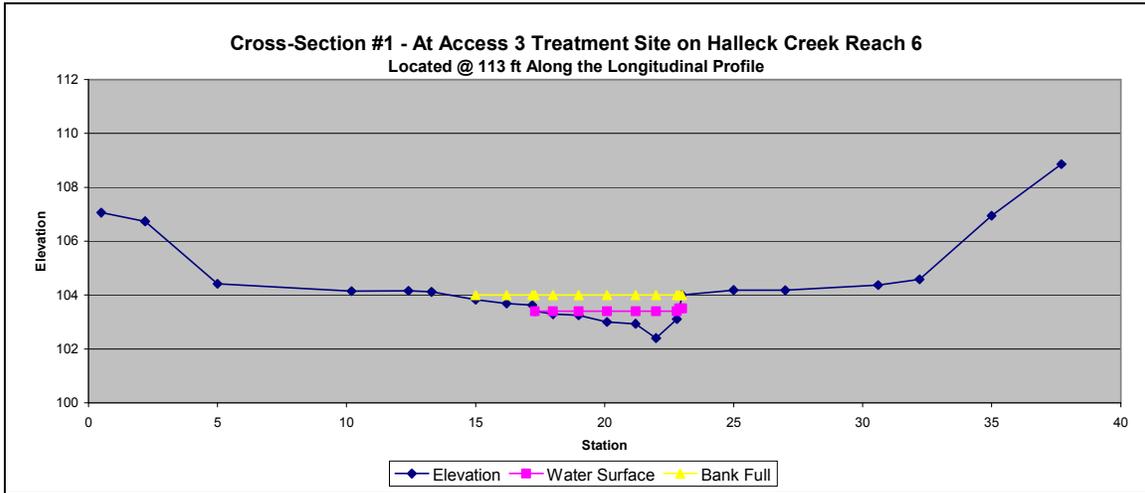
Chart 5: Cross Section #1 on Halleck Creek.

Cross-sections #1 and #2 show the moderately entrenched characteristics of the stream channel within the reach. Entrenchment ratios of 3.2 and 2.3 were observed at each cross-section. Width/depth ratios were calculated to be 12 and 14. Entrenchment ratios and W/D ratios were slightly higher than expected for a Ba channel type, but were likely due to the locating of the cross-sections at brief low gradient transitional areas within the representative sub-reach. The cross-sections bisect the creek at Pool 8 and a new pool described later in this document.

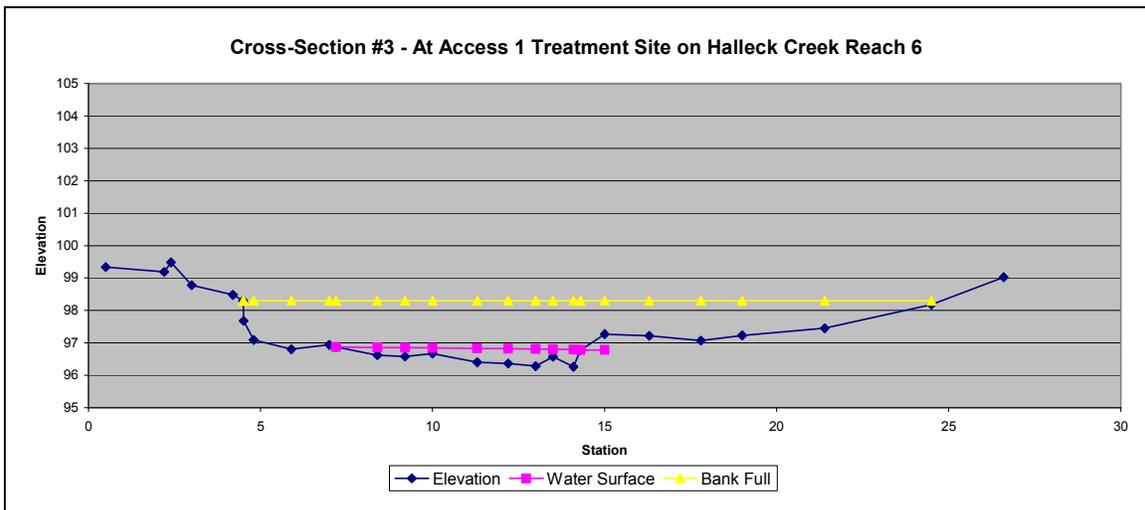
Chart 7: Cross-Section #3 at Treatment Site Access_1 on Halleck Creek.

Treatment Site Access_1 is located approximately 420 feet upstream of the 3rd Diversion on Halleck Creek. There is a faint remnant of a skid trail accessing the creek through the aspen forest on the east side, and this path appears to be regularly used by elk and cattle. The stream channel at the site is somewhat over-wide, due to tramping of the stream banks. A cross-section of the stream at the crossing shows a bank full width of >22 ft, a width/depth ratio in excess of 16 (Chart 7). A boulder cross vane will be installed immediately upstream of the crossing, and the cobble armoring the channel will be excavated to create a large plunge pool, with a maximum depth of 2 ft and a residual pool depth of 1.3 - 1.6 ft. Some of the excavated cobble may be used to reinforce the riffle crest and tail of the pool, creating crossing and watering site for elk and cattle utilizing the path. Two large logs will be used to redefine and protect the stream banks on either side of the new pool. Native willow and alder will be planted behind these logs to establish robust streamside vegetation. Large wood will be placed along the path above the ordinary high water mark of the stream in order to direct elk and cattle towards the hardened pool tail and riffle crest to protect the newly vegetated stream banks along the constructed pool. The structures in Access_1 will require 12 - 15 boulders and 6 trees to complete. Estimated fill below the ordinary high water mark of the stream is 6 to 7 yd³ for the cross vane structure, and 0.2 yd³/linear ft of log toe slope stabilization (4 yd³ total).

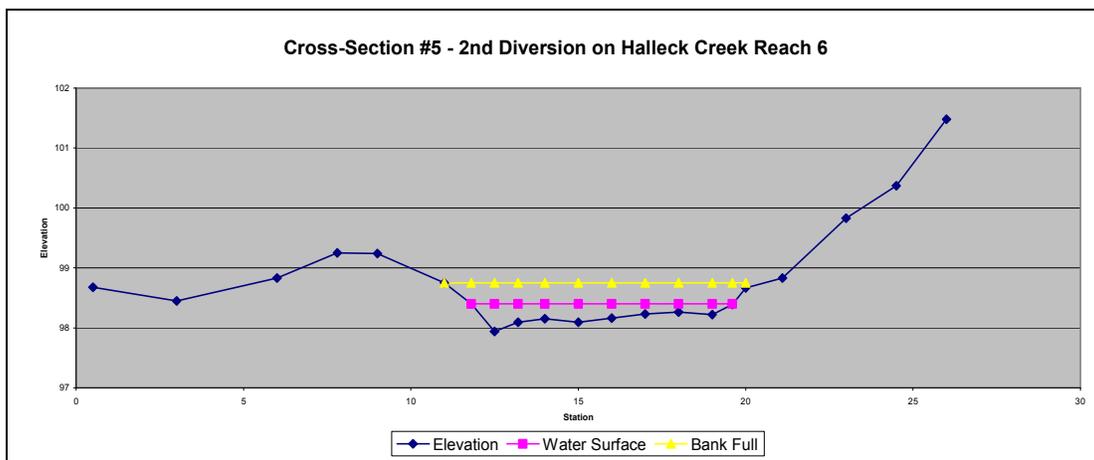
Chart 8: Cross-Section #5 at the 2nd Diversion on Reach 6 of Halleck Creek.

Treatment Site H6 Diversion 2 is located near the downstream boundary of Halleck Creek Reach 6, and is approached from an ATV access route that parallels the irrigation ditch feeding the pasture lands between the main stem of Halleck Creek and Halleck#4 Creek to the east. H6 Diversion 2 is approximately 450 ft upstream of the east/west ATV access route that defines the downstream boundary of the project area. The existing diversion structure at H6 Diversion 2 consists of a 12" cast iron pipe embedded into an earthen berm consisting mostly of small cobble and gravel. The diversion is at a sharp, 90 degree bend that appears to have been constructed when the diversion was installed. Downstream of this point, there is a brief higher gradient riffle leading to the undisturbed stream channel below. The "head-gate" control on this diversion consists of a steel cap that seals the end of the pipe extending into the stream. In order for the diversion to function, a "come-a-long" block and tackle must be fastened to trees upstream of the pipe, and the cap forced open and held in place (Photo 7).

In addition to being difficult to operate, the diversion at H6 Diversion 2 is at risk of catastrophic failure from high flows breaching the earthen berm creating the artificially tight meander bend. If the existing structure were to be overtopped and fail, there is a high probability that the stream could re-align into the diversion ditch, creating significant problems downstream along the ATV access trail and in the pasture lands below. Additionally, the current structure, as configured, presents a significant barrier to fish and other aquatic organisms moving through the reach.

To reduce the risk of failure and improve the functionality of the diversion, a new 12" culvert and screw-type head-gate will be installed approximately 15 feet upstream of the present diversion point. This culvert and head-gate will be incorporated into a boulder cross vane that will provide sufficient stage at low flow to provide full capacity to the pipe leading to the diversion ditch. Downstream of the new cross-vane diversion structure, the stream channel will be re-aligned to reduce the radius of curvature of the meander bend and create a more consistent channel bed and water surface slope through the pocket water riffle below. Approximately 15 feet of stream channel will need to be re-aligned toward the right bank. Willow and alder vegetation removed along the right bank will be used to create a new bank-full riparian bench on the left bank at the old diversion point. Additionally, the existing earthen berm will be raised and re-enforced to ensure that the stream does not over-top this structure.

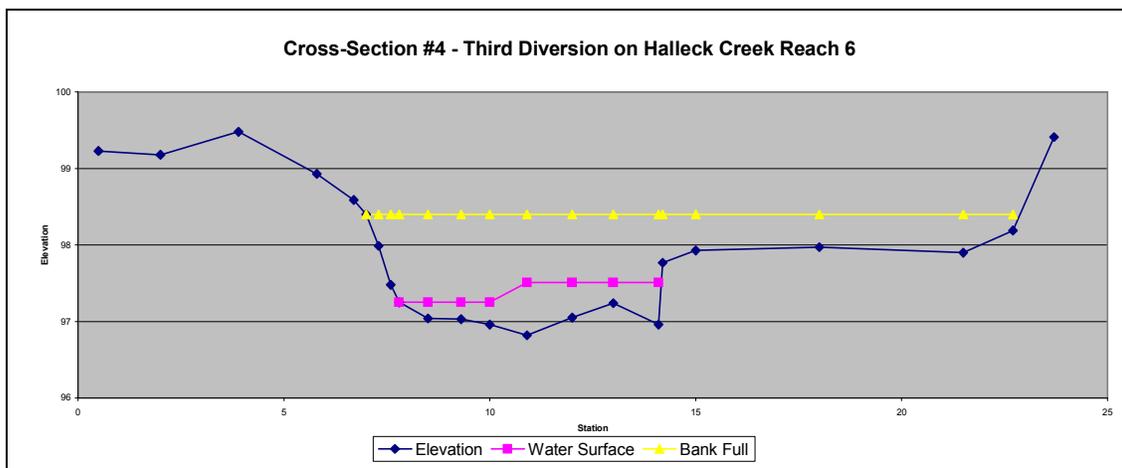
Chart 8: Cross-Section #4 at the 3rd Diversion on Reach 6 of Halleck Creek.

The diversion at H6 Diversion 3 appears to have a slight risk of catastrophic failure from high flows breaching the earthen berm, possibly resulting in an undesirable stream re-alignment into the diversion ditch. The existing irrigation ditch elevation is considerably lower than the stream channel bed elevation, and failure of the structure would likely create a head-cut that would progress upstream.

In addition to addressing the potential barrier by reducing the channel bed and water surface slope of the riffle immediately downstream of the diversion, additional cover and pool habitat will be gained by selectively removing cobble armoring the channel bed immediately upstream and downstream of the new boulder cross-vane to create a new dam pool and plunge pool above and below the structure.

To reduce the risk of failure and improve the functionality of the diversion all flows, a new 12" culvert and screw-type head-gate will be installed at the same location as the present diversion point. This culvert and head-gate will be incorporated into a boulder cross vane that will provide sufficient stage at low flow to provide full capacity to the pipe leading to the diversion ditch. The right stream bank forming the outside of the meander bend upstream of the diversion point will be reinforced using boulder and large wood to ensure that the stream cannot re-align into the diversion ditch. The existing earthen berm will be raised and re-enforced at the same time so that the stream does not over-top this structure.
