Brush Creek
Aquatic Habitat Enhancement Project
Elk Mountain Ranch
Carbon County, WY

Brush Creek Reach 2 Aquatic Habitat Enhancement Plan

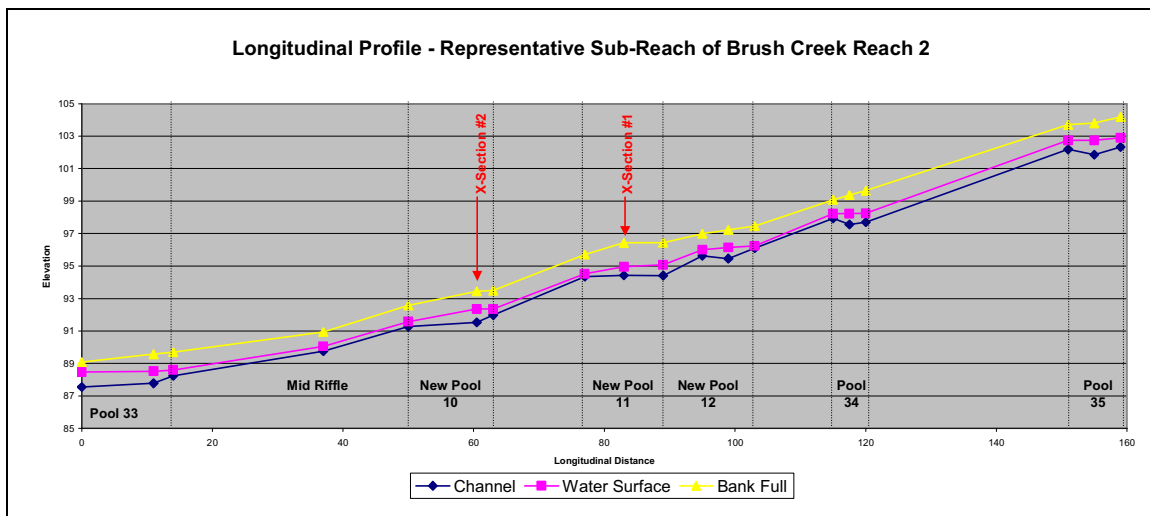
Chart 4: Longitudinal Profile of the representative segment of Reach 2 on Brush Creek.

A longitudinal profile (Chart 4) of the stream channel and the two cross-sections were established in July 2007. Stream flow was measured at cross-section #1, using a Marsh-McBirney FlowMate 2000 flow meter, and was calculated to be 0.8 cfs. The longitudinal profile is typical of the steeper Ba channel type, characterized by high gradient and infrequent pool habitat. The average slope of the channel and bank full stage throughout the profile was 9.5%, and the water surface slope was 9.1%. Riffle slopes ranged from 9.5% to 14%, with brief, transitional areas exhibiting slopes of 4% to 6%. These transitional segments in the riffles are identified for conversion to pool habitat in the habitat enhancement plan. Stream channel sinuosity was low (<1.5) in the representative sub-reach, as would be expected for a Ba type channel.

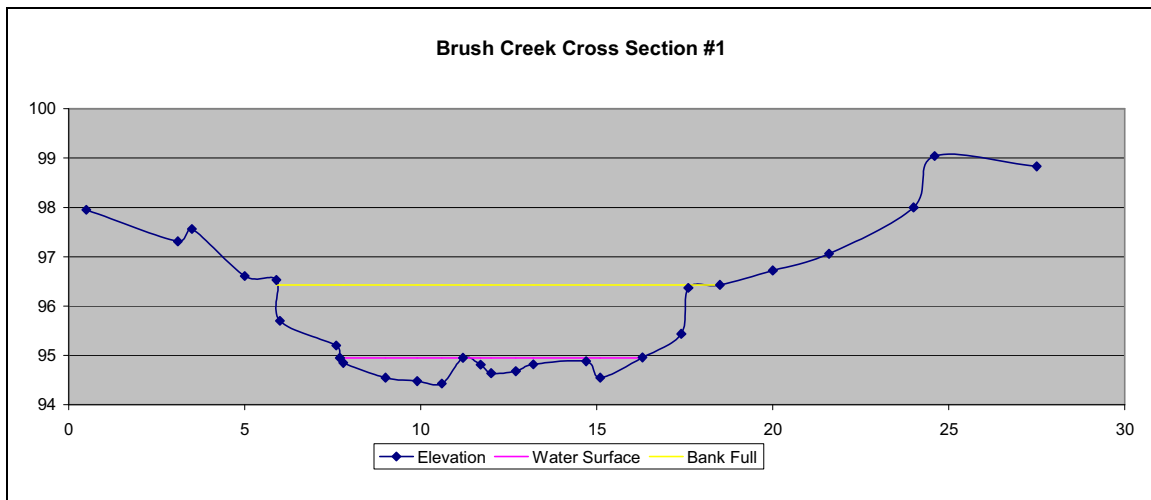
Chart 5: Cross Section #1 on Brush Creek.

Cross-sections #1 and #2 show the moderately entrenched characteristics of the stream channel within the reach. Entrenchment ratios of <1.9 were observed at each cross-section. Width/depth ratios were calculated to be <10 . Entrenchment ratios and W/D ratios were slightly higher than expected for a Ba channel type, but were likely due to the locating of the cross-sections at brief low gradient transitional areas within the representative sub-reach. The cross-sections bisect the creek at the transition between New Pool 10 and New Pool 11, described later in this document. Photographs of the cross-sections described in this section can be found in the site descriptions for New Pool 10 and New Pool 11 in the next section (page 22).

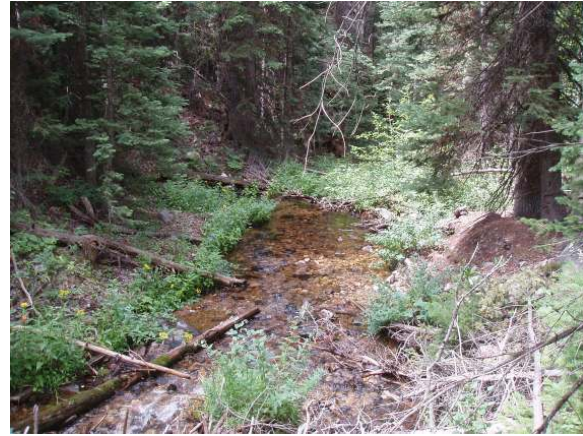
Photo 37 - P62 Looking Downstream.

The next 340 ft of stream is a few hundred feet from the southern edge of the Secret Meadow, and is not accessible by equipment. Four existing pools (P61 - P64) were identified within this segment. One of these pools, Pool 62 (P62, Photo 37) is formed by a small woody debris dam, and may be enhanced without the use of heavy equipment by adding additional wood to the dam. Two small trees will be cross-felled into the stream channel immediately downstream of the debris dam to gradually capture an accumulation of leaves and smaller woody materials, leading to improved depth of the existing dam pool.
