Aquatic Habitat Survey
&
Habitat Enhancement Plan
for Bear Creek
Bear Creek Regional Park
El Paso County Parks Department
Colorado Springs, El Paso County
Colorado

FIN-UP Habitat Consultants, Inc.

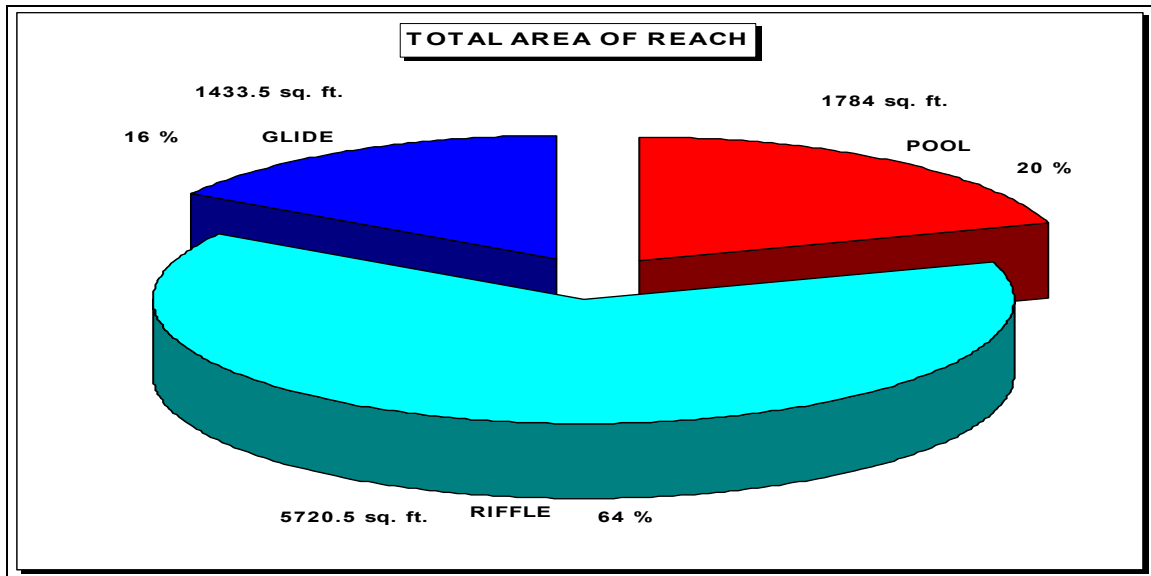
Chart 2 - Distribution of Pool, Riffle and Glide habitats in Reach 2 of Bear Creek.

There were 48 individual meso-habitats measured in the reach (15 pools, 23 riffles and 10 glides), along a length of 1,330 feet of river, and comprising a total wetted area of 8,938ft². The total area of the reach consisted of 64% riffles and 20% pools, with the remaining 16% consisting of glide/run habitat (Chart 1). The average wetted width of the stream was 6.7 feet throughout the reach. Approximately 70% of left bank, and 74% of the right bank were found to be vegetated and stable, consisting mostly of sand and gravel sized fragments. There were 321 feet of actively eroding stream banks contributing sediment directly into the river. This accounted for slightly more than 12% of the total length of banks in the study reach.

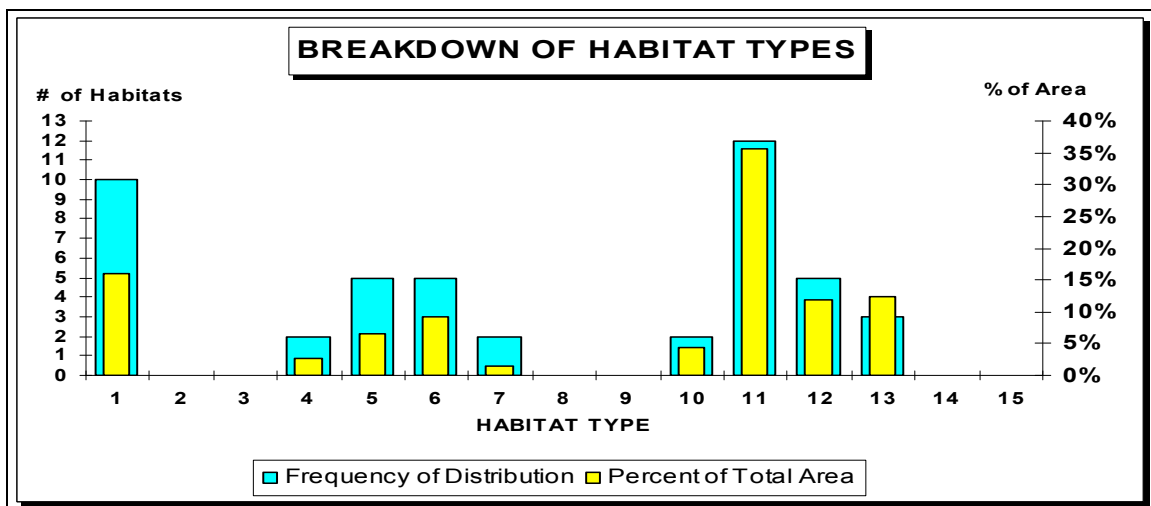
Chart 2 - Distribution of Habitat Unit Types (HUT's) as a percentage of # of habitats and as a percentage of wetted perimeter of Reach 2.

Low gradient cobble riffles were the most common habitat type in terms of numbers and area, accounting for 36% of the total reach area (Chart 2). Low gradient riffles can provide good spawning habitat, but are somewhat limited in terms of cover from high flows and predators. Low gradient gravel riffles and sand riffles were also common in the reach, each amounting to 12% of the wetted area of this segment. Gravel riffles exhibit similar characteristics to cobble riffles, and may provide excellent spawning habitats if not impacted by excessive sediment loads. Sand riffles typically provide little useful habitat, and may become barriers to fish passage at extremely low flow. A few higher gradient, pocket water dominated riffle types were observed near the upstream boundary of the reach. Overall, very little cover for trout was observed in the riffles, amounting to less than 0.1% (8 ft²) of the total wetted area of these habitat types. The average width of all the riffles observed in the reach was 6.5 feet.

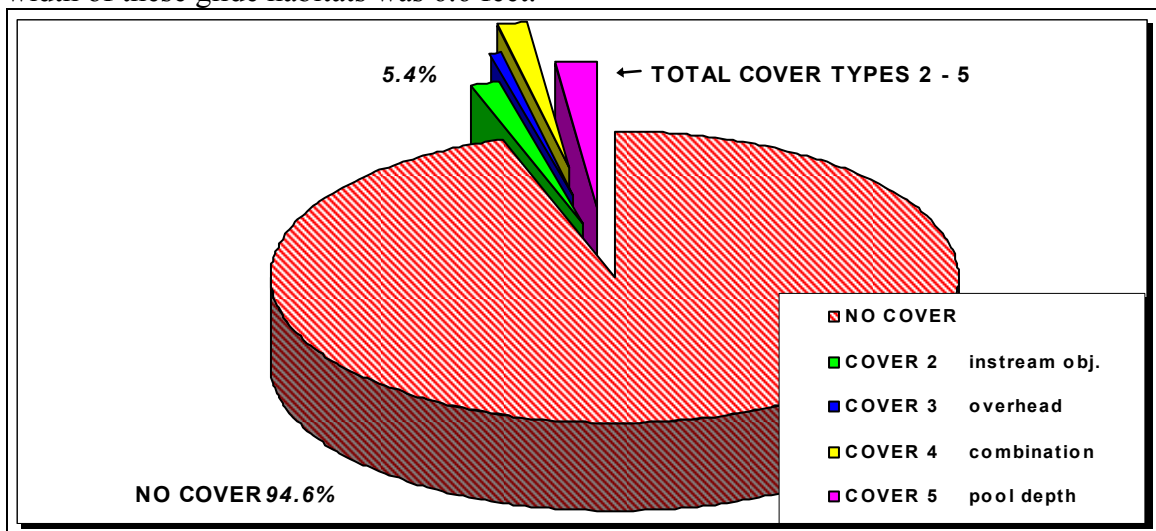
Chart 4 - Percentage of cover for trout to the total wetted perimeter of Reach 2.

Cover for adult trout accounted for approximately 5% of the reach, which is relatively poor for a river the size of Bear Creek (Chart 4). Available cover appears to be a limiting factor in the fishery, particularly in the riffle habitats. Pool cover (Cover Type 5 -

>1.5' deep) was the dominant type observed in the reach, and was typically associated with the lateral scour pools. Pool cover is another important indicator for determining the available over-wintering capacity of the stream reach, and appeared to adequately support the wintertime habitat requirements of trout in this reach. Instream object cover (Cover Type 2 - >1' deep) was the next most abundant form, and was found in both pool and riffle habitats. Instream object cover was abundant in the pool habitats, but was somewhat limited in the riffles. Combination cover was present in several of the large lateral scour pools, and was formed primarily by undercut banks and submerged rock ledges. Overhead cover was the least abundant cover type. Overhead cover appeared to be limited not by lack of adjacent riparian vegetation, but due to a lack of velocity shelters in the channel.

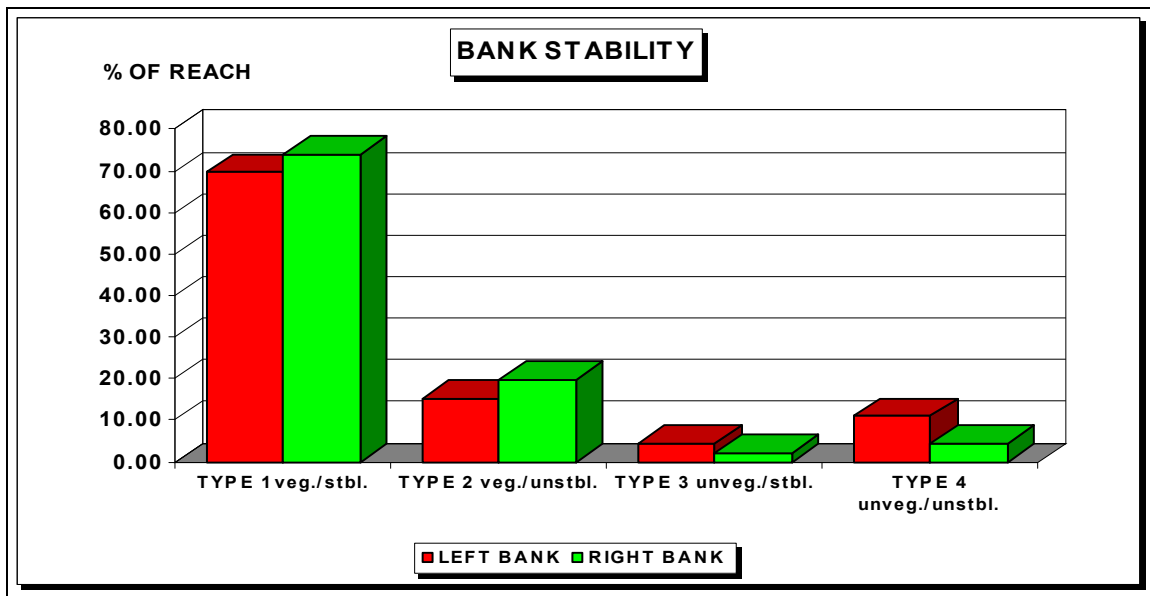
Chart 5 - Percentage of stable banks to unstable banks in Reach 2

Stream banks were generally in good condition in this reach. Deeply rooted, streamside riparian vegetation is a critical component in maintaining the integrity of stream banks during runoff and other high flow events, and in this study reach, this vegetation component appears to be in reasonably sound condition. Seventy percent of the left bank and 74% of the right bank were found to be vegetated and stable and 4% of the left banks and 2% of the right banks of the habitat units were found to be stable and unvegetated (Chart 5). Bank rock content consisted mostly of sand and smaller fragments (Type 8), with small accretions of larger materials (Chart 6). Bank rock content is a good indicator as to the armored condition of the banks, and in this case the undisturbed, vegetated banks appear to be adequate to resist higher flows. The general reach substrate was determined using an ocular estimate of each habitat unit. Stream substrate in Reach 2 was estimated to consist of approximately 73% sand and other fine materials, 15% gravel, 9% cobble, and 3% boulder. Twenty-seven pieces of large wood (>4" diameter and > 3' long) were found in the reach. Large wood is an important habitat forming component for rivers in the Rocky Mountains, and provides cover and complexity to the aquatic ecosystem.

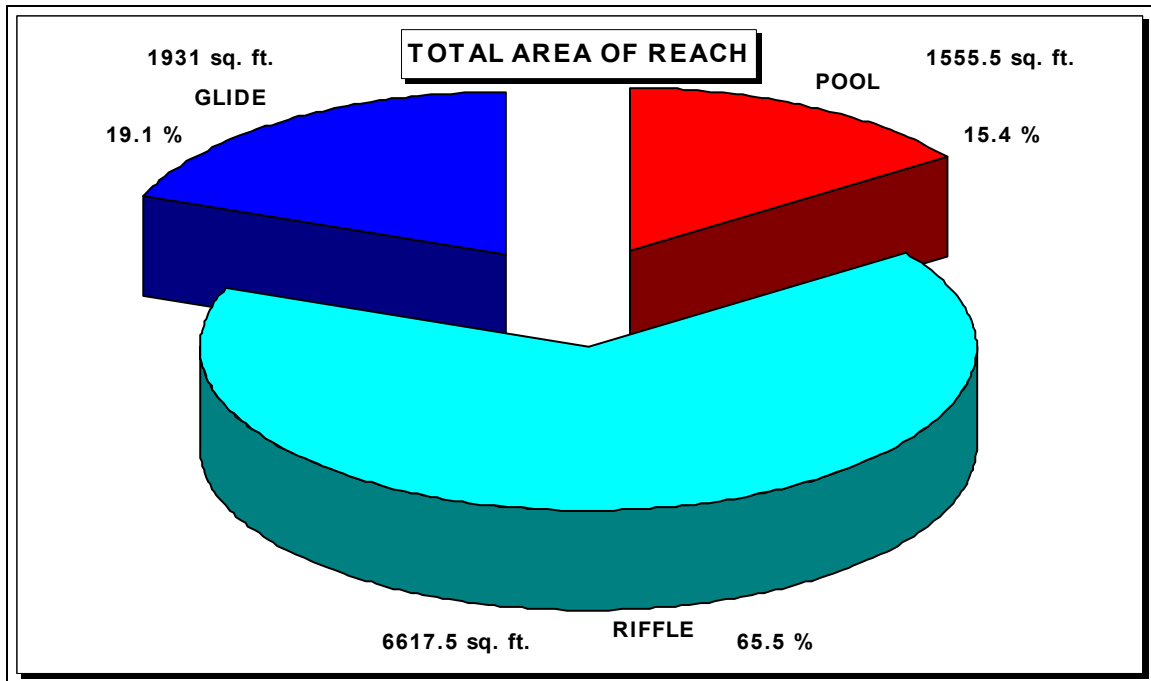
Chart 7 - Distribution of Pool, Riffle and Glide habitats in Reach 3 of Bear Creek.

There were 44 individual meso-habitats measured in the reach (11 pools, 22 riffles and 11 glides), along a length of 1,455 feet of river, and comprising a total wetted area of 10,104ft². The total area of the reach consisted of 66% riffles and 19% glides, with the remaining 15% consisting of pool habitat (Chart 7). The average wetted width of the stream was 7.1 feet throughout the reach. Approximately 62% of the stream banks were found to be stable, consisting mostly of sand and gravel sized fragments. There were 774 feet of actively eroding stream banks contributing sediment directly into the river. This accounted for slightly more than 27% of the total length of banks in the study reach.

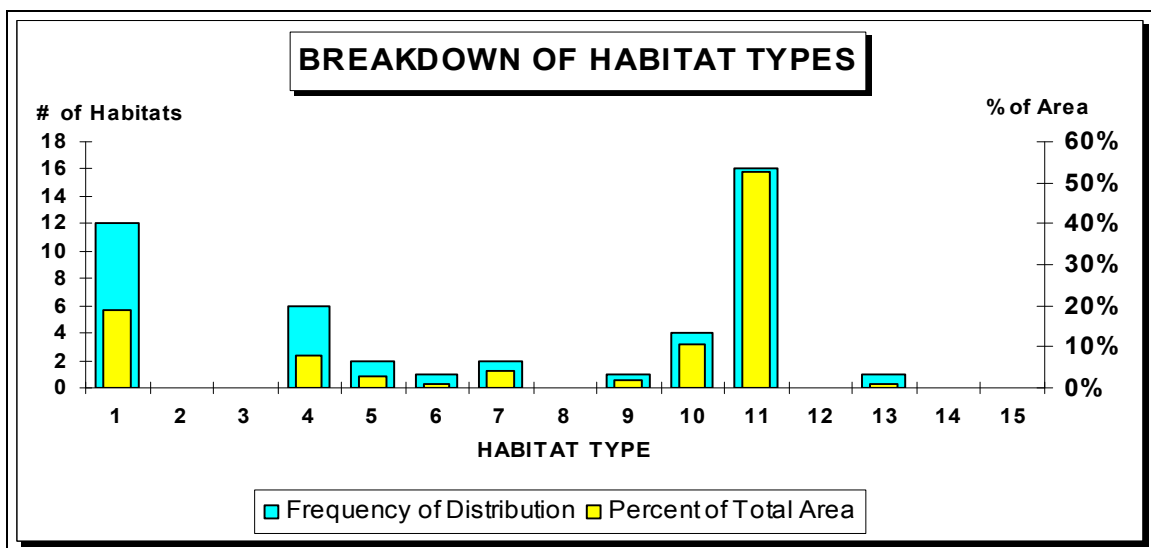
Chart 8 - Distribution of Meso-Habitat Types as a percentage of # of habitats and as a percentage of wetted perimeter of Reach 3 on Bear Creek.

Low gradient cobble riffles were the most common habitat type in terms of numbers and area, accounting for 52% of the total reach area (Chart 8). Low gradient riffles can provide good spawning habitat, but are somewhat limited in terms of cover from high flows and predators. A few higher gradient, pocket water dominated riffle types were observed in the reach. Overall, very little cover for trout was observed in the riffles, amounting to less than 0.5% (30 ft²) of the total wetted area of these habitat types. The average width of all the riffles observed in the reach was 7.1 feet.

Pool habitat is very limited in the reach, with trench pools being the most abundant (Chart 8). This pool type forms due to root-wad and other restrictions in the channel creating scour along the stream bottom. Lateral scour pools were found, as well as plunge pools and debris dam pools. All of the pools exhibited some degree of in-filling of sediment, mostly consisting of smaller particles of decomposed granite. Due to this in-filling of fines, the average pool depth in Reach 3 was barely more than 1/2 foot. Residual pool depth (RPD) in Reach 3 was found to range from 0.6 to 1.5 feet, with an average of 0.9 feet throughout the reach. Only three pools exhibited RPD of greater than 1 foot. RPD in the reach is relatively poor, and likely does not provide adequate overwintering habitat for salmonids and other native species in this reach. Cover for trout accounted for slightly less than 12% of the total wetted area of the pools, which is quite poor for a stream of this size. The average wetted width of all pool types found within the reach was 7.4 feet.

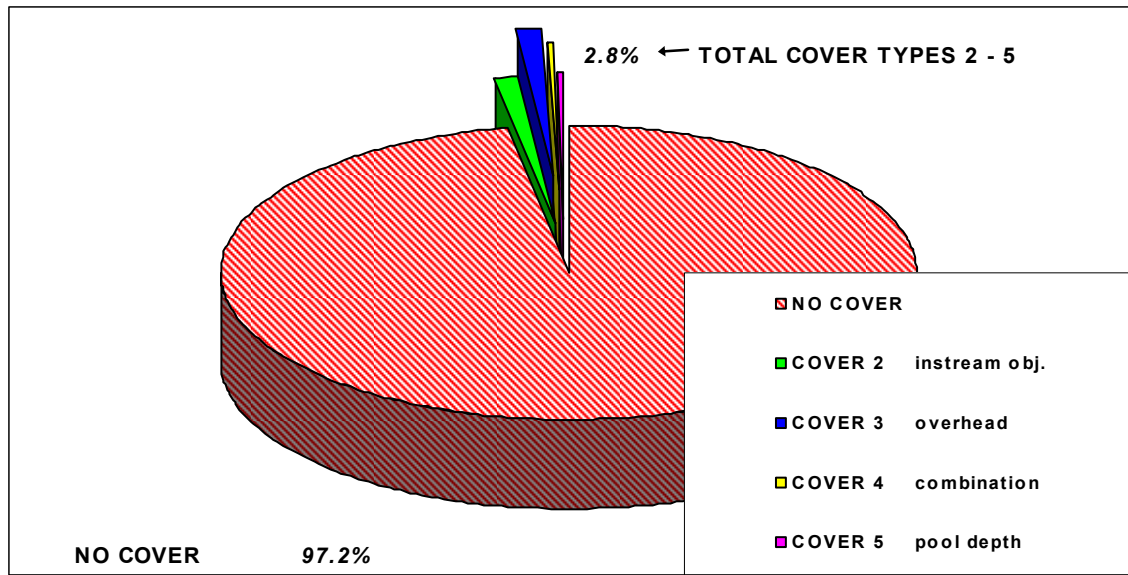
Chart 10 - Percentage of cover for trout to the total wetted perimeter Reach 3 on Bear Creek.

Cover for adult trout accounted for approximately 2.8% of the reach, considerably less than in Reach 2 (Chart 10). Available cover appears to be a limiting factor in the fishery, and will be addressed in the Habitat Enhancement Plan. Instream object cover (Cover Type 2 - >1' deep) was the dominant type observed in the reach, and was typically associated with the pool habitats. Overhead cover was the next most abundant form, and

was found in both pool and riffle habitats. Pool cover (Cover Type 5 - >1.5' deep) was very limited in the reach, and comprised only 2% of the wetted area of the pools. Pool cover is an important indicator for determining the available over-wintering capacity of the stream reach, and appeared to be severely limited in this reach. Combination cover was present in three of the pools, and was formed primarily by undercut banks. Instream and overhead cover could be enhanced in the riffle habitats by adding structure and velocity shelters along the stream banks with strategically placed boulders and large wood. Additionally, pool cover may be increased by improving scour in existing pools as well as creating new pool habitats.

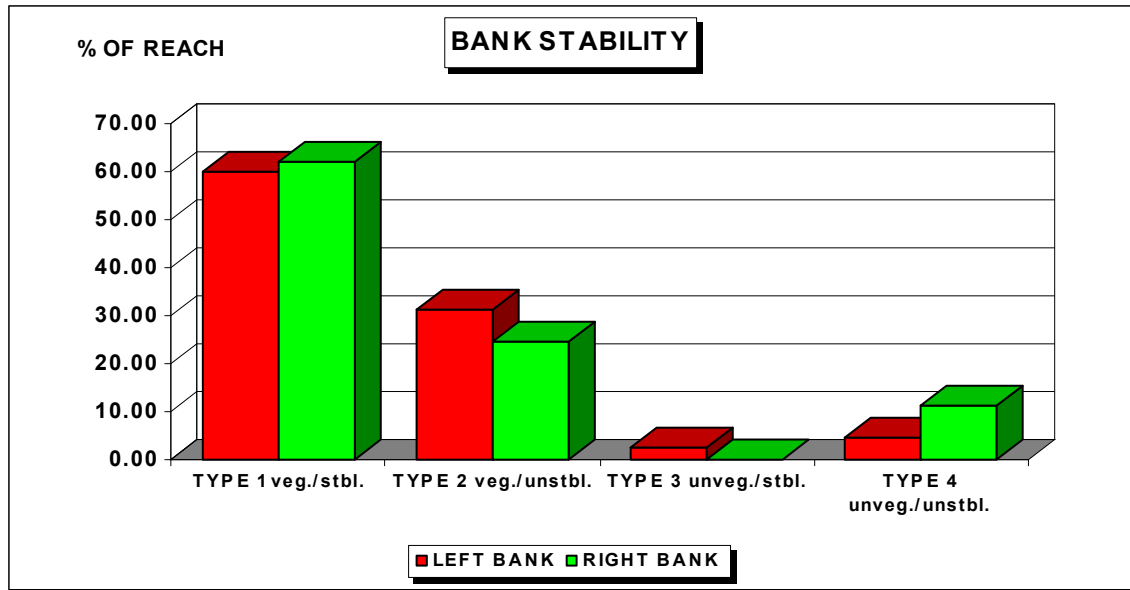
Chart 11 - Percentage of stable banks to unstable banks in Reach 3 on Bear Creek.

Stream bank stability was generally poor, primarily due to the active head cuts in the reach. In the segments of the reach not affected by head-cutting, the stream banks were generally in good condition. Deeply rooted, streamside riparian vegetation is a critical component in maintaining the integrity of stream banks during runoff and other high flow events. Sixty percent of the left bank and 62% of the right bank were found to be vegetated and stable and 2% of the left banks of the meso-habitat units were found to be stable and unvegetated (Chart 11). Bank rock content consisted mostly of sand and smaller fragments (Type 8), with small accretions of larger material (Chart 12). The general reach substrate was calculated using a Z-Walk pebble Count (Bevenger, 1997) and the results are shown in Table 1. A bimodal distribution of smaller particles (fines) and larger cobble and boulder is readily apparent in the pebble count data (Chart 13), and suggests that sediment yield in the stream exceeds the capacity of the stream to move the material. Large wood (>4" diameter and > 3' long) is somewhat scarce in the reach, with only nine pieces being observed. Large wood is an important habitat forming component for rivers in the Rocky Mountains, and provides cover and complexity to the aquatic ecosystem.

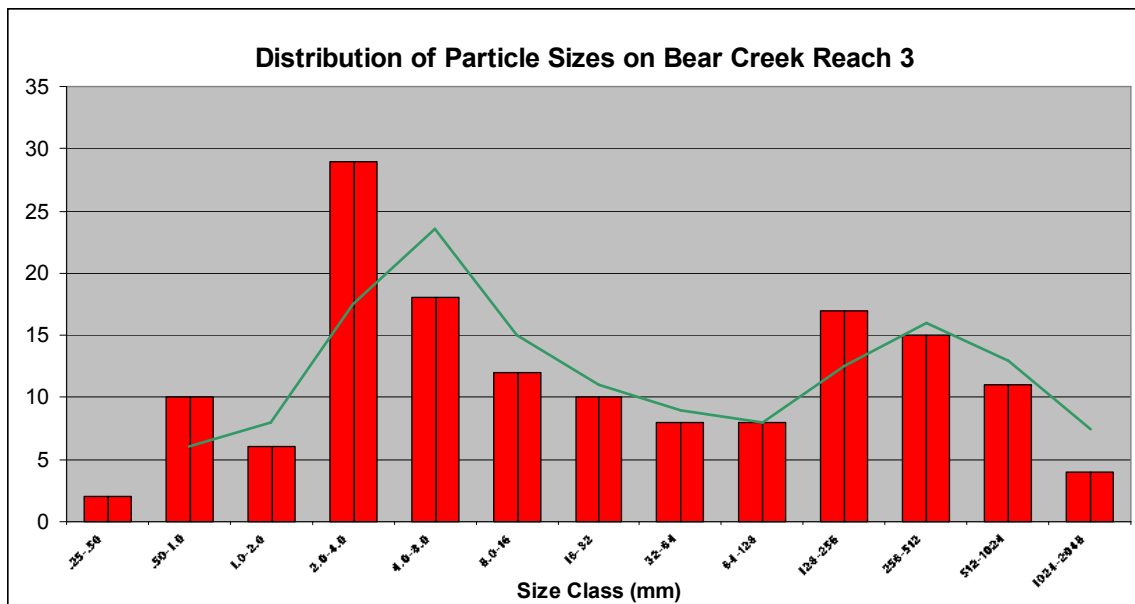
Chart 13 - Distribution of particle size classes showing a bi-modal distribution of sand and larger cobbles and boulder in Reach 3 on Bear Creek.

Aquatic habitat conditions throughout Reach 3 were generally very poor. Limiting factors to the fishery appear to be excessive sedimentation due to head-cutting and sediment from upstream areas, a severe lack of pool habitat, and limited in-channel object cover in the low gradient riffles. Several problem areas were identified during the course of the inventory that should be addressed in order to alleviate potential worsening problems and loss of habitat, as well as to help the river achieve its full potential as a cold water fishery.
