Aquatic Assessment & Habitat Enhancement Plan The Cucharas River Cuchara Valley Ranch Huerfano County - Colorado

J. Peter Gallagher 220 Illinois Ave Manitou Springs, CO 80829 (719) 685-9768 (Office) (719) 332-2550 (Cell) <u>pete@fin-up.com</u> September 30, 2008

Table of Contents

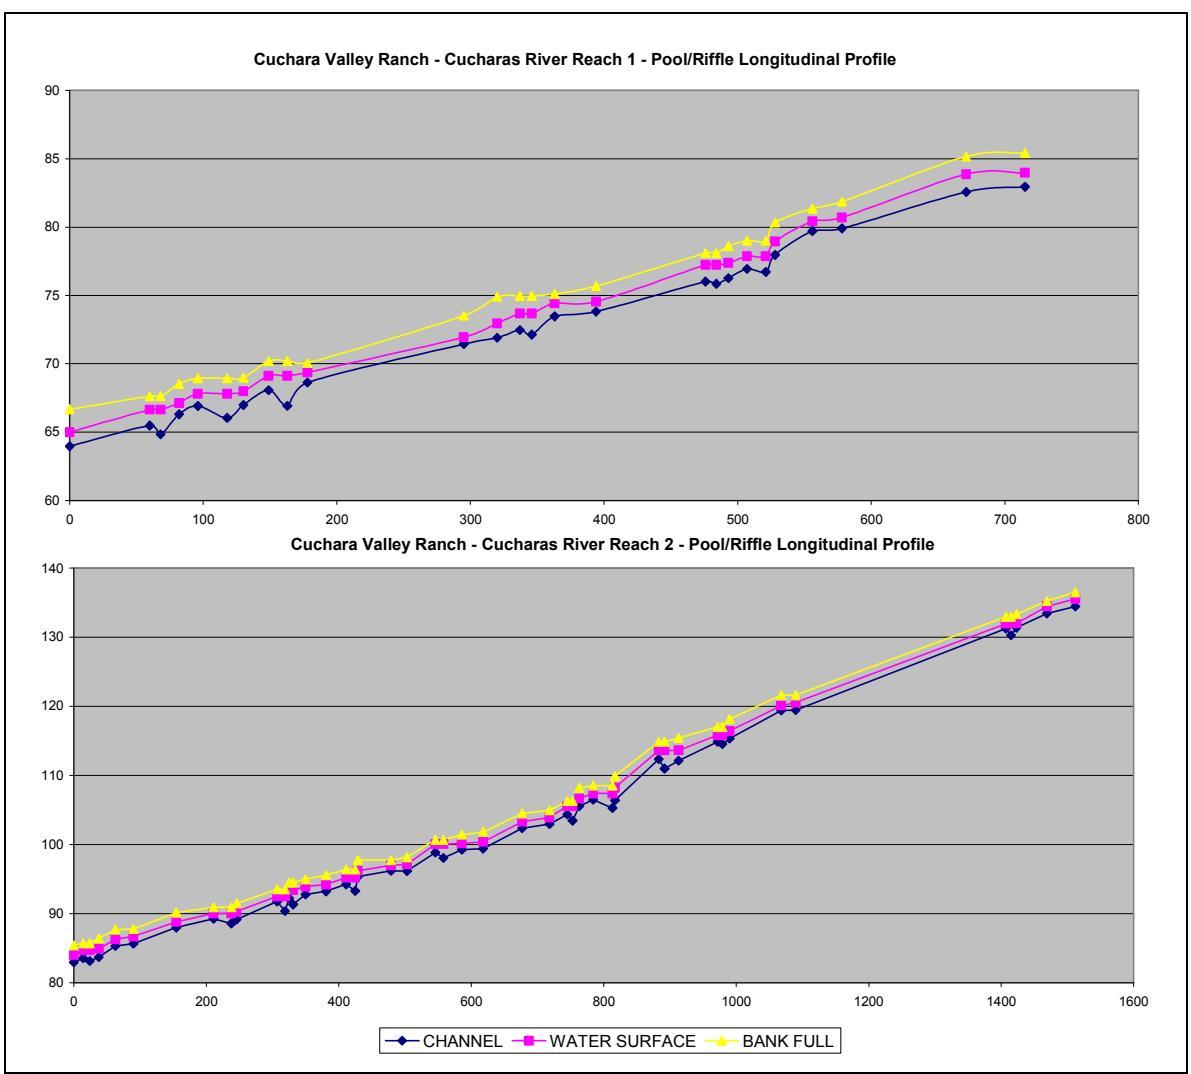
Chart 1: Longitudinal Profile of Reach 1 and Reach 2 on the Cucharas River.

Longitudinal profiles (Chart 1) of the stream channel were surveyed for both reaches. The longitudinal profiles are characterized by relatively high gradient, slight to moderate degrees of entrenchment, and relatively infrequent pool development. The average slope

of the channel, water surface and bank full elevation throughout the profile in Reach 1 was 2.7%, and in Reach 2 was 3.4%.. Riffle slopes ranged from 1% to 9%. Stream channel sinuosity was relatively low (<1.2) in Reach 2, and slightly greater in Reach 1.

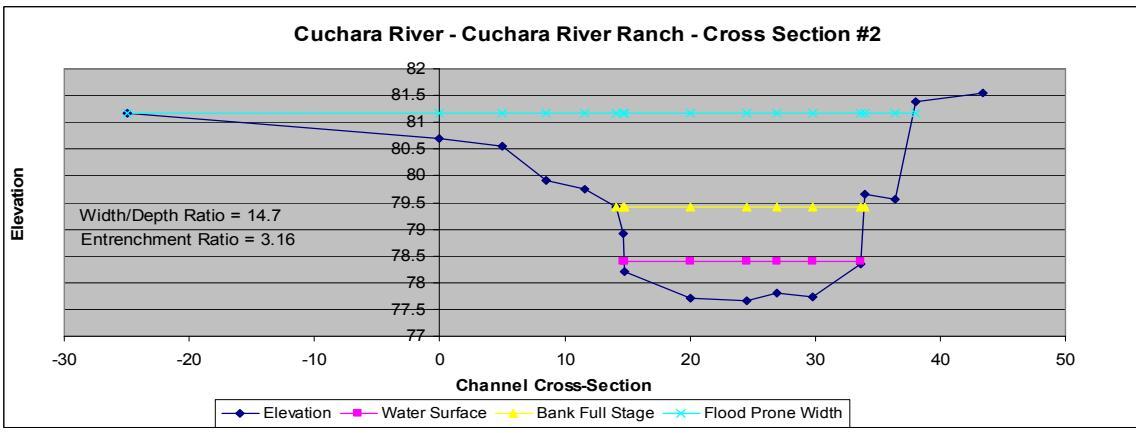
Chart 2: Cross Section #2 at Riffle #10 on Reach 1 of the Cucharas River.

Cross-sections #2 and #3 show representative profiles of a typical riffle and glide habitat within Reach 1. The riffle cross-section is dominated by larger substrate particle sizes, resulting in greater velocity complexity and surface turbulence. The glide cross-section exhibits some scour in the center of the channel, indicating that a pool could develop here with the removal of some channel armor. Each of the cross-sections exhibits slightly entrenched characteristics of the stream channel within the reach. Entrenchment ratios of greater than 3 were observed at the cross-sections. Width/depth ratios were calculated to be approximately 14 to 19. W/D ratios were similar to what would be expected to occur in a C channel.

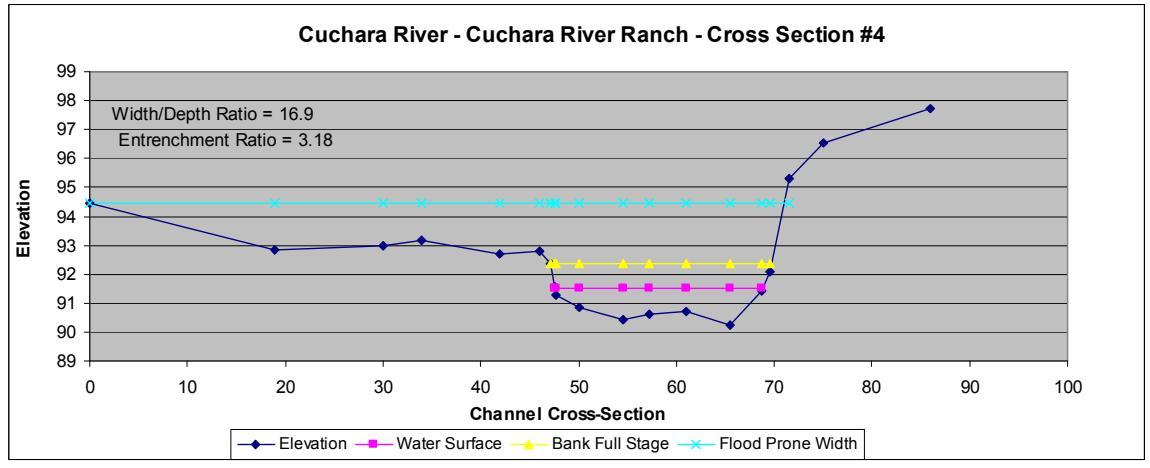
Chart 4: Cross-Section #4 at Riffle #6 on Reach 2 of the Cucharas River.

Cross-section #4, #5, and #7 show representative profiles of pool and riffle channels in Reach 2. The riffle in cross-section #4 is found in the lower portion of the reach, which exhibits geomorphic characteristics similar to Reach 1. Entrenchment in this cross-

section is similar to that found in Reach 1, and iss considered to be only slightly entrenched. The width/depth ratio is almost 17, consistent with a C type channel form. The slope of the stream channel through this cross-section is slightly greater than would be found in a pure C channel form, approaching 3.6%.

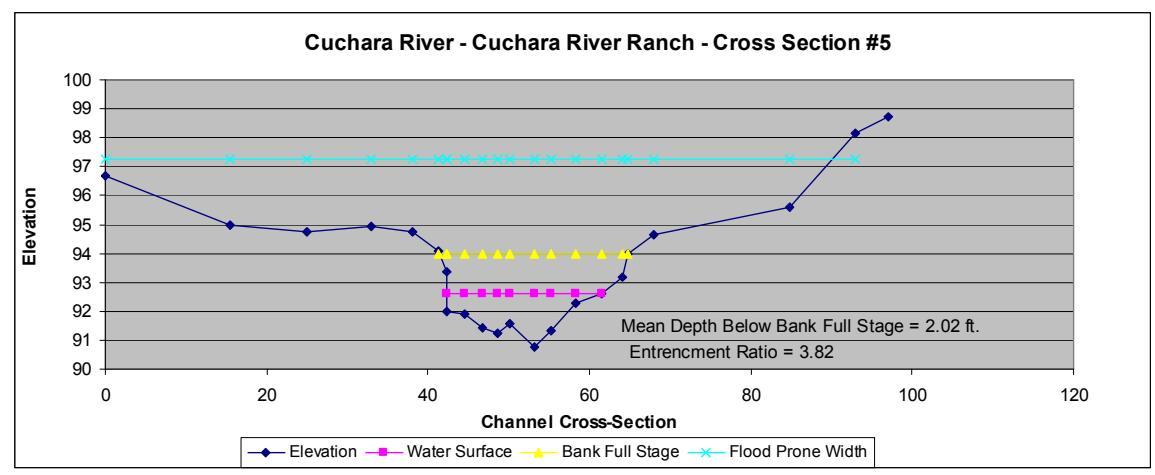
Chart 5: Cross-Section #5 at Pool #3 on Reach 2 of the Cucharas River.

The pool in cross-section #5 is also found near the downstream boundary of Reach 2, and exhibits similar characteristics with cross-section #4. The pool is characterized by deep scour in the center of the channel, with a mean depth below the bank full stage of the channel of greater than 2 feet. The entrenchment ratio is considered low in this channel unit, approaching a value of 4.

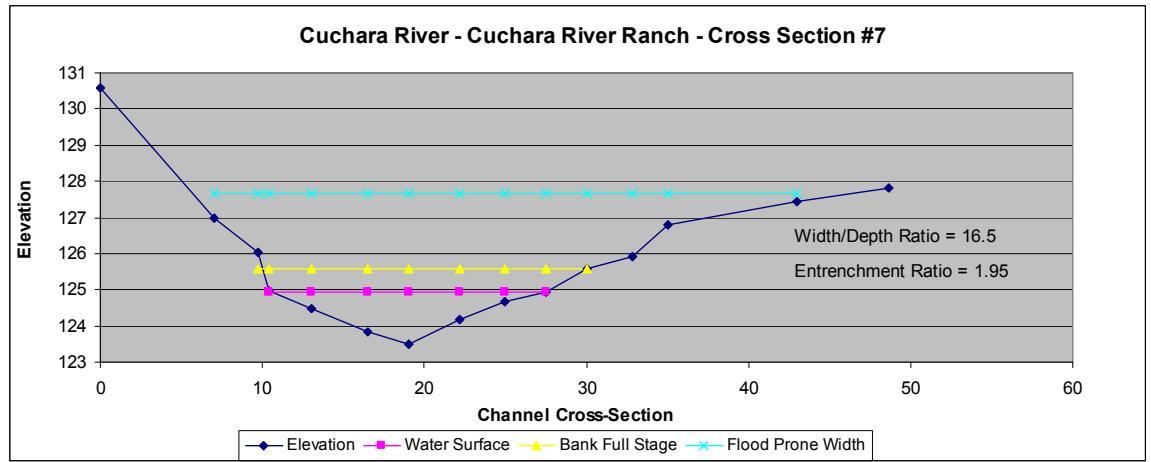
Chart 6: Cross-Section #7 at Riffle #18 on Reach 2 of the Cucharas River.

The riffle in cross-section #7 is found in the near the upstream boundary of Reach 2, along a nearly 400 ft long boulder dominated pocket-water riffle. This upstream segment of Reach 2 is considerably steeper (<4%), and exhibits less sinuosity than the lower segment. The entrenchment ratio in cross-section is considered to be moderate (1.95), and is more consistent with a steeper, straighter B channel type. The width/depth ratio of the cross-section is much lower than the values observed in the other cross-sections, and is also consistent with a B type channel form.

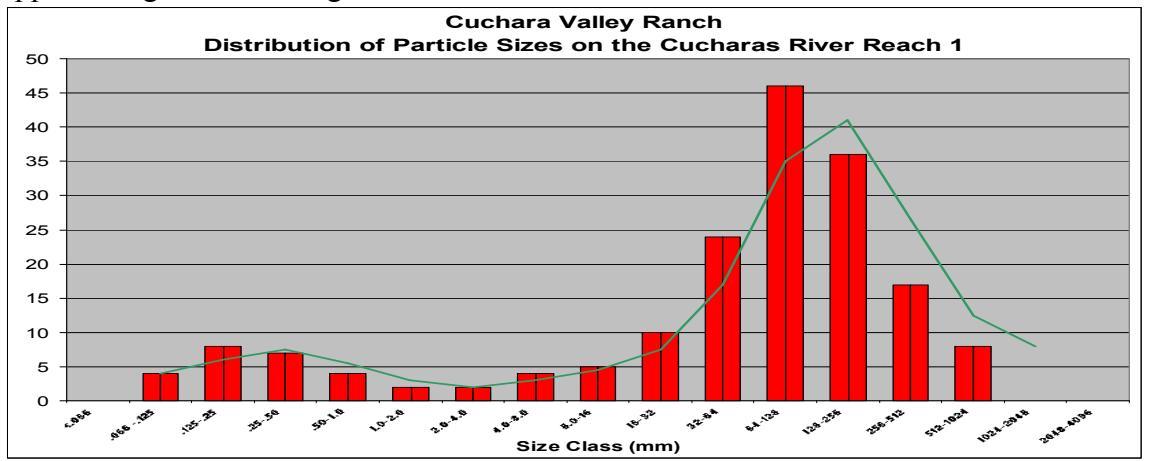
Chart 7: Distribution of substrate particle sizes in Reach 1 of the Cucharas River.

Within Reach 1, channel substrate composition was calculated using a Z-Walk pebble Count (Bevenger, 1997) and the results are shown in Table 2. A slight bi-modal distribution of smaller particles (fines), large gravel/small cobble, and small boulder is apparent in the pebble count data (Chart 7), and suggests that sediment inputs to the stream may exceed the capacity of the stream to move the material. The D50 (mean) particle size is estimated to be approximately 100mm, and the D84 particle size is estimated to be 125mm. Particle size ran from very fine sand to large boulders approaching 1 meter along the medial axis.

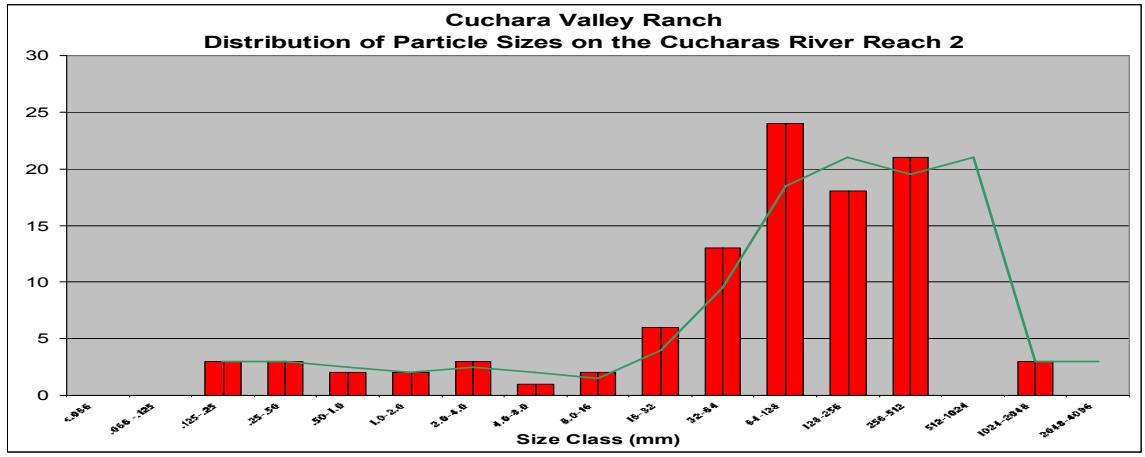
Chart 8 - Distribution of particle size classes distribution of sand and larger cobbles and boulder in Reach 2 on The Cucharas River.

There is less evidence of a bi-modal distribution pattern of smaller particles (fines) than in Reach 1(Chart 7), indicating that there is likely adequate energy in the reach to transport fine sediment through the system. Substrate size is dominated by small and large cobbles, with lesser amounts of channel armoring small boulder and larger gravels suitable for trout spawning. The D50 (mean) particle size is estimated to be approximately 100mm, and the D84 particle size is estimated to be 125mm, which is consistent with the values found in Reach 1. Particle size ran from very fine sand to large boulders in excess of 1 meter along the medial axis.

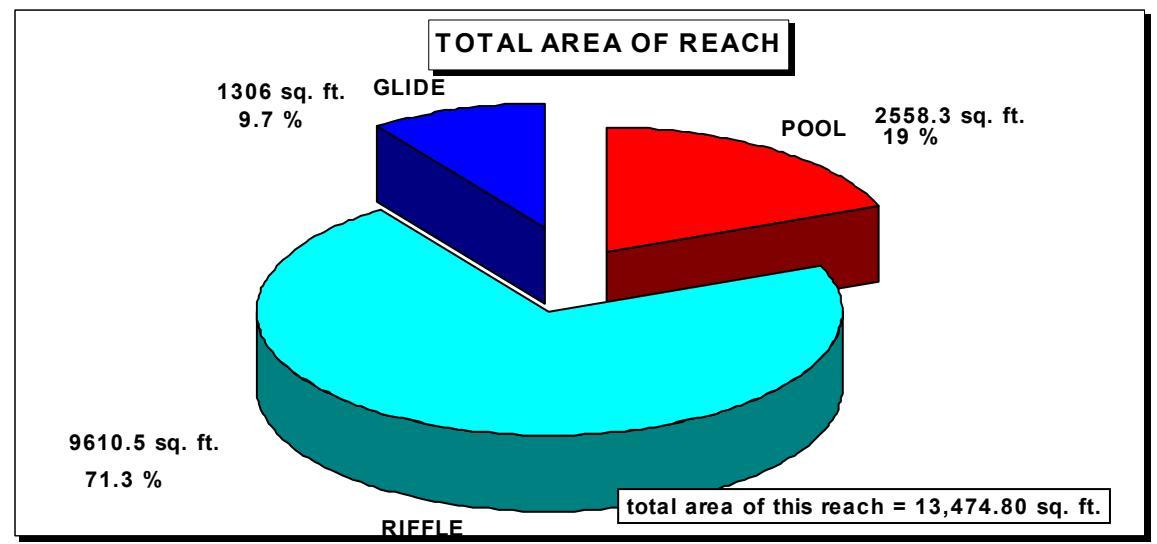
Chart 9 - Distribution of Pool, Riffle and Glide habitats in Reach 1 of the Cucharas River.

13,474ft². The total area of the reach consisted of 71% riffles and 19% pools, with the remaining 10% consisting of glide habitat (Chart 9). The average wetted width of the stream was 17 feet throughout the reach. Stream bank stability throughout much of the reach was generally good, with alder, willow and cottonwood comprising most of the riparian vegetation. Several areas of bank degradation and instability are found within the reach. The causes of stream bank instability in these areas include bank failure from failure of in stream structures and shear at high flows. There were 180 feet of actively eroding stream banks contributing sediment directly into the stream. This accounted for slightly more than 12% of the total length of banks in the study reach.

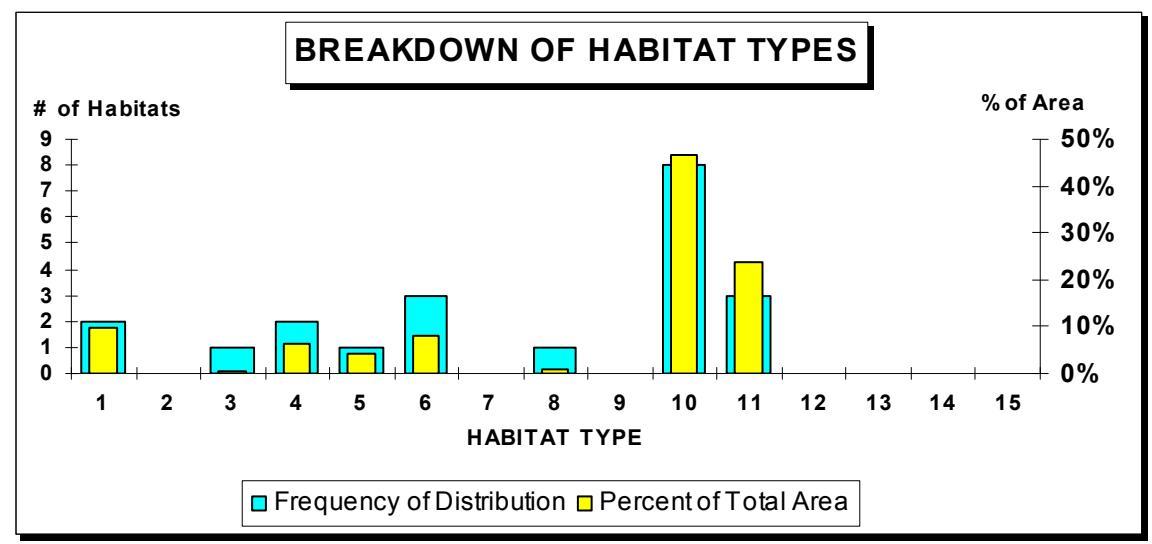
Chart 10 - Distribution of Meso-Habitat Types as a percentage of # of habitats and as a percentage of wetted perimeter of Reach 1 on the Cucharas River.

Higher gradient boulder dominated riffles exhibiting pocket water characteristics were the most common habitat type in terms wetted area, accounting for 47% of the total reach area (Chart 10). Lower gradient, cobble dominated riffles were the next most common habitat, accounting for 24% of the wetted area of the reach. Low gradient riffles can provide good spawning habitat, but are somewhat limited in terms of cover from high flows and predators. Generally, a good mix of higher gradient pocket water riffles providing cover and velocity shelter, combined with lower gradient cobble and gravel riffles for spawning habitat, should provide excellent habitat conditions for resident trout. One secondary channel riffle (Type 8) was observed in the reach, comprising 1% of the wetted area. Secondary channel riffles may provide important rearing habitat for youngof-the-year and juvenile trout, particularly during periods of higher flows. Overall, very little cover for trout was observed in these riffles, amounting to less than 1.5% (142 ft²) of the total wetted area of these habitat types. The average width of all the riffles observed in the reach was 18.5 feet.

Pool development is quite limited in the reach, with only seven of these habitats observed during the survey. Lateral scour pools were the most abundant, comprising 8% of the total wetted area of the reach (Chart 10). The lateral scour pools were mostly associated with root-wad constrictions in the stream channel created by cottonwood and other tree root systems, and meanders along the stream channel. Trench pools and plunge pools were also observed in the reach, accounting for somewhat less wetted area than the lateral

scour pools. The plunge pool was associated with a failed boulder-drop structure. Trench pools and plunge pools comprised 6% and 4% of the total wetted area of the reach.

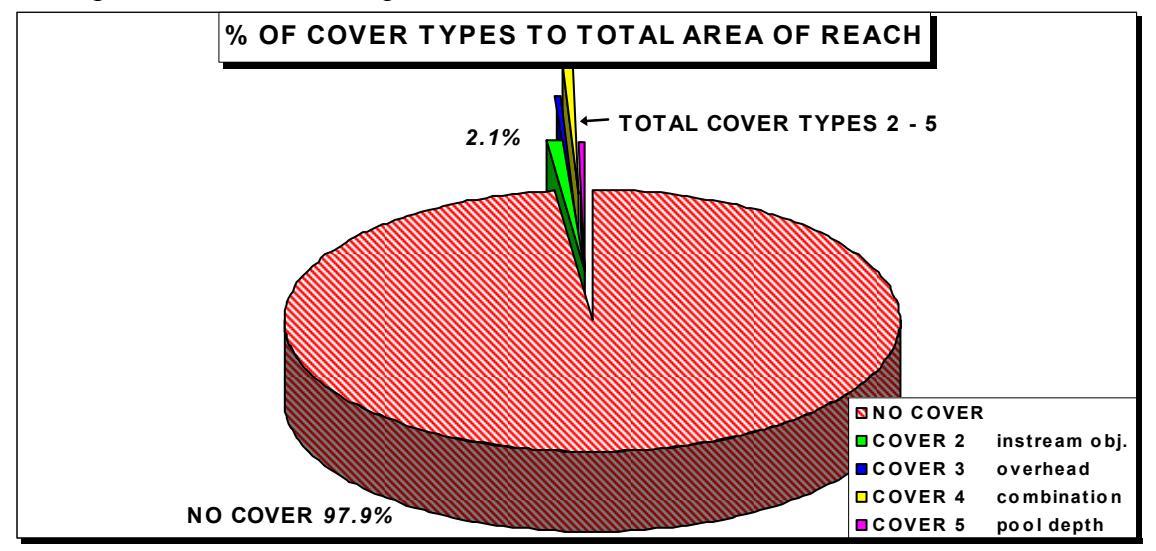
Chart 11 - Percentage of cover for trout to the total wetted perimeter Reach 1 on the Cucharas River.

All forms of cover for adult trout accounted for only 2.1% of Reach 1 (Chart 11). Available cover is considered to be relatively poor in the reach, and may be a significant limiting factor to the health of the fishery. Creating additional cover will be an important component in the Habitat Enhancement Plan. Instream object cover (Cover Type 2 - >1'deep) was the dominant type observed in the reach, but was limited mostly to the pool habitats. Pool cover (Cover Type 5 - >1.5'deep) was very limited in the reach, and comprised only 1.3% of the wetted area of the pools and 0.25% of the total reach area. Pool cover is an important indicator for determining the available over-wintering capacity of the stream reach, and appeared to be severely limited in this segment of the Cucharas River. Combination and overhead cover were observed, but were limited in part due to the lack of velocity shelter along the stream bank. In-stream and overhead cover could be enhanced in the riffle habitats by adding structure and velocity shelters along the stream banks with strategically placed boulders and large wood. Pool cover may be increased by improving scour in existing pools by removing some of the cobble/boulder armor, as well as by creating new pool habitats, particularly in the segments of the stream currently exhibiting glide characteristics. Combination cover may be improved throughout the reach through stabilizing and re-vegetating the eroding stream banks using large wood toe-slope stabilization techniques.

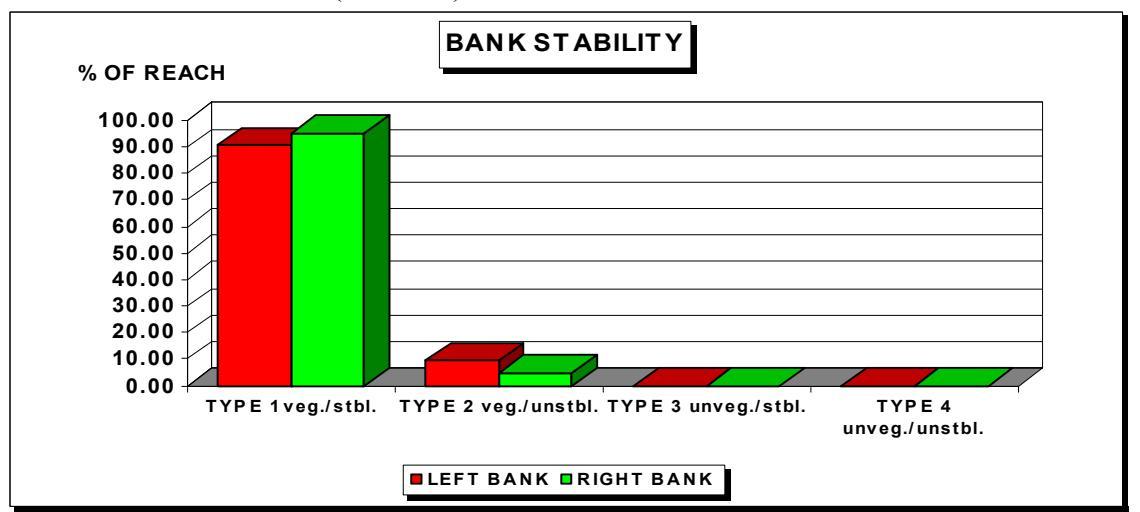
Chart 12 - Percentage of stable banks to unstable banks in Reach 1.

Stream bank stability was generally good in the reach. Only a few areas of actively eroding stream banks were observed. Ninety percent of the left bank and 95% of the right bank were found to be stable. The remaining 5% of the left bank and 10% of the right bank were found to be generally unstable and at risk of failure due to high flow shear forces on the banks (Chart 12).

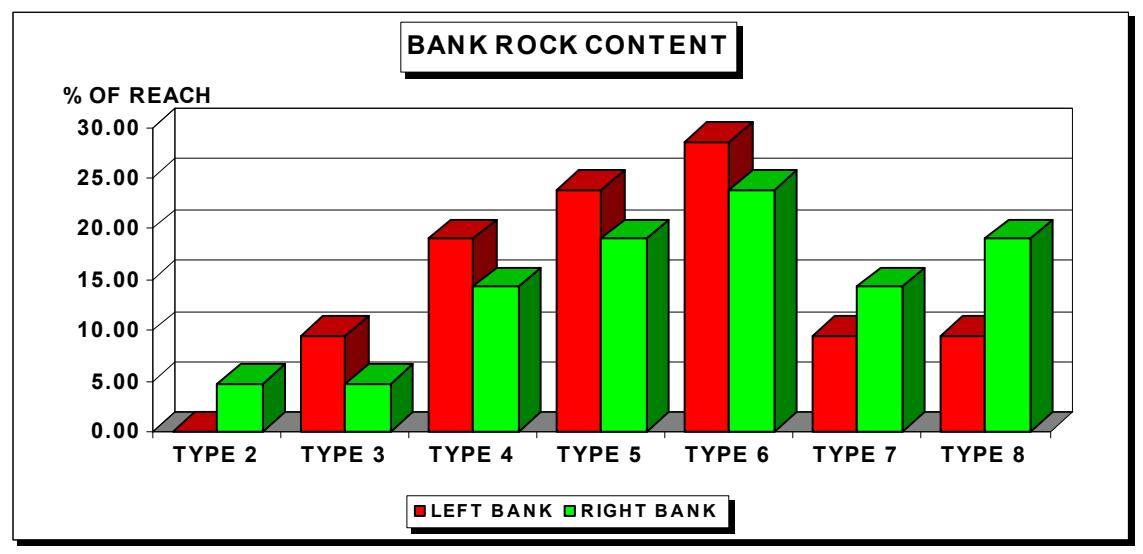
Chart 13 - Percentage of bank rock content sizes in Reach 1 on the Cucharas River.

Bank rock content in the reach is shown in Chart 13, and consisted principally of large and small cobble fragments (Type 5 & 6). Smaller fragments of less than 1/8" were observed along the stream banks, but mostly along the point bars forming the inside of meander bends. Large wood (>4" diameter and > 3' long) is present in the reach, with eighteen pieces being observed. Large wood is an important habitat forming component for rivers in the Rocky Mountains, and provides cover and complexity to the aquatic ecosystem.

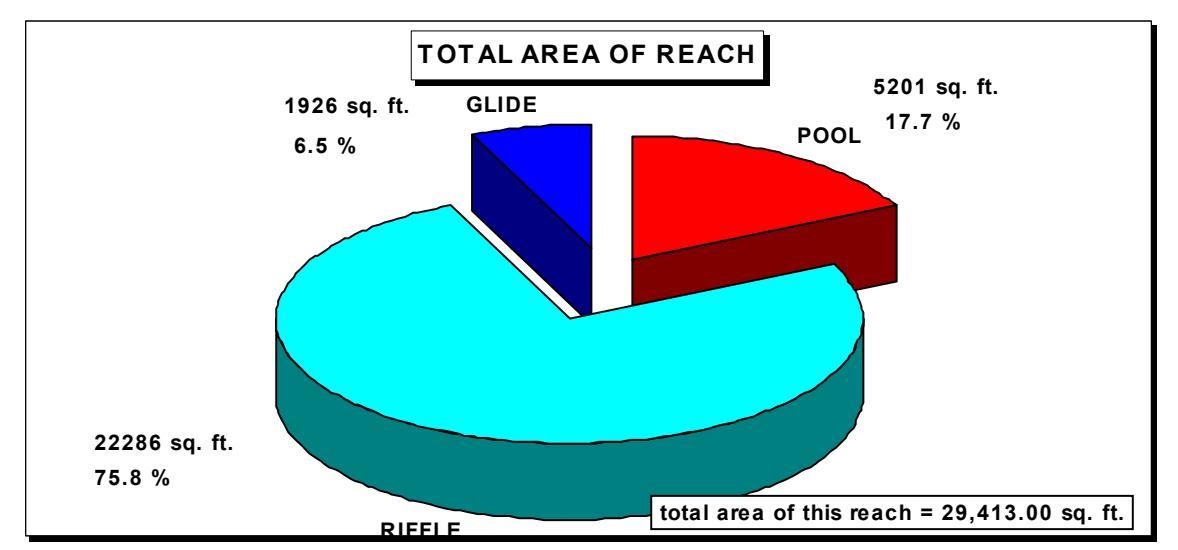
Chart 14 - Distribution of Pool, Riffle and Glide habitats in Reach 2 of the Cucharas River.

There were 35 individual habitat units measured in the reach (11 pools, 21 riffles and 3 glides), along a length of 1,548 feet of stream, and comprising a total wetted area of 29,413ft². The total area of the reach consisted of 76% riffles and 18% pools, with the remaining 6% consisting of glide habitat (Chart 14). The average wetted width of the stream was 19.7 feet throughout the reach. It is interesting to note that stream channel width in Reach 2 was greater than in Reach 1, although flow regimes for Reach 2 are slightly less than in Reach 1, due to the inflow from White Creek. This would appear to indicate that width/depth ratios within Reach 2 are generally poorer than in Reach 1, and this does appear to be the case, particularly in the lower portion of the reach. Stream bank stability throughout the reach was generally good, with similar riparian vegetation found in Reach 1. A few areas of bank degradation and instability are found within the reach, mostly due to bank failures from poorly aligned in stream structures and shear at high flows. There were 152 feet of actively eroding stream banks contributing sediment directly into the stream. This accounted for approximately 5% of the total length of banks in Reach 2.

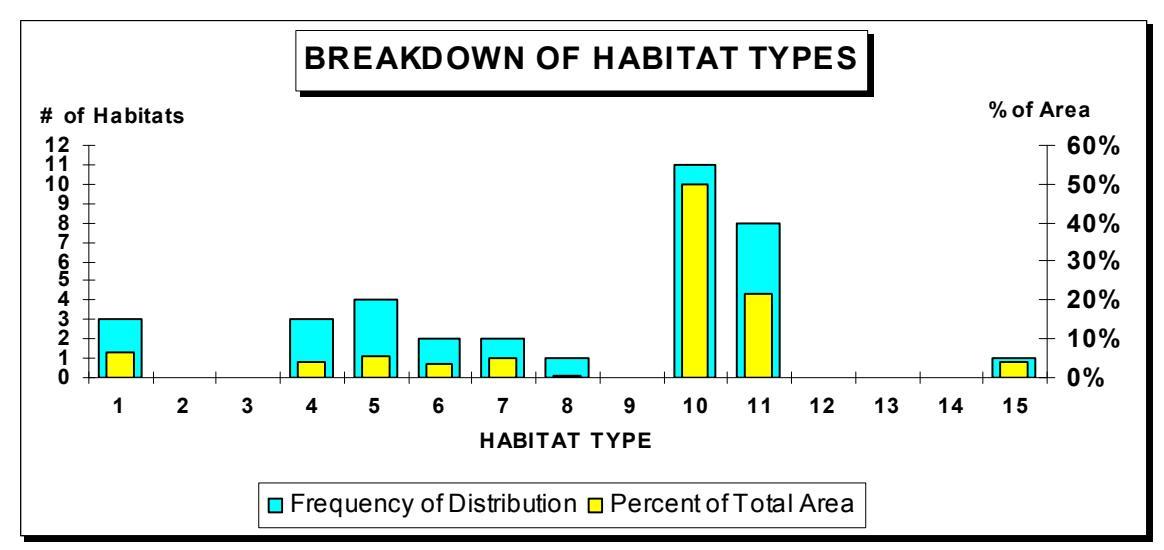
Chart 15 - Distribution of Meso-Habitat Types as a percentage of # of habitats and as a percentage of wetted perimeter of Reach 2 on the Cucharas River.

As is the case in Reach 1, higher gradient boulder dominated riffles exhibiting pocket water characteristics are the most common habitat type in terms wetted area, accounting for 50% of the total reach area (Chart 15). Indeed, one long pocket water boulder riffle occupies nearly 400 feet of the upper portion of the reach. Lower gradient, cobble dominated riffles were the next most common habitat, accounting for 21% of the wetted area of the reach. Generally, a good mix of higher gradient pocket water riffles for spawning habitat, should provide excellent habitat conditions for resident trout. One secondary channel riffle (Type 8) was found near the upstream boundary of Reach 2, comprising 1% of the wetted area. Overall, very little cover for trout was observed in these riffles, amounting to less than 1% (192 ft²) of the total wetted area of these habitat types. The average width of all the riffles observed in the reach was 18.25 feet.

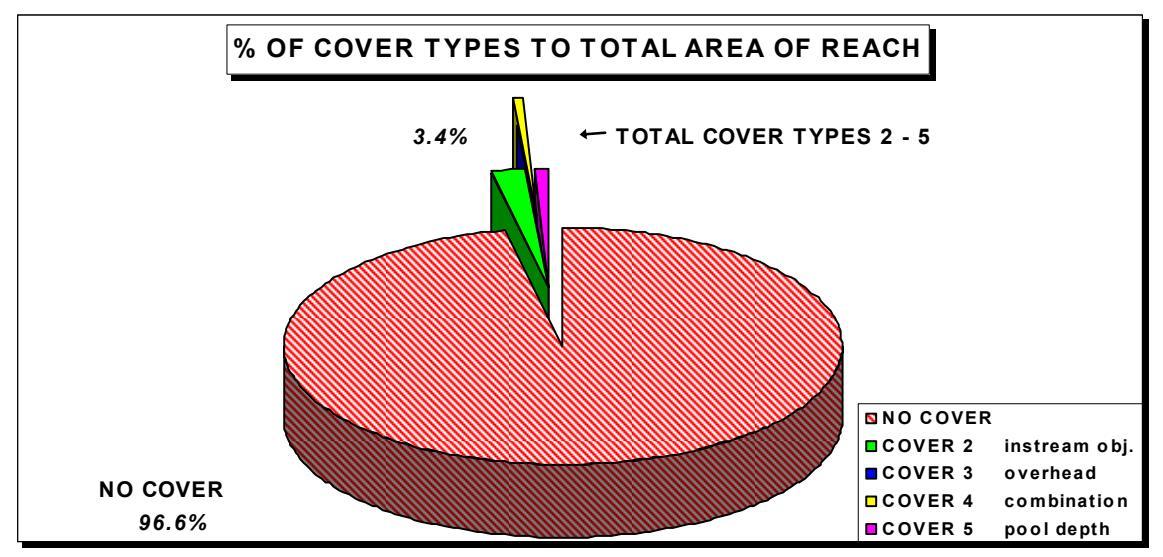
Chart 16 - Percentage of cover for trout to the total wetted perimeter Reach 2 on the Cucharas River.

On a percentage basis, cover for trout in Reach 2 was 60% greater than that found in Reach 1. All forms of cover for adult trout accounted for 3.4% of Reach 2 (Chart 16), and is closer to what would be expected in a C3b/B3 stream channel of this size. Available cover is considered to be fair in the reach. In-stream object cover (Cover Type 2 - >1' deep) was the dominant type observed in the reach, and was observed mostly to the pool habitats. Pool cover (Cover Type 5 - >1.5'deep) was much less limited in this reach, comprised 5% of the wetted area of the pools and 1% of the total reach area. Pool cover, as a percentage of the overall pool area and stream reach area, was four times greater in Reach 2 than in Reach 1, indicating that over-wintering habitat is likely less limited in this reach. A very small amount of combination and overhead cover were observed, but were limited in part due to the lack of velocity shelter along the stream banks.

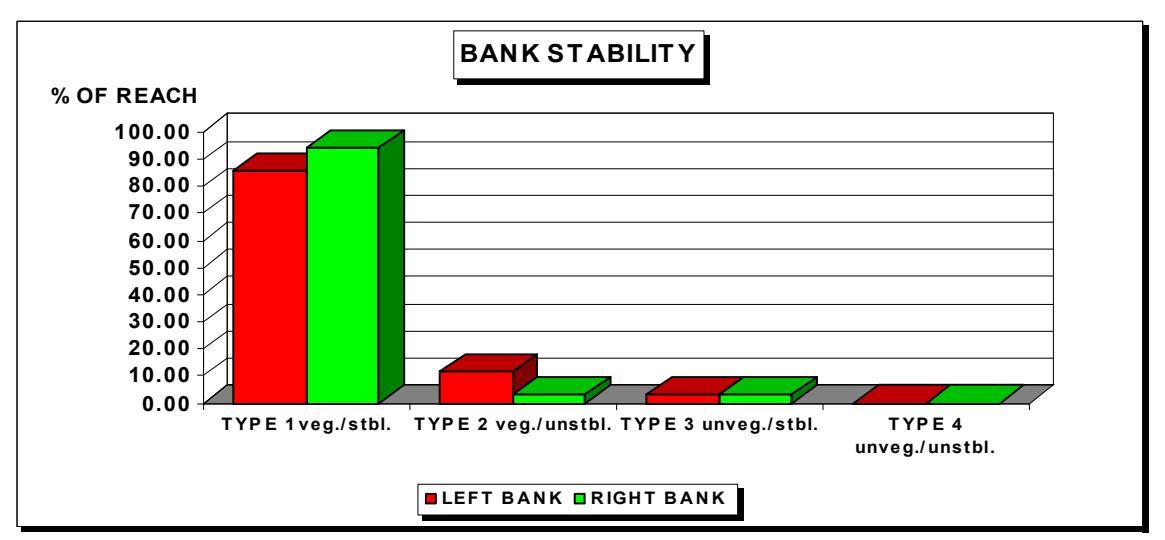
Chart 17 - Percentage of stable banks to unstable banks in Reach 2.

As was the case in Reach 1, stream bank stability was generally good in this reach. Only a few areas of actively eroding stream banks were observed. Eighty-nine percent of the left bank and 97% of the right bank were found to be stable. The remaining stream bank was found to be generally unstable and at risk of failure due to high flow shear forces on the banks (Chart 17).

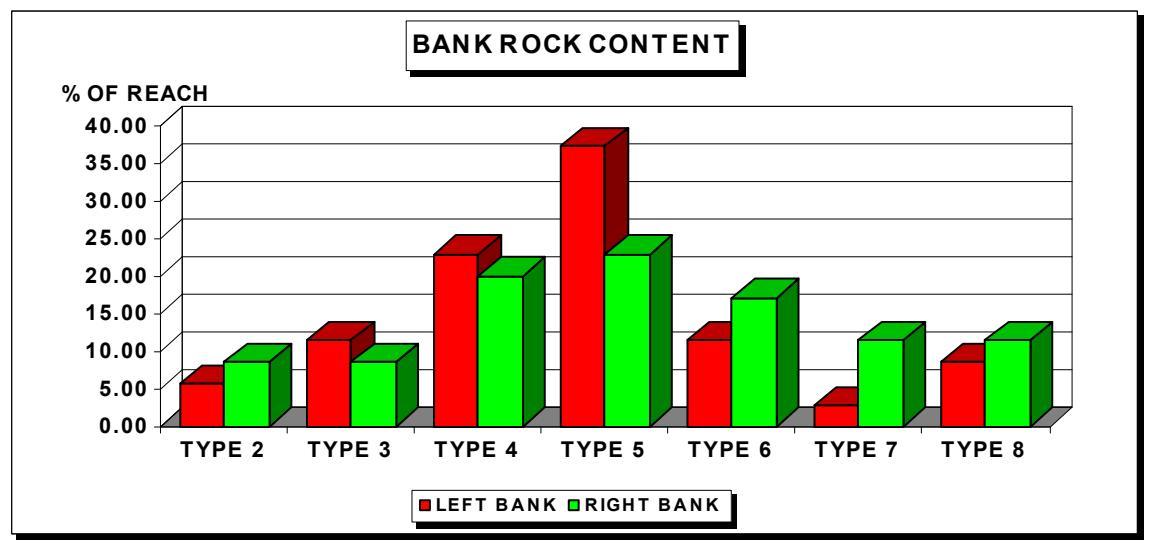
Chart 18 - Percentage of bank rock content sizes in Reach 2 on the Cucharas River.

Bank rock content was similar to that found in Reach 1, and is shown in Chart 18. Bank rock content is a good measure of how resistant the stream banks are to high flow induced shear stress, in Reach 2 consisted principally of large cobble fragments (Type 5). Large wood (>4" diameter and > 3' long) is abundant in the reach, particularly in the upstream segment. Thirty-six pieces of wood were counted in the reach, and were creating additional scour and cover in the channel.
