Aquatic Assessment
&
Habitat Enhancement Plan
Fountain Creek - The Fields Park
City of Manitou Springs
El Paso County - Colorado

FIN-UP Habitat Consultants, Inc.

In February 2008, FIN-UP Habitat Consultants, Inc. was contracted by the City of Manitou Springs to conduct an aquatic habitat analysis and habitat enhancement strategy for a segment of Fountain Creek within The Fields Park, near the eastern limits of the city. The stream within the park is approximately 1,200 feet in length, consisting of a moderately entrenched natural channel flowing through a cottonwood and alder dominated floodplain. An aquatic assessment was conducted within the project area during the 2nd week of May, 2008, and the results of this study are summarized in this document.

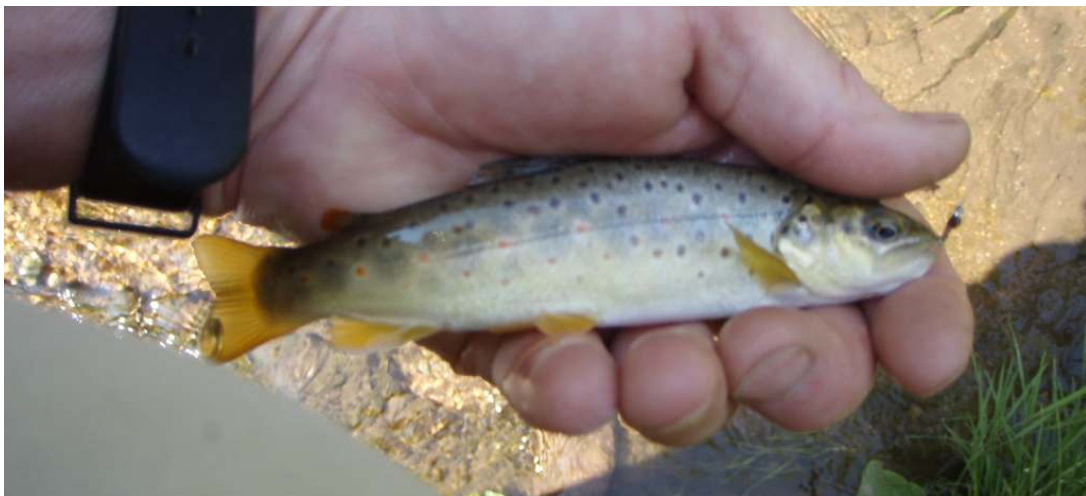
Photo 1: Typical Brown Trout in Reach 2 of Fountain Creek.

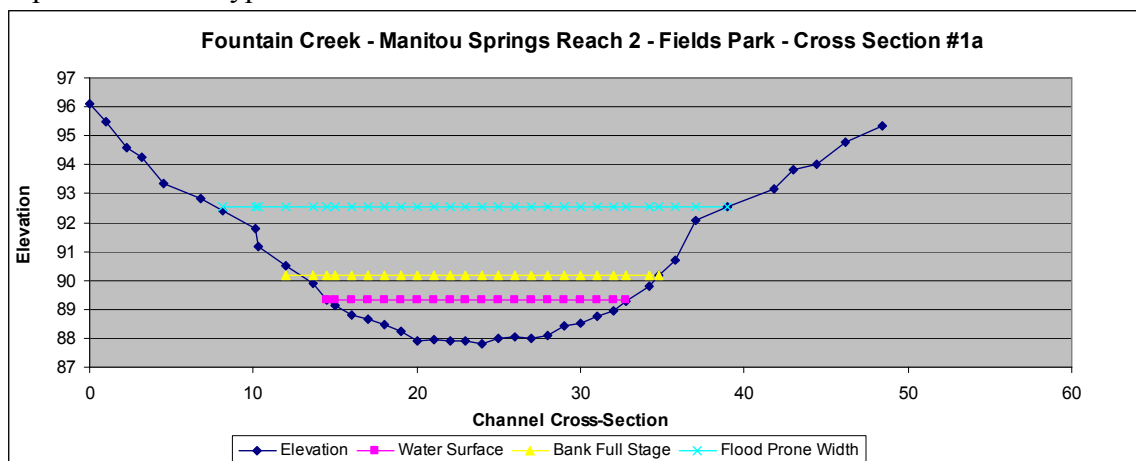
Chart 2: Cross Section #1a on Reach 2 of Fountain Creek - Typical Riffle Habitat.

Cross-sections #1, #1a, and #3 show representative profiles of typical riffle habitat within the reach. The riffle cross-sections are dominated by larger substrate particle sizes, resulting in greater velocity complexity and surface turbulence. Chart 2 above shows a typical riffle cross-section in the reach. Cross-sections #2 and #5 were surveyed within glide habitats in the reach, with a typical profile shown in Chart 3. These cross-sections exhibit the typical uniform channel elevation and laminar flow characteristics of the glide meso-habitat form. Cross-Section #4 was surveyed in a trench pool at P6, which was the most typical form observed in the reach, and exhibits a maximum bank-full depth of just under 2.7 feet. This profile can be seen in Chart 4. All of the cross-section surveys may also be found in the appendix.

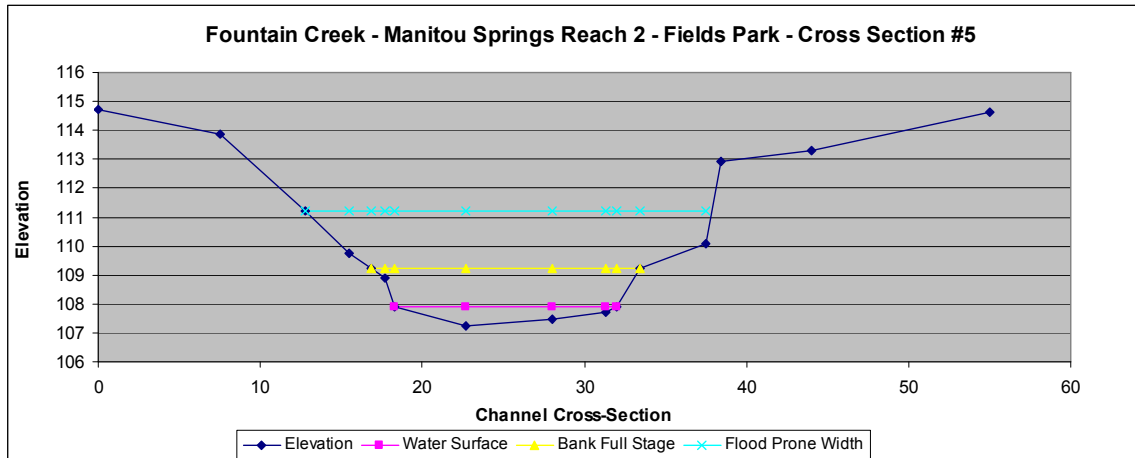
Chart 3: Cross-Section #5 on Fountain Creek - Typical Glide Habitat.

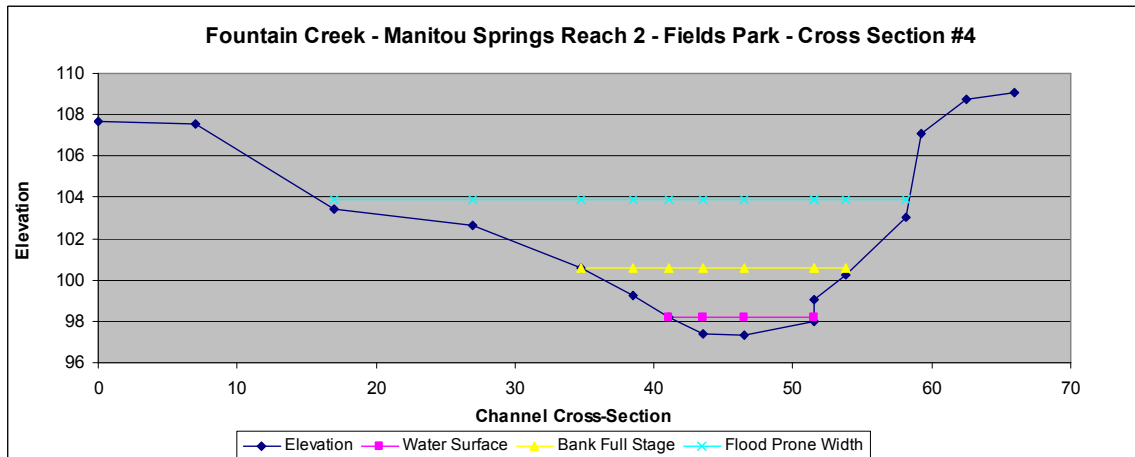
Chart 4: Cross-Section #3 on Fountain Creek - Typical Pool Habitat.

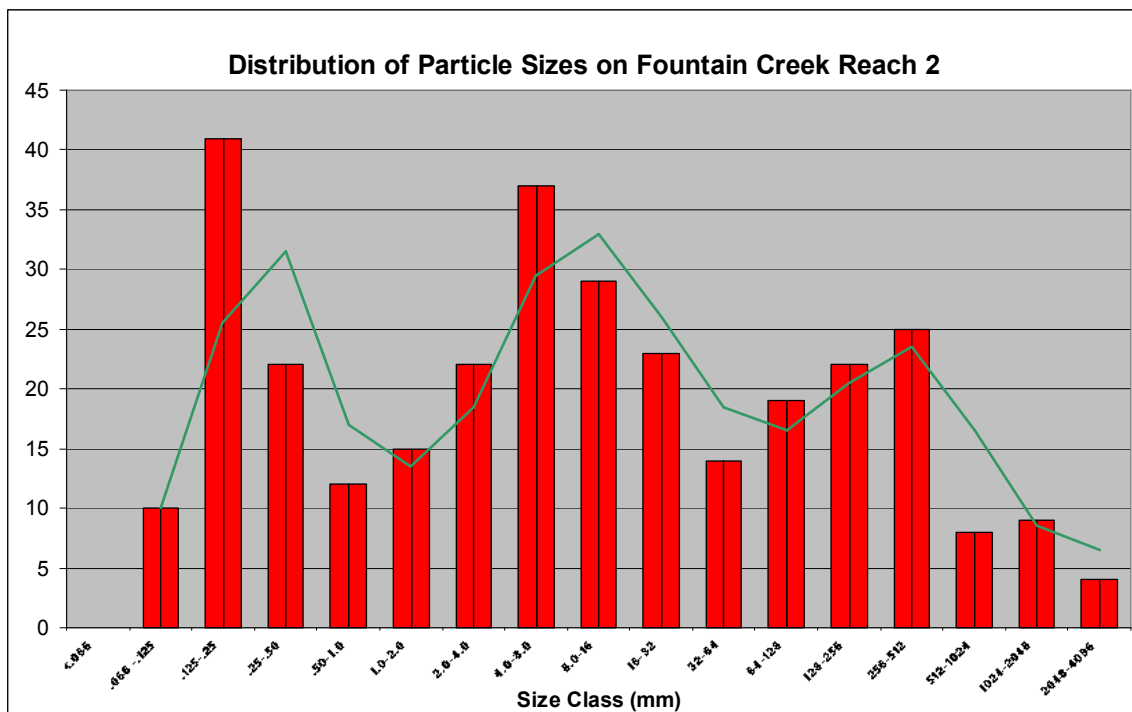
The general reach substrate was calculated using a Z-Walk pebble Count (Bevenger, 1997) and the results are shown in Table 1. A tri-modal distribution of smaller particles (fines), large gravel/small cobble, and small boulder is apparent in the pebble count data (Chart 5), and suggests that sediment inputs to the stream may exceed the capacity of the stream to move the material. The D50 (mean) particle size is estimated to be approximately 8mm, and the D84 particle size is estimated to be 225mm. Particle size ran from very fine sand to large boulders in excess of 1 meter along the medial axis. Large wood (>4" diameter and > 3' long) is extremely scarce in the reach, with only seven pieces observed, and mostly associated with old drop structures. Large wood is an important habitat forming component for rivers in the Rocky Mountains, and provides cover and complexity to the aquatic ecosystem.

Chart 5 - Distribution of particle size classes distribution of sand and larger cobbles and boulder in Reach 2 on Fountain Creek.

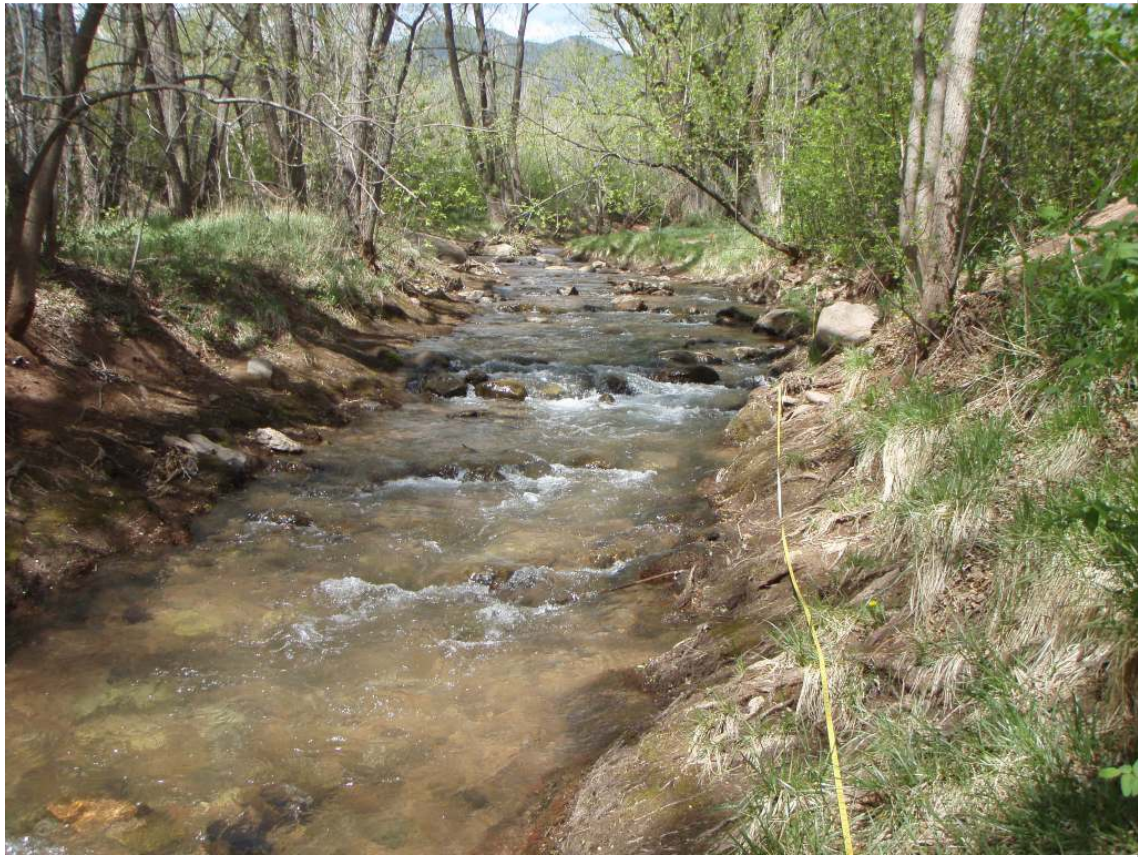
Photo 2: Typical Cobble Riffle (Riffle #4) on Reach 2 of Fountain Creek

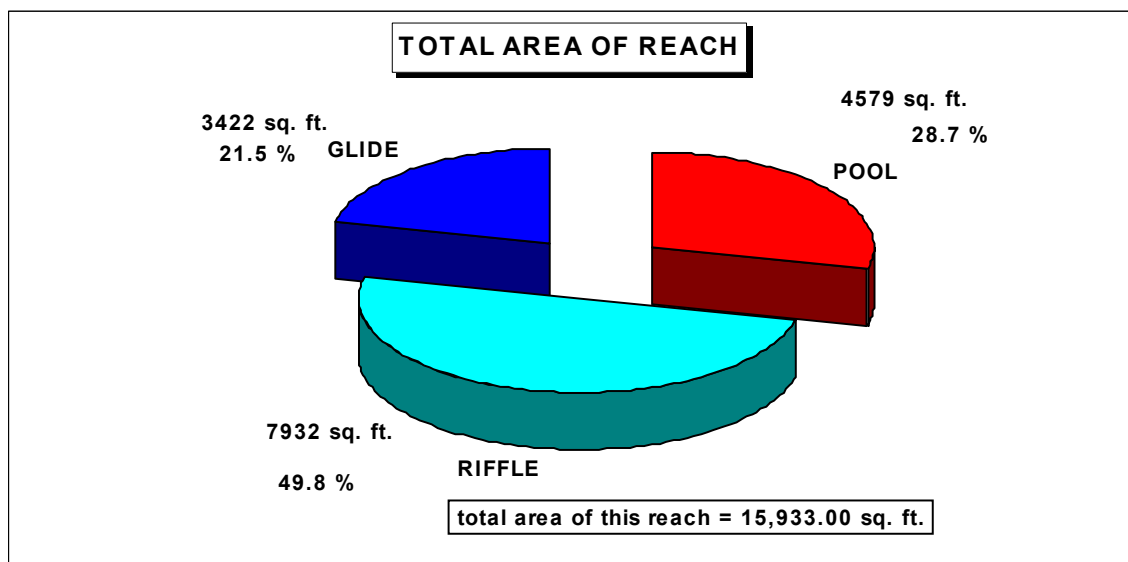
There were 38 individual meso-habitats measured in the reach (14 pools, 14 riffles and 10 glides), along a length of 1,179 feet of stream, and comprising a total wetted area of 15,933ft². The total area of the reach consisted of 50% riffles and 29% pools, with the remaining 21% consisting of glide habitat (Chart 6). The average wetted width of the stream was 13.7 feet throughout the reach. Stream bank stability throughout much of the reach was generally good, with alder, willow and cottonwood comprising most of the riparian vegetation. Several areas of bank degradation and instability are found within the reach. The causes of stream bank instability in these areas include bank failure from shear at high flows and heavy recreational use, particularly on the north, right stream bank adjacent to the park. There were 427 feet of actively eroding stream banks contributing sediment directly into the stream. This accounted for slightly more than 18% of the total length of banks in the study reach.

Chart 6 - Distribution of Pool, Riffle and Glide habitats in Reach 2 of Fountain Creek.

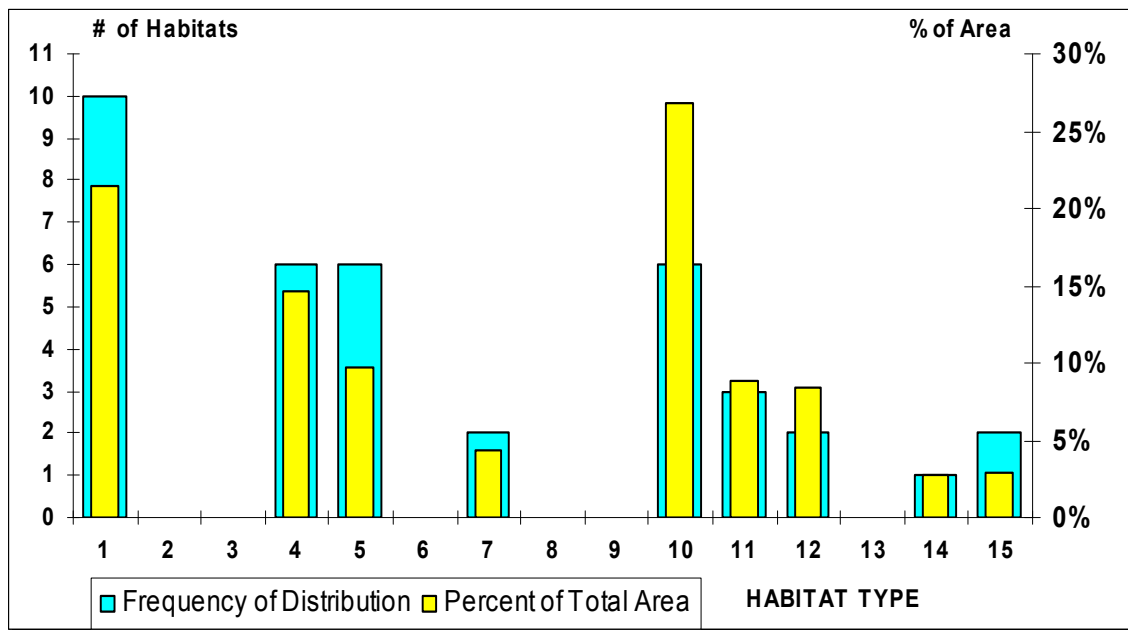
Higher gradient boulder dominated riffles exhibiting pocket water characteristics were the most common habitat type in terms wetted area, accounting for 27% of the total reach

area (Chart 7). Lower gradient, cobble and gravel dominated riffles were the next most common habitat, accounting for 9% and 8% of the wetted area of the reach respectively. Low gradient riffles can provide good spawning habitat, but are somewhat limited in terms of cover from high flows and predators. Generally, a good mix of higher gradient pocket water riffles providing cover and velocity shelter, combined with lower gradient cobble and gravel riffles for spawning habitat, should provide excellent habitat conditions for resident trout. In the case of Reach 2, however, excess sediment from sources upstream has reduced the quality and utility of these micro habitats. Overall, very little cover for trout was observed in these riffles, amounting to less than 0.5% (37 ft²) of the total wetted area of these habitat types. The average width of all the riffles observed in the reach was 12.7 feet.

Chart 7 - Distribution of Meso-Habitat Types as a percentage of # of habitats and as a percentage of wetted perimeter of Reach 2 on Fountain Creek.

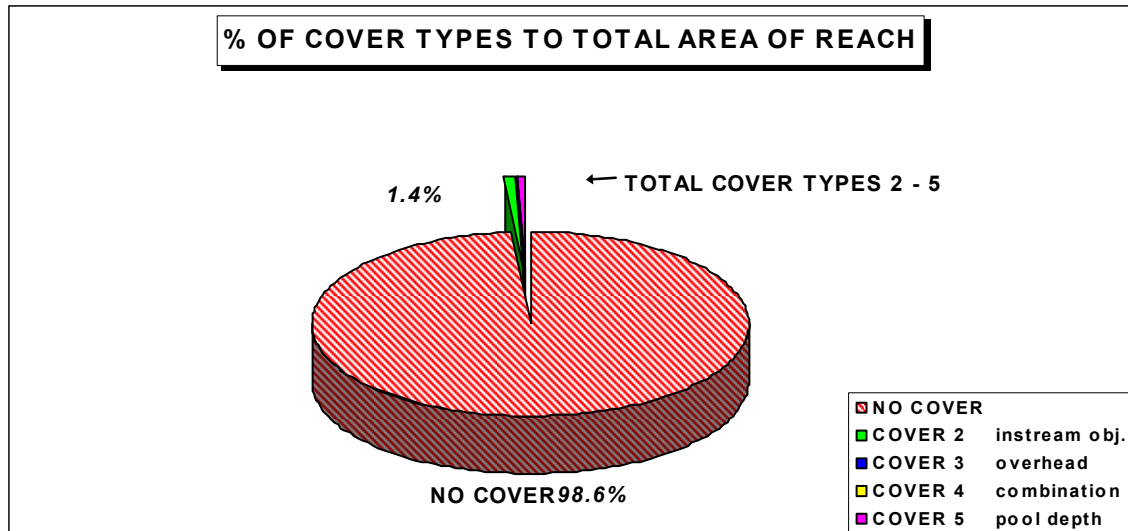
Chart 8 - Percentage of cover for trout to the total wetted perimeter Reach 2 on Fountain Creek.

All forms of cover for adult trout accounted for only 1.4% of Reach 2 (Chart 8). Available cover was significantly less than that observed in Reach 4 (Shryver Park), appears to be a significant limiting factor to the health of the fishery. Creating additional cover will be an important component in the Habitat Enhancement Plan. Instream object cover (Cover Type 2 - >1' deep) was the dominant type observed in the reach, but was limited mostly to the pool habitats. Pool cover (Cover Type 5 - >1.5' deep) was very limited in the reach, and comprised only 1.6% of the wetted area of the pools and 0.5% of the total reach area. Pool cover is an important indicator for determining the available over-wintering capacity of the stream reach, and appeared to be severely limited in this reach. Combination and overhead cover were the least abundant cover types, due to the lack of velocity shelter along the stream bank and limited large wood in the channel. Instream and overhead cover could be enhanced in the riffle habitats by adding structure and velocity shelters along the stream banks with strategically placed boulders and large wood. Pool cover may be increased by improving scour in existing pools as well as creating new pool habitats. Combination cover may be improved throughout the reach through stabilizing and revegetating the eroding stream banks using large wood toe-slope stabilization techniques.

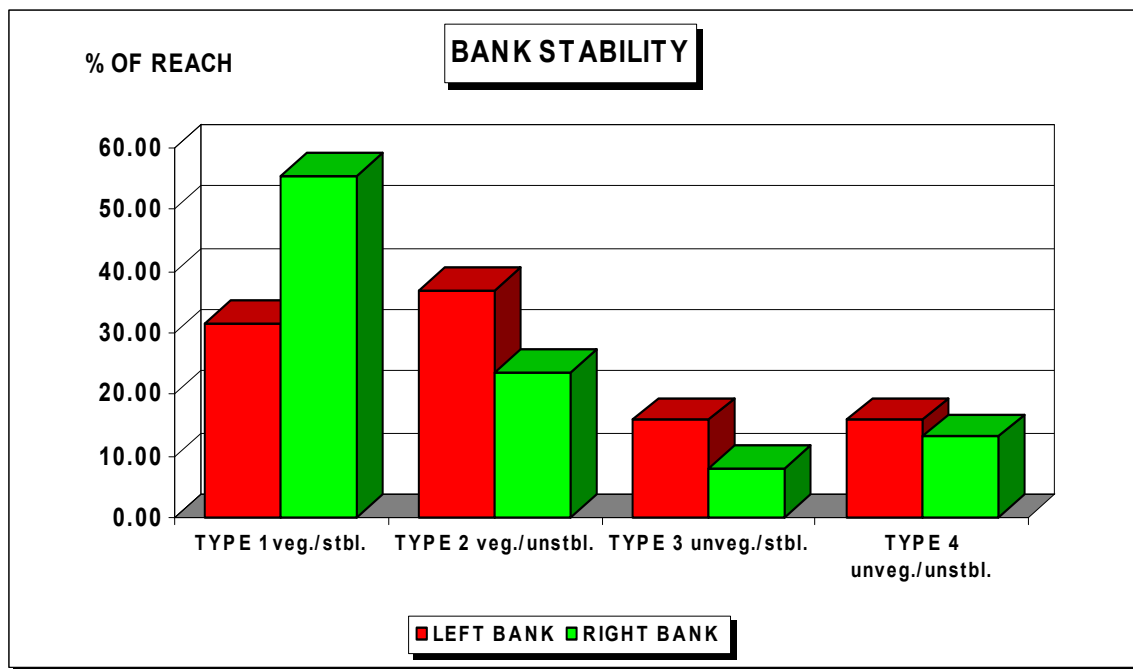
Stream bank stability was generally fair to poor in the reach, depending on vegetation composition degree of recreation use along any particular stream bank. Generally well vegetated stream banks were found on the side of the stream opposite of The Fields Park. Several areas of actively eroding stream banks were observed, particularly along the side of the stream adjacent to the park, and in the upstream half of the reach where the channel is more deeply entrenched. Forty-eight percent of the left bank and 63% of the right bank were found to be stable. The remaining 52% of the left bank and 37% of the right bank were found to be generally unstable and at risk of failure due to high flow shear forces on the banks (Chart 9). Bank rock content in the reach is shown in Chart 10, and consisted principally of gravel and smaller fragments (Type 8). Smaller fragments of less than 1/8"

Chart 9 - Percentage of stable banks to unstable banks in Reach 2 on Fountain Creek.

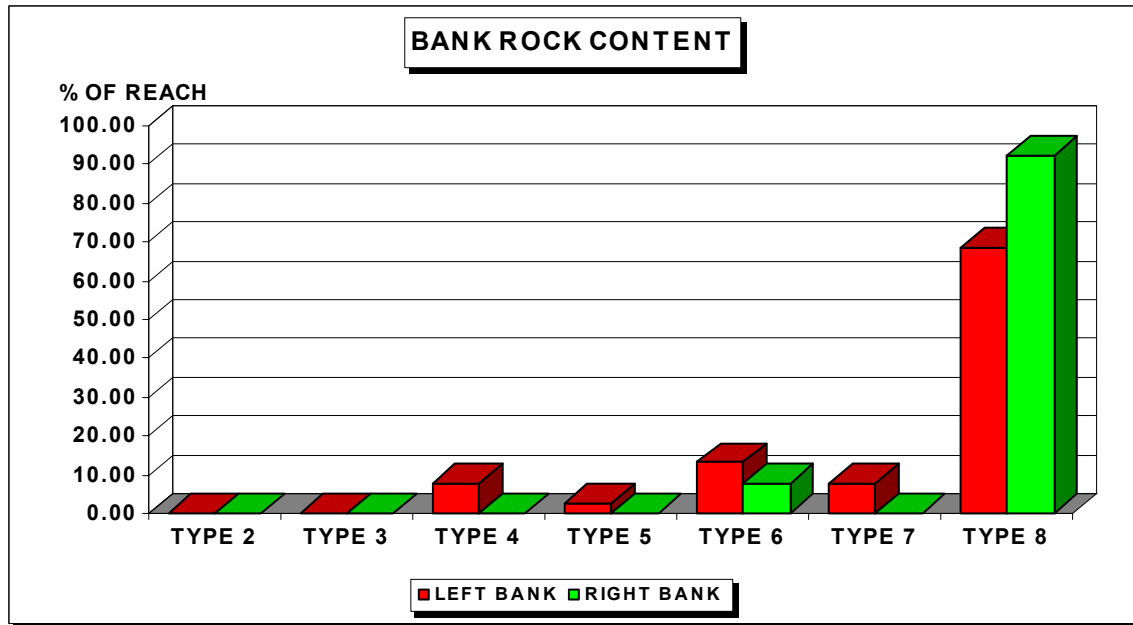
were the most dominant type, indicating that the stream banks are more susceptible to erosion due to high flows than other reaches already assessed in Manitou Springs.

Chart 10 - Percentage of bank rock content sizes in Reach 2 on Fountain Creek.
