Aquatic Assessment & Habitat Enhancement Plan
The South Platte River
Lake George Company
Park County - Colorado

FIN-UP Habitat Consultants, Inc.

J. Peter Gallagher
220 Illinois Ave
Manitou Springs, CO 80829
(719) 685-9768 (Office)
(719) 332-2550 (Cell)
pete@fin-up.com
January, 2009

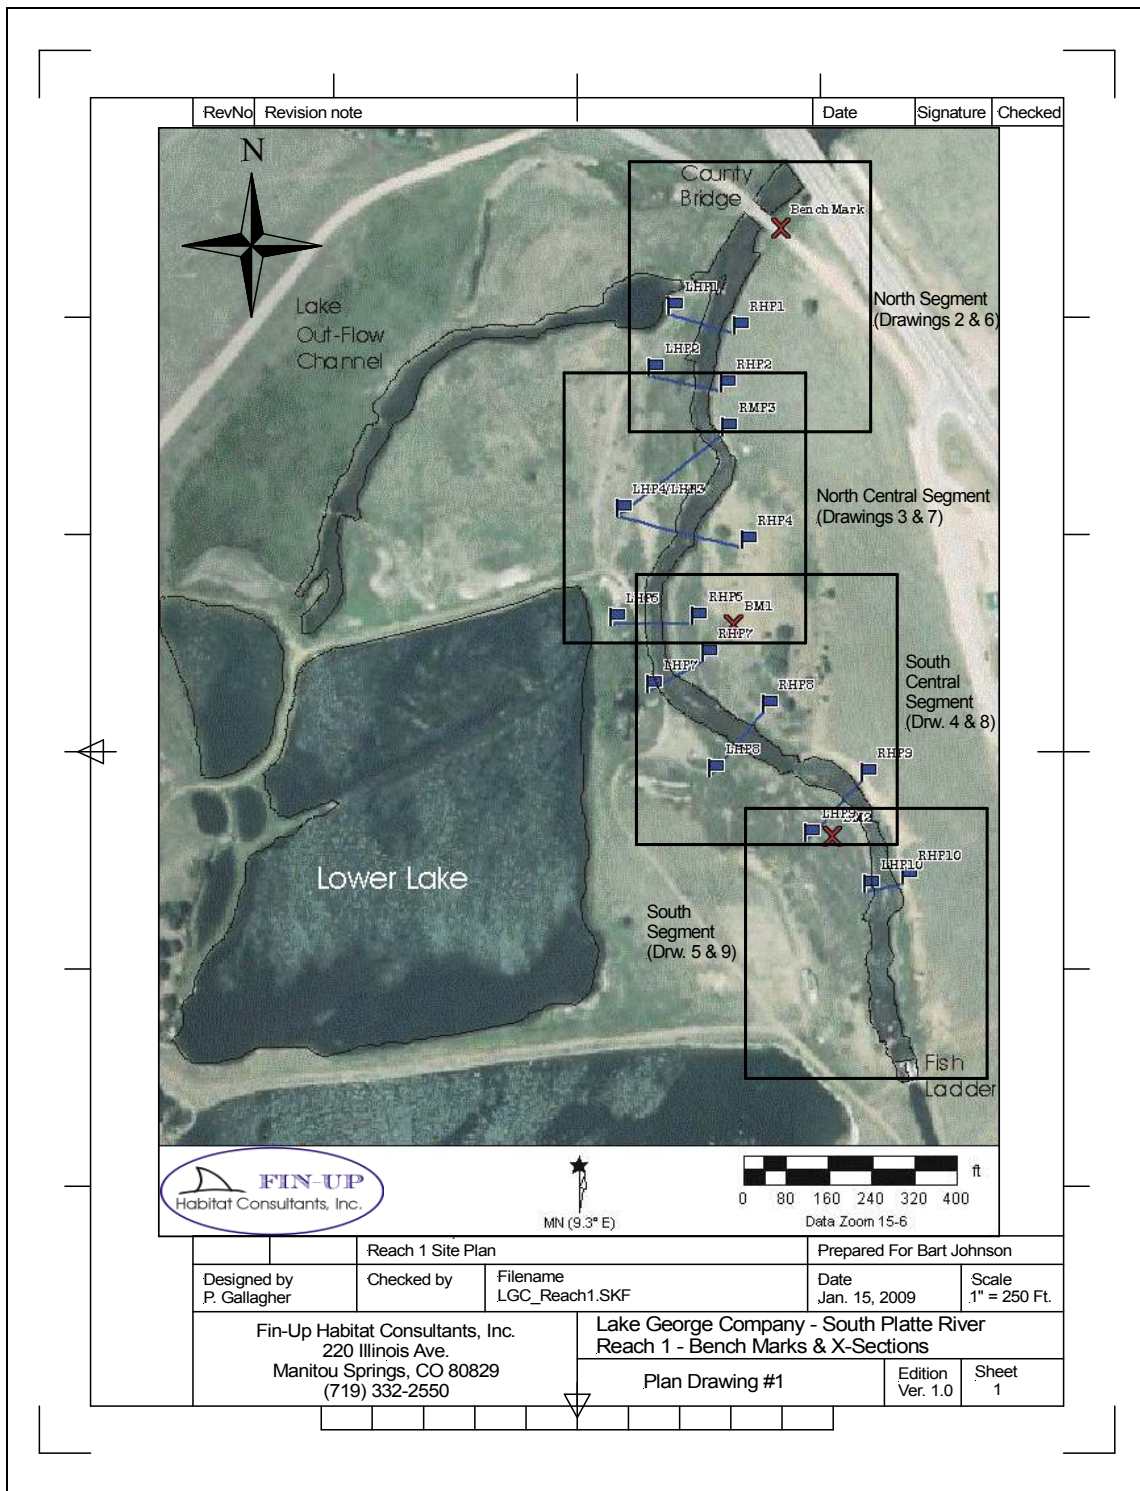
Drawing #1: Locations of the study reach, benchmarks, and cross-sections on the The South Platte River – Lake George Company, Park County, CO.

were established along the study reach. Nine cross-sections were located along the project reach in various different habitat and channel types. The location of the project reach, bench marks and cross-sections is shown in Drawing #1.

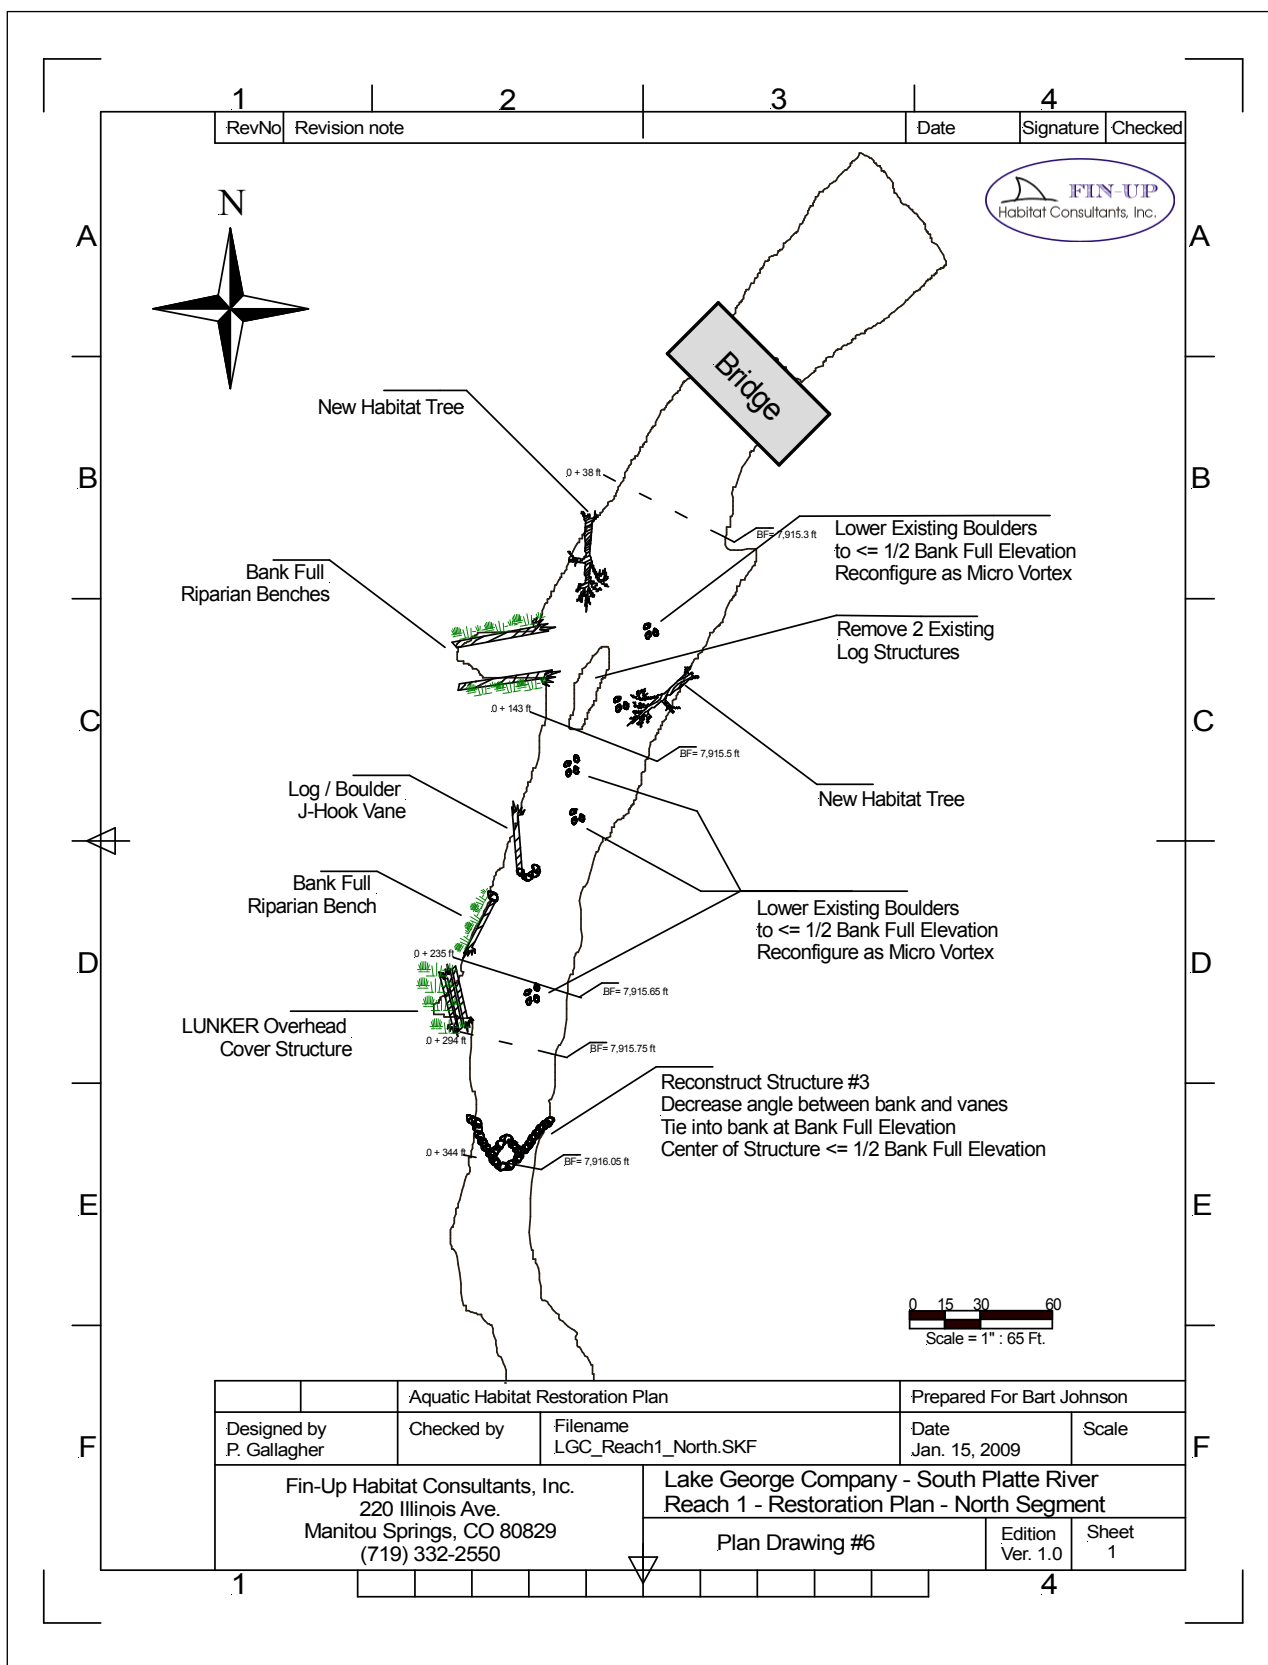
Drawing #6: Reach 1 Restoration Plan – North Segment.

The three existing log/boulder structures in this glide are not providing effective cover and velocity shelter for trout, and should be removed. To enhance large wood recruitment in this segment, we recommend installing two habitat trees on either side of the channel upstream of the riffle crest defining the transition between Riffle #1 and Glide#1. The habitat trees should be whole trees, with the root ball and as many branches as is practical still attached. Ideally, the trees will be ponderosa pine, approximately 30 – 40 ft long, with a basal diameter (DBH) of 18-24". The trees should be placed in the channel with the root-ball embedded into the river bank, and extending upstream at an angle not to exceed 30° off of the stream bank. The elevation of the tree, where it meets the river bank, should not exceed the bank full stage of the channel at this point. Habitat trees are typically anchored near the root ball and at the end of the tree with large flat

boulders, however, in this case, considering the proximity of the US 24 highway bridge, it is recommended that additional anchoring with Manta-Ray MR-1 dead-man anchors be used.

A log/boulder J-hook structure will be installed along the left bank of the stream at approximately 0+180ft along the LP, in order to direct the thalweg away from the bank, and to create additional velocity shelter. The log/boulder J-hook structure is, in some respects, similar to a habitat tree, but with the addition of a boulder “hook” on the end of the tree, which may create a small pocket of scour providing cover and velocity shelter for resident trout. Detailed plans for all of these structure types may be found in the Appendix. Nine trees will be required to complete the work in this segment and will consist of an additional 27yd³ of fill in the channel.
