Upper Rattlesnake Creek
Aquatic Habitat Enhancement Project
Elk Mountain Ranch
Carbon County, WY

FIN-UP Habitat Consultants, Inc.

Upper Rattlesnake Creek
Habitat Enhancement Project
Elk Mountain Ranch
Carbon County, WY

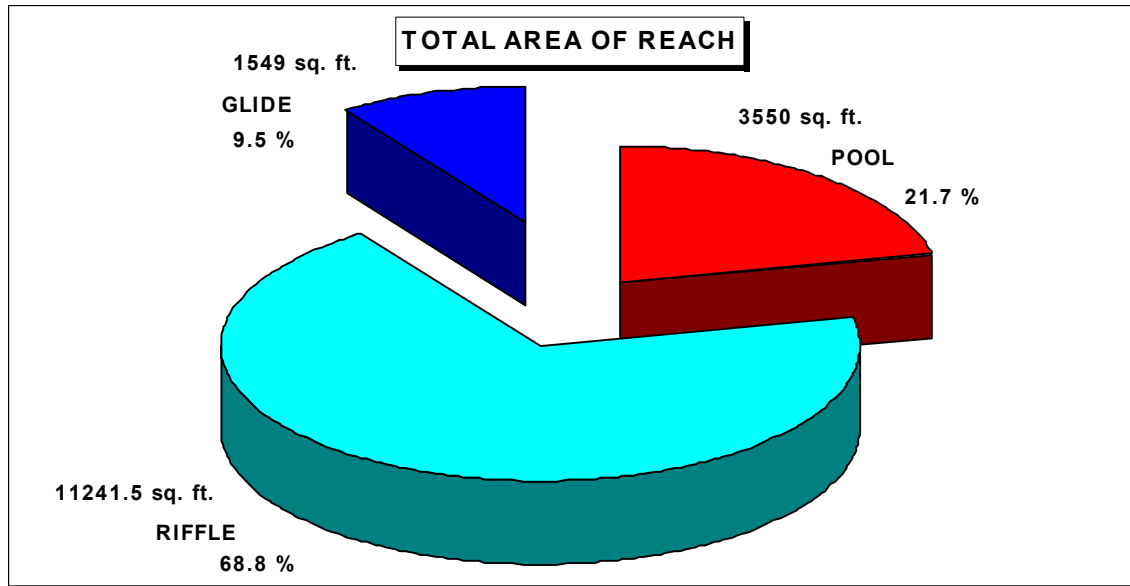
A total of seventy-two separate meso-habitats were identified in the study segment. These were composed of thirty-one pools, thirty-four riffles, and seven glide habitats (Chart 1). The average width of the stream was 8.2 feet, and the average depth was 0.4 feet. Channel substrate was predominately gravel, with considerable accumulations of cobble and a few boulders. Sand and silt was present in all habitat types, filling the interstitial spaces between the gravels and cobble, and was significant in depositional areas such as the bottom of pools and in the glides. Large wood was present but somewhat limited in the study segment, with 70 individual pieces counted during the survey. Large wood provided important velocity shelter and cover, and was a significant contributor to habitat creation and scour. Stream banks were mostly vegetated

Chart 1: Distribution of Pool, Riffle, & Glide Habitats in Reach 5 on Rattlesnake Creek.

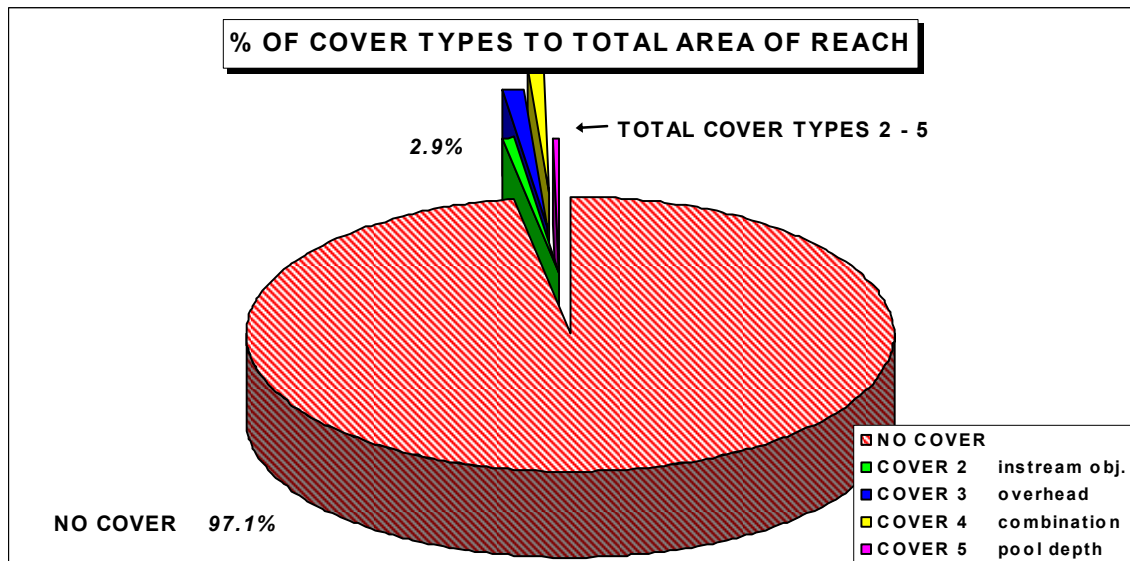
Chart 3: Percentage of Cover Types within Reach 5 on Rattlesnake Creek.

The quantity of suitable cover for salmonids in the Reach 5 study segment was very limited (Chart 3), accounting for less than 3% of the total wetted area of the channel. Suitable cover was more abundant in the less disturbed downstream segment of the reach. Less cover is expected in higher gradient B type channels, particularly those with larger stream channel substrates that

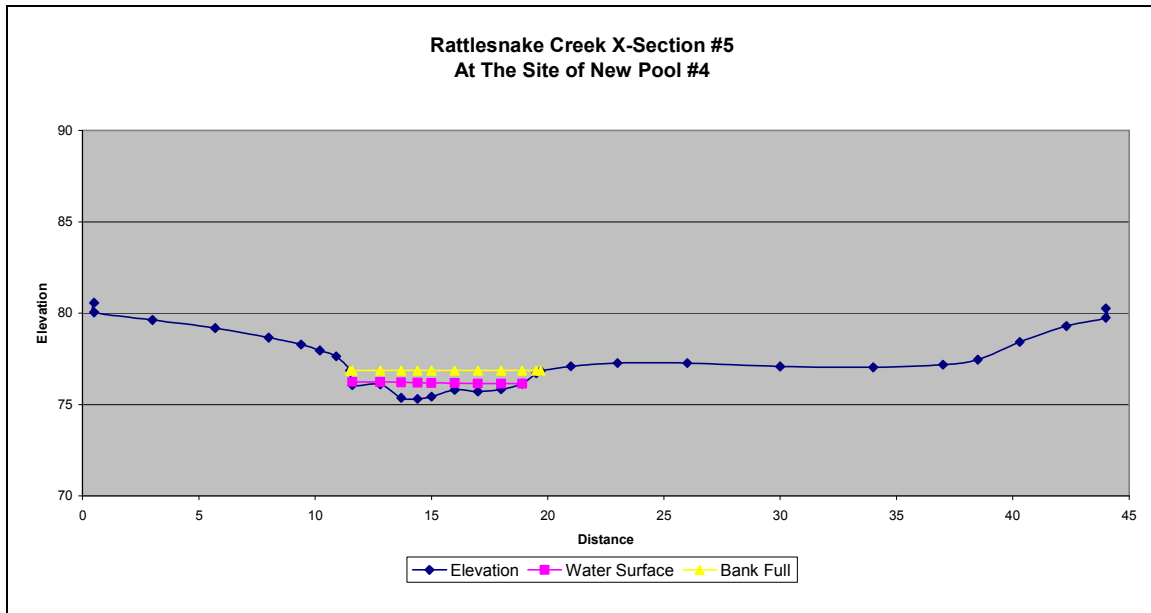
Chart 5: A representative reference cross-section along Reach 5 on Rattlesnake Creek.

Cross-section #5 depicts a reference channel within the reach, with a width to depth ratio near the optimal value for this channel type (B3 Channel - W/D ratio = 9.75). There is a well developed flood-plain on the east side of the creek, and the stream banks are stable and well vegetated. The cross-section bisects the creek at the transition between Pool 18 and Riffle 18, described in the BWSHI assessment in the previous section, and is also the location for planned pool enhancement described later in this document. The composite photo to the right shows the cross-section, looking from RHP5 toward LHP5, and from downstream of the cross-section.

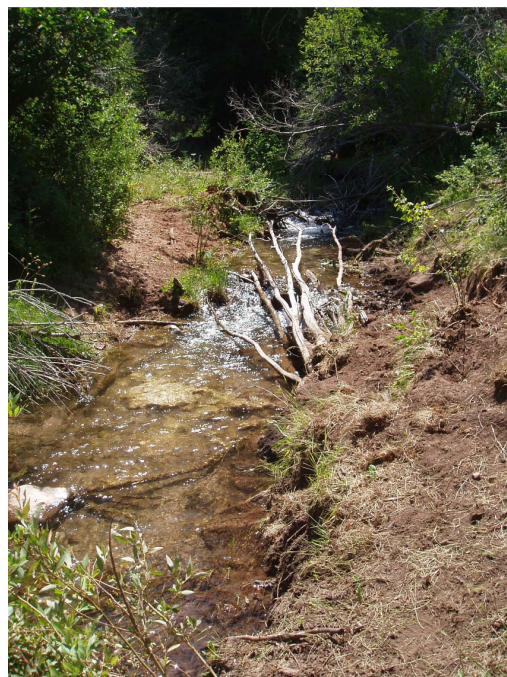
Photo 8 - Site R4-EB1 Upstream

The first treatment site on Reach 4 is designated as GPS point R4-EB1 on the map, and consists of 75 ft. of actively eroding stream bank on the right side of the channel. This segment of the stream lies along a corridor frequently utilized by elk, which has resulted in severe hoof-shear and collapse of the bank. Additional pressure from grazing cattle has resulted in banks that are nearly devoid of vegetation and actively contributing sediment to habitats downstream. Two pools exist along the 75 ft length, and could be further enhanced at the same time as the bank stabilization. The segment is shown in Photos 7 and 8, looking downstream and upstream respectively. Recommended treatment includes installing 3 log toe-slope structures along the right bank, and transplanting willow behind these structures. The channel throughout this segment is not overly wide, therefore the logs will be installed flush against the existing stream bank, creating a bench on which to transplant willow harvested from the riparian area beyond the left bank. A short segment of the right and left banks immediately downstream of Pool 3 will be armored with small cobble in order to provide a hardened crossing for elk. Two log/boulder J-hook vanes will be installed on the right bank adjacent to the existing pool habitats, to further protect the right bank and to enhance scour in these habitats. A total of 5 pieces of large wood, 8 to 10 boulders (0.5 yd³ each), and 1.5 yd³ of cobble will be required for this site. Fill below the ordinary high water mark of the stream for the log/boulder J-hook vane structures is estimated to be approximately 2.5 to 3.5 yd³ for each structure. Bank stabilization fill below the ordinary high water mark is expected to be approximately 0.1 yd³ per linear foot of bank for the log-toe-slope structures, and 0.2 yd³ per linear foot for the cobble hardened crossing. Total fill for the site is estimated not to exceed 15.5 yd³. Good access is available to the site along the elk / cattle path leading to the stream, therefore no wetlands will be effected in the course of this work.

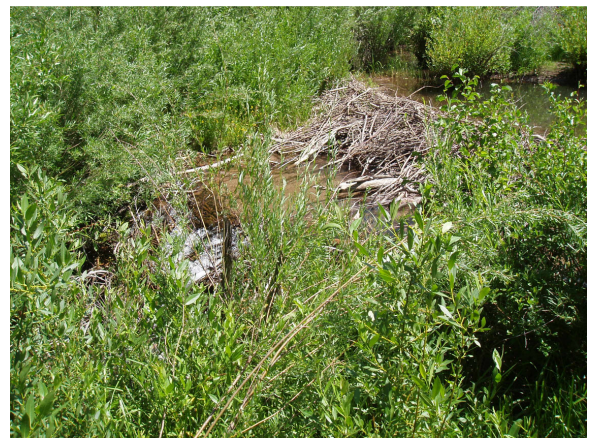
Photo 12 - Site R4-HC1 Looking Upstream

The small head-cut observed in Reach 4 is designated on the map as R4-HC1, and can barely be seen in Photo 12. This site is also inaccessible to equipment, therefore, the usual treatment of installing a grade controlling structure such as a cross vane will not be practical here. In lieu of a cross-vane, it may be desirable to create a woody debris dam pool immediately downstream of this feature by dropping two or three small tree-tops into the channel. The tree-tops will capture smaller woody debris moving through the stream and form a dam pool at the head-cut, reducing the downward erosional pressure on the channel. This work can be accomplished without the use of heavy equipment.

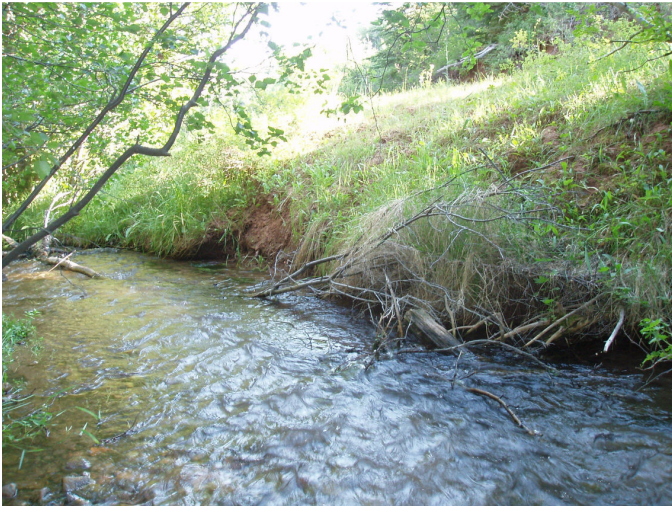
Photo 15 - Site R5-EB3 From the Right Bank

Site R5-EB3 (Photos 15 & 16) corresponds with Riffle 16 in the BWSHI and consists of 35 ft of actively eroding bank on the left side of the channel adjacent to the road. A log toe-slope structure will be installed flush with the left bank, and revegetated using native willow available on the other side of the stream. Additionally, a poorly developed pool (Pool 16) exists immediately below the actively eroding stream bank. This pool will be enhanced by installing a boulder cross vane to improve scour and depth of the pool, as well as anchoring the toe-slope structure above. One piece of large wood, and 13 -15 boulders (0.5 yd^3 each) will be required for this site. Fill below the ordinary high water mark of the stream for the cross-vane is estimated to be approximately 7 yd^3 . Bank stabilization fill below the ordinary high water mark is expected to be

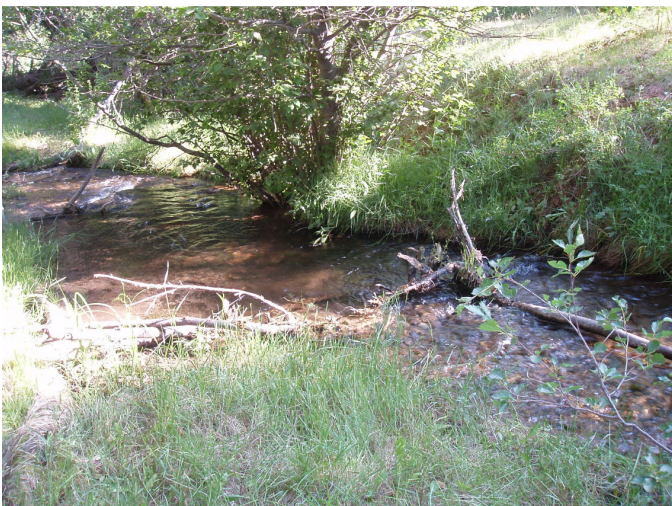
Photo 16 - Site R5-EB1 From the Right Bank

The first eroding stream bank treatment site on Reach 5 is designated as GPS point R5-EB1 on the map, and corresponds with Riffle 7 in the BWSHI and Cross-Section # 6 described in the previous chapter. The site consists of 35 ft. of actively eroding stream bank on the left side of the channel. The road is immediately adjacent to the stream channel at this site, and is at risk of collapsing into the stream (Photo 13). The road will need to be moved approximately 8 ft to the east, away from the stream. There is adequate width between the stream and the steep hill slope to allow for this re-location. The collapsing left bank will be stabilized using two log toe-slope bank structures placed flush against the existing stream bank. These toe-slope structures will be anchored using small boulder vanes extending $1/3$ of the distance into the channel, at an angle not to exceed 30° from the bank. These structures will further reduce the sheer stress along the outside of this meander bend, as well as providing additional in-stream cover within Riffle 7. The existing vertical bank will be sloped back to the edge of the newly relocated road and will be revegetated using native willow and sedges transplanted from the point bar on the inside of the meander bend. A total of 2 pieces of large wood, and 12 to 14 boulders (0.5 yd^3 each) will be required for this site. Fill below the ordinary high water mark of the stream for the boulder vanes is estimated to be approximately 2.5 to 3.5 yd^3 for each structure. Bank stabilization fill below the ordinary high water mark is expected to be approximately 0.1 yd^3 per linear foot of bank for the log-toe-slope structures. Total fill for the site is estimated not to exceed 10 yd^3 .

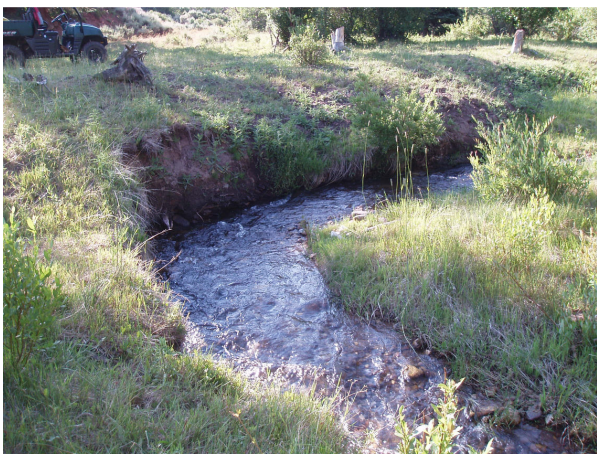
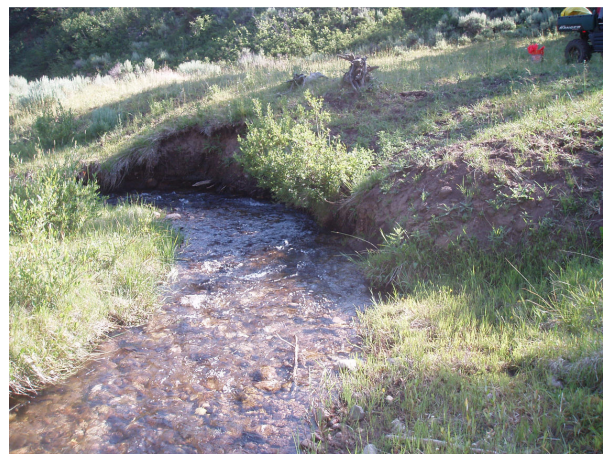
Photo 19 - Site R5-EB6 Looking Upstream

Photo 20 - Site R5-EB6 Looking Downstream

Site R5-EB6 corresponds with Riffle 24 in the BWSHI and Cross-Section # 4 described in the previous chapter. The site consists of 40 ft. of actively eroding stream bank on the left side of the tightly meandering stream channel (Photos 19 and 20). Enlarging the stream meander radius of curvature, lengthening the channel and reducing the water surface slope will reduce the sheer on this extremely unstable bank. The left bank of the stream will be excavated approximately 3 feet in order to increase the radius of curvature of the meander bend. Material from this excavation will be used to augment the point bar on the inside of the meander bend in order to maintain the existing channel width/depth ratio and cross-sectional bank-full dimension. The new stream bank will be stabilized using two log toe-slope bank structures placed flush against the bank, with the slope above pulled back to an angle of repose of 3:1 or less. These toe-slope structures will be anchored on the downstream side and middle of the bank by installing two small boulder vanes extending 1/3 of the distance into the channel, at an angle not to exceed 30° from the bank. A full channel cross-vane will be installed at the upstream boundary of the site to anchor the toe slope treatments, as well as creating additional pool habitat. The left stream bank and augmented point bar will be re-vegetated using native willow and sedges transplanted from behind the point bar on the inside of the

meander bend. Two pieces of large wood, and 18 - 20 boulders (0.5 yd³ each) will be required for this site. Fill below the ordinary high water mark of the stream for the cross-vane is estimated to be approximately 6 yd³., and 3 yd³ for each rock vane. Bank stabilization fill below the ordinary high water mark is expected to be approximately 0.1 yd³ per linear foot of bank for the log-toe-slope structure. Total fill for the site is estimated not to exceed 16 yd³.

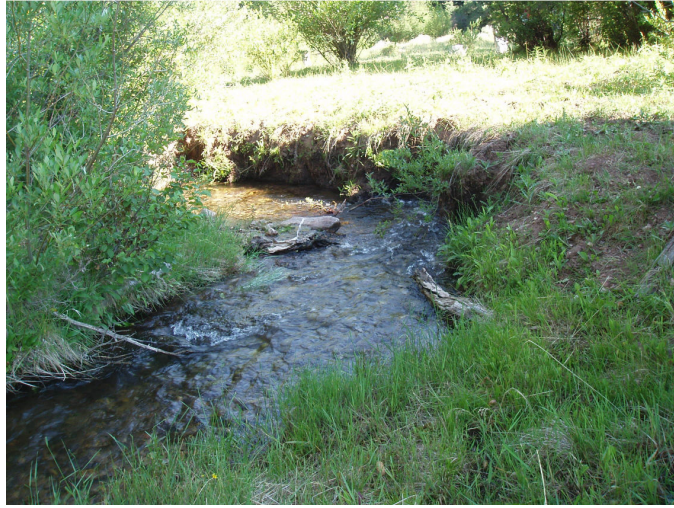
Photo 21 - Site R5-EB7 Looking Downstream

Site R5-EB7 (Photo 21) corresponds with Pool 26 in the BWSHI and consists of 17 ft of generally unstable stream bank on the left side of the channel. Treatment will include installing a tree flush along the left stream bank, and revegetating the bank with willow harvested from the point bar on the inside of the meander bend. A small log/boulder vane will be installed at the upstream boundary of the toe slope structure to enhance scour and cover in Pool 26. Two pieces of large wood, and 4 - 5 boulders (0.5 yd³ each) will be required for this site. Fill below the ordinary high water mark of the stream for the log/boulder vane is estimated to be approximately 2.5 to 3.5 yd³. Bank stabilization fill below the ordinary high water mark is expected to be approximately 0.1 yd³ per linear foot of bank for the log-toe-slope structure. Total fill for the site is estimated not to exceed 5.5 yd³.

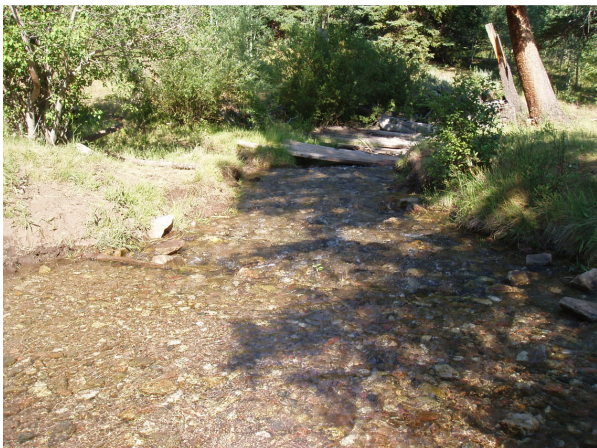
Photo 26 - Site R5-EB11 Looking D/S.

Site R5-EB11 and R6-EB1 (Photos 26, 27 and 28) correspond with the low water road crossing at the upstream Reach 5/Reach 6 boundary, and Cross-Sections #1 and #2 in the preceding chapter. R5-EB11 and R6-EB 1 are immediately adjacent, and have been combined into one project site for the purposes of this description. The channel throughout this site is characterized by high width/depth ratios, unstable and poorly vegetated stream banks, and severely limited habitat for trout. During low flows in the late summer and fall, the site is likely a barrier to migration of fall spawning brown trout. The site is approximately 100 ft long, with most of the banks actively contributing sediment to the channel. A schematic of the proposed work is shown in Diagram 1 and in the appendix.

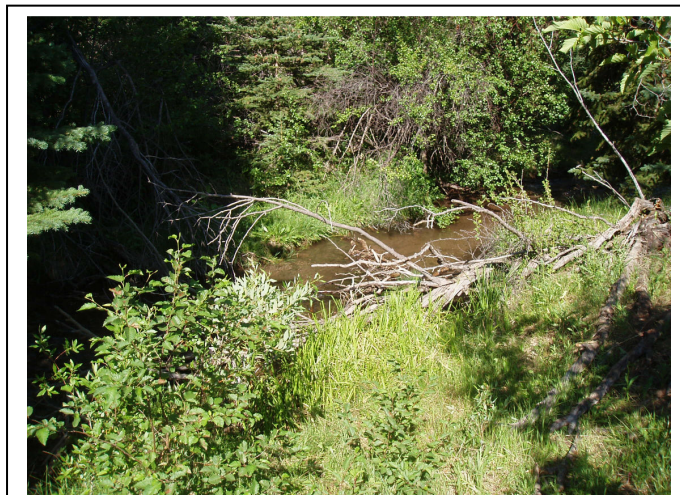
Photo 29 - Site R5-NP1 From Left Bank

The first new pool development site on Reach 5 is designated as GPS point R5-NP1 on the map, and corresponds with Riffle 5 in the BWSHI described in the previous chapter (Photo 29). The proposed work here is to install a log/boulder-vane above a brief low-gradient transition within the riffle habitat to create a new pool. One piece of large wood, and 3- 4 boulders (0.5 yd³ each)

will be required for this site. Fill below the ordinary high water mark of the stream for the log/boulder vane is estimated to be approximately 3 yd³. Larger cobbles/boulder armoring the channel within the pool may be removed to enhance scour. These materials will be placed outside the water influence zone of the stream.

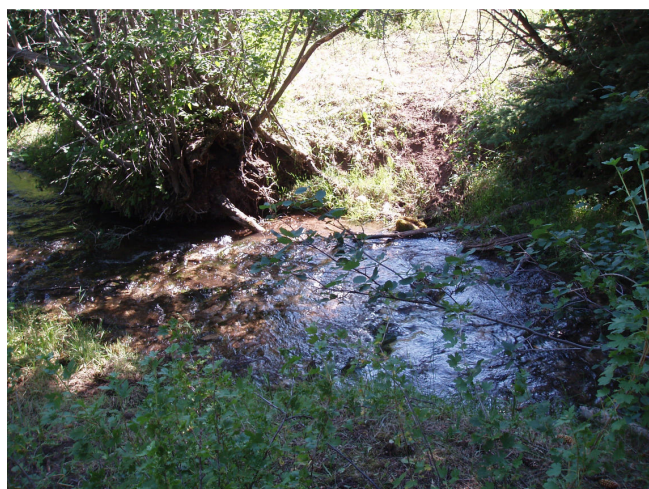
Photo 30 - Site R5-NP2 From Right Bank

Site R5-NP2 (Photo 30) is 26 ft. upstream of the previous new pool site, and corresponds with Glide 2 in the BWSHI. This habitat is well suited for conversion to a plunge pool by installing a double-log cross-vane at the upstream boundary of the feature to enhance scour. Two pieces of large wood, and 5- 6 boulders (0.5 yd³ each) will be required for this site. Fill below the ordinary high water mark of the stream for the log/boulder vane is estimated to be approximately 5 yd³.

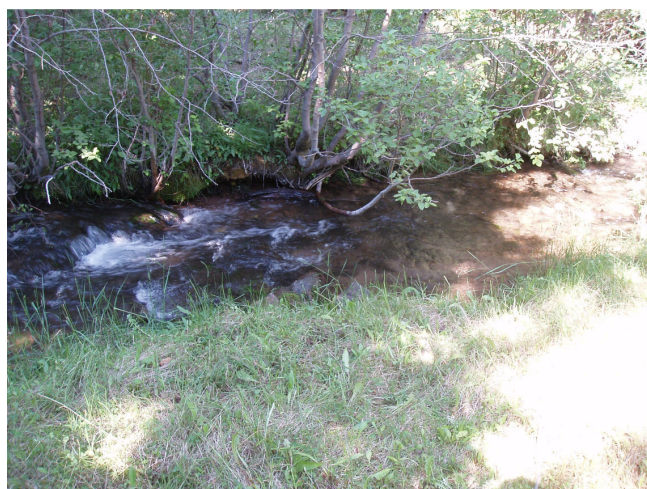
Photo 31 - Site R5-NP3 From Left Bank

Site R5-NP3 (Photo 31) corresponds with Pool 18 in the BWSHI, and Cross-Section #5 discussed in the previous chapter. This habitat is characterized by a well armored substrate, allowing little scour and poor residual pool depth in the feature. Larger cobbles/boulder armoring the channel within the pool will be removed to enhance scour. Large cobble and boulders removed from the pool and existing boulders immediately upstream of the pool will be re-configured as a cross-vane to enhance scour through the habitat. Any excess materials will be removed from the site and placed outside the water influence zone of the stream.

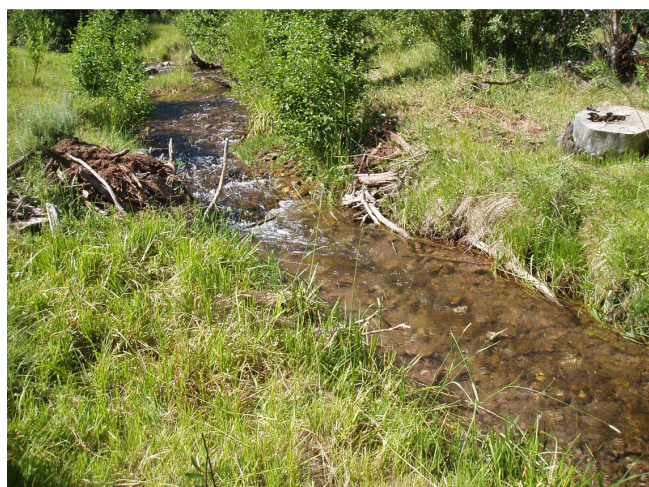
Photo 32 - Site R5-NP5 Looking Upstream

Site R5-NP5 (Photo 32) corresponds with Glide 6 in the BWSHI. There is a remnant of a beaver dam near this feature. This habitat is a natural low-gradient transition between two cobble riffles, and is well suited for conversion to a plunge pool by installing a double-log cross-vane at site of the beaver dam remnant. Two pieces of large wood, and 5- 6 boulders (0.5 yd³ each) will be required for this site. Fill below the ordinary high water mark of the stream for the log/boulder vane is estimated to be approximately 5 yd³.

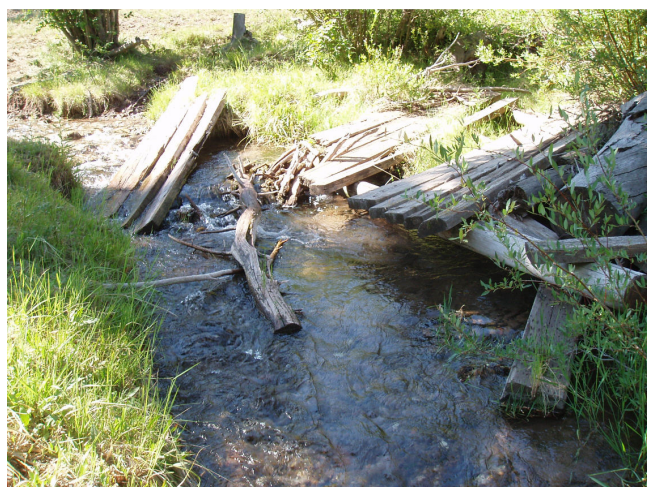
Photo 33 - Site R5-NP6 Looking Upstream

Site R5-NP5 (Photo 33) corresponds with Pool 31 in the BWSHI. There is a collapsed bridge fragment along the right bank of this feature that is providing some overhead cover. The pool itself is poorly functioning, exhibiting limited residual pool depth and cover. This habitat may be enhanced by removing larger cobbles/boulder armoring the channel within the pool and re-configuring

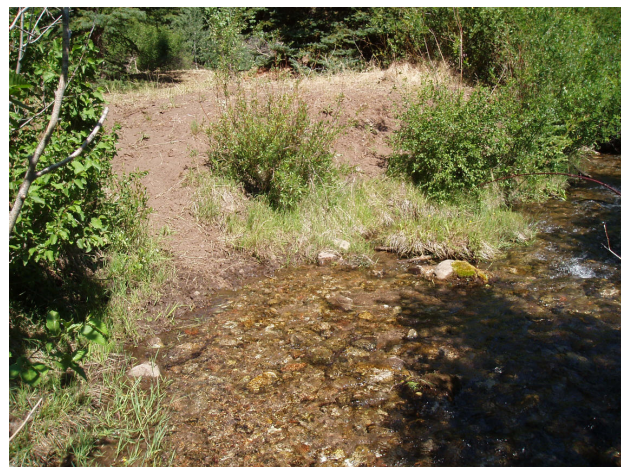
Photo 34 - Site R6-EB2 Left Bank

and Rattlesnake Creek (Photo 34). The site consists of 75 ft. of actively eroding stream bank on the right side of the channel, extending upstream past the confluence and up along the Beaver Pond outflow channel. The channel is over-wide throughout the upstream half of this site, due to the collapsing banks. There is good access to the site from the road immediately to the west. The collapsing right bank will be stabilized using three log toe-slope bank structures. The downstream log will be placed flush against the bank since W/D ratios are not an issue along this portion of the channel. The other two log toe-slope structures will be installed so as to reduce the width/depth ratio of the channel to a W/D of 10-11. Additionally, a cross vane will be installed at the downstream boundary of the site to enhance an existing pool, as well as anchor the tree toe-slope treatments. Three pieces of large wood, and 12 - 14 boulders (0.5 yd³ each) will be required for this site. Fill below the ordinary high water mark of the stream for the cross-vane is estimated to be approximately 6 yd³. Bank stabilization fill below the ordinary high water mark is expected to be approximately 0.1 - 0.25 yd³ per linear foot of bank for the log-toe-slope structure, depending on whether the structure is used to reduce W/D ratios in addition to bank stabilization and revegetation. Total fill for the site is estimated not to exceed 21 yd³.

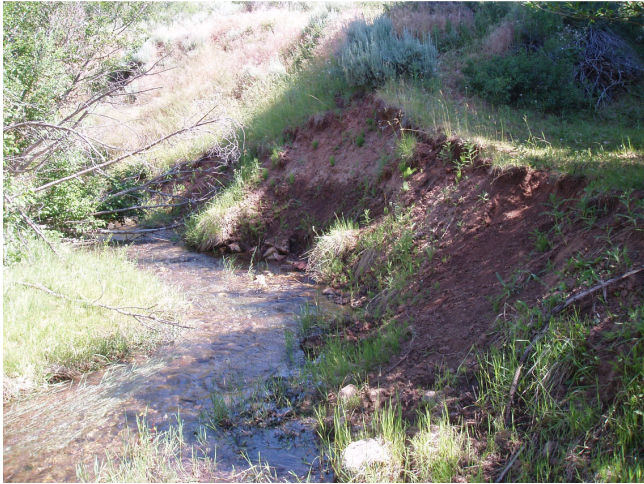
Photo 35 - Site R6-EB4 Looking Downstream

Site R6-EB4 (Photos 35) consists of 60 ft of actively eroding stream bank on the left side of the stream channel. Care will need to be taken to access this site, as it is the farthest site from the road that has been identified for treatment. A path that crosses no wet areas or important riparian/water influence zones has been identified that begins upstream of the off channel beaver pond and follow a bench above the right bank of the stream downstream to the site. Minimal existing vegetation (one or two small alder/aspen saplings) will need to be removed to use this path. Three toe-slope structures will be installed, placing the trees flush along the left stream bank, and revegetating the bank with willow and sedge harvested from the point bar beyond the right bank of the stream. Three pieces of large wood, available at the site, and 4 boulders (0.5 yd³ each) will be required for this site. Bank stabilization fill below the ordinary high water mark is expected to be approximately 0.1 yd³ per linear foot of bank for the log-toe-slope structure. Total fill for the site is estimated not to exceed 6 yd³.

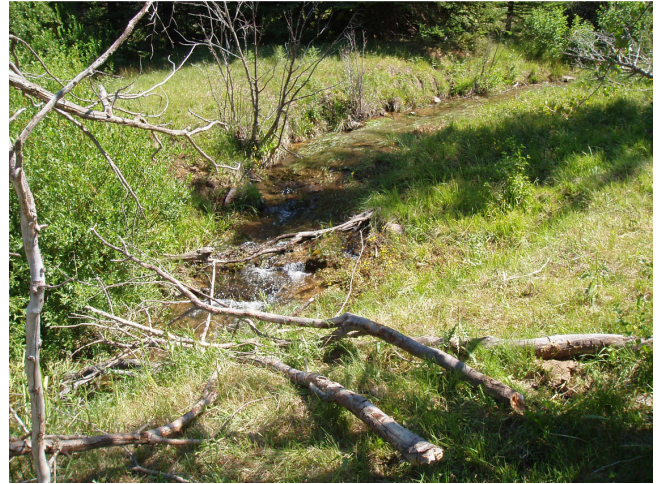
Photo 36 - Site R6-NP1 Looking Upstream

Site R6-NP1 is located approximately 325 ft upstream of R6-EB4, and can be accessed along the same route as that site (Photo 36). There is a natural constriction in the channel at this point where a large woody debris dam pool can be created by dropping two tree-tops into the channel. The trees will capture smaller woody debris moving through the stream and gradually form a dam pool. Suitable trees are available at the site. Total fill for the site is estimated not to exceed 3 yd³.

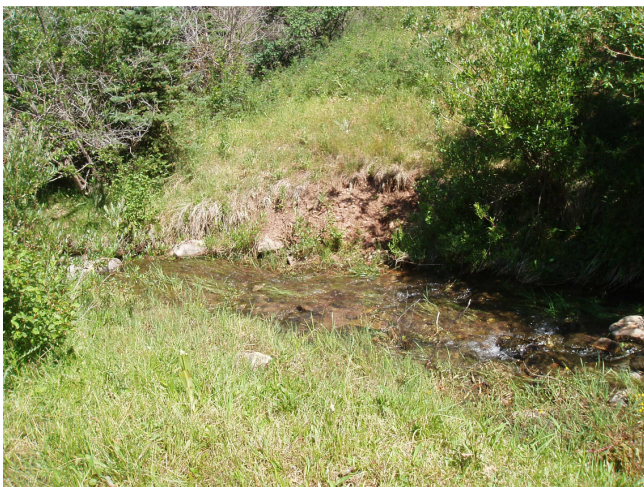
Photo 37 - Site R6-EB5 From the Right Bank

Site R6-EB5 (Photos 37) is approximately 80 ft upstream of R6-NP1, and consists of 20 ft of actively eroding stream bank on the left side of the stream channel. A single tree toe-slope structure will be installed, placing the tree flush along the left stream bank, and revegetating the bank with willow and sedge harvested from the point bar beyond the right bank of the stream. Additionally, there is a natural constriction in the channel immediately downstream of the site where a large woody debris dam pool can be created by dropping two tree-tops into the channel. Suitable trees are available at the site. Three pieces of large wood, and 2 boulders (0.5 yd³ each) will be required for this site. Bank stabilization fill below the ordinary high water mark is expected to be approximately 0.1 yd³ per linear foot of bank for the log-toe-slope structure. Total fill for the site is estimated not to exceed 5 yd³.

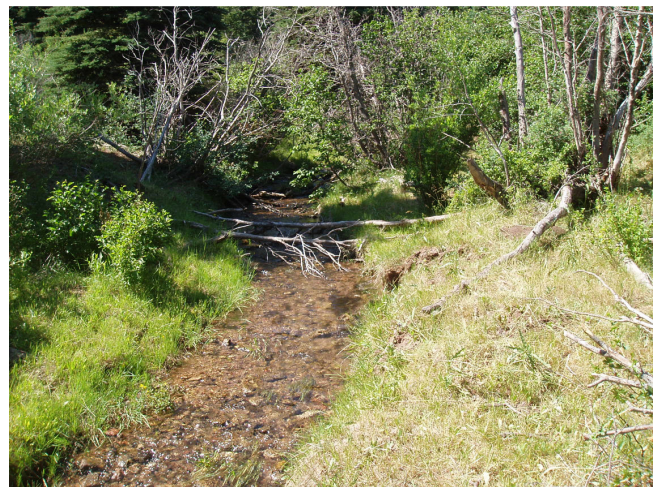
Photo 38 - Site R6-NP2 Looking Upstream

Site R6-NP2 is located approximately 165 ft upstream of R6-EB5, and can be accessed along the same route as that site (Photo 38). The site is characterized by a brief low-gradient transition within a long high gradient boulder/cobble riffle. A new plunge pool will be constructed at this site by installing a boulder cross vane in the channel. Eight to ten boulders (0.5 yd³ each) will be required for the cross-vane. Total fill for the site is estimated not to exceed 5 yd³.

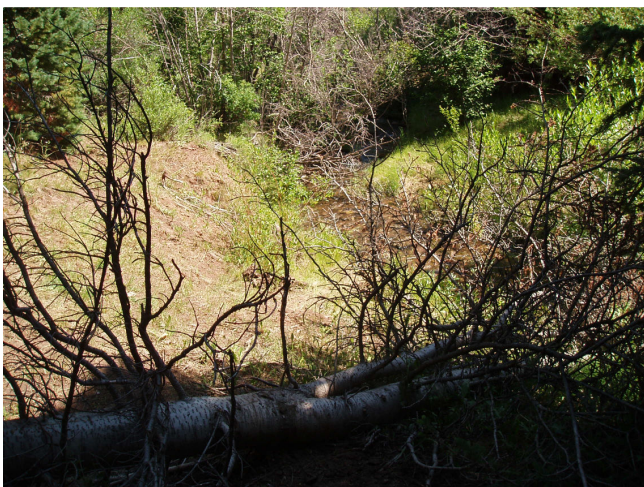
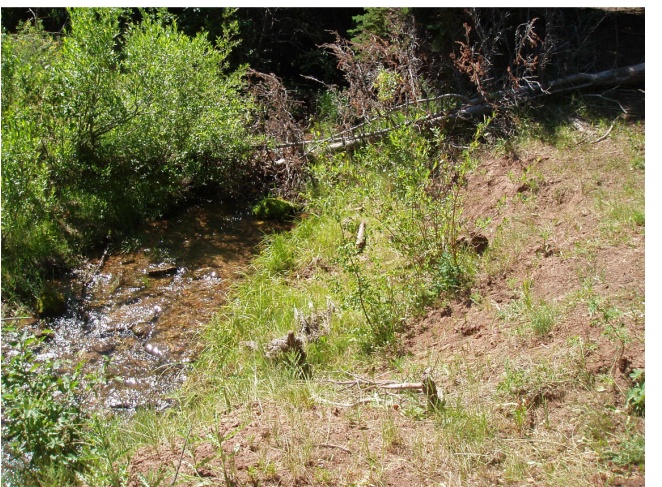
Site R6-EB6 (Photos 39 & 40) is 80 ft upstream of R6-NP2, and consists of 20 ft of generally unstable stream bank on the right side of the channel. Treatment

will include installing a tree flush along the right stream bank, and revegetating the bank with willow and sedge harvested from near the site. A small log/boulder vane will be installed at the upstream boundary of the toe slope structure to enhance scour and cover in an existing pool. Two pieces of large wood, and 4 - 5 boulders (0.5 yd³ each) will be required for this site. Fill below the ordinary high water mark of the stream for the log/boulder vane is estimated to be approximately 2.5 to 3.5 yd³. Bank stabilization fill below the ordinary high water mark is expected to be approximately 0.1 yd³ per linear foot of bank for the log-toe-slope structure. Total fill for the site is estimated not to exceed 5.5 yd³.

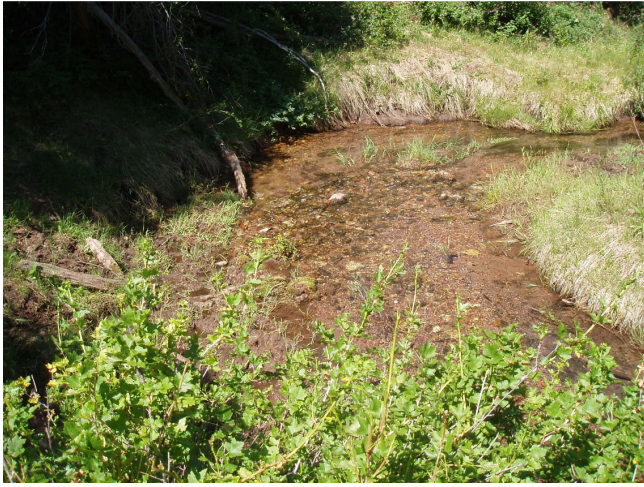
Photo 41 - Site R6-EB7 Looking Downstream

The remaining sites on Rattlesnake Creek Reach 6 may be easily accessed from the forest opening noted as ACCESS1 on the map, upstream of the off-channel beaver pond. Site R6-EB7 (Photo 41) is 200 ft upstream of R6-EB6, and appears to be a cattle watering and crossing area. The site is generally over-wide, with 40 ft of unstable stream bank on the right side of the channel. Treatment will include installing two logs along the right stream bank, and revegetating the bank with willow and sedge harvested from near the site. Accumulated sediments from the existing scour pool immediately downstream will be excavated and removed from the site and placed outside the water influence zone of the stream. Two pieces of large wood, and 3-4 boulders (0.5 yd³ each) will be required for this site. Bank stabilization fill below the ordinary high water mark is expected to be approximately 0.2 yd³ per linear foot of bank for the log-toe-slope structures. Total fill for the site is estimated not to exceed 8 yd³.

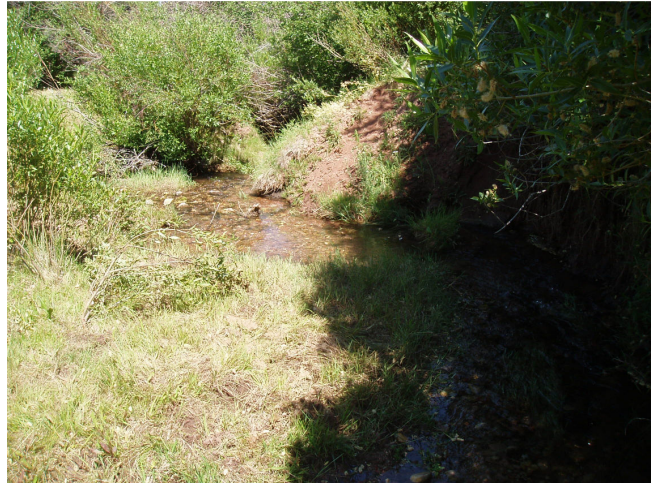
Photo 42 - Site R6-EB8 Looking Downstream

Site R6-EB8 (Photo 42) is 135 ft upstream of R6-EB7, and appears to be another cattle watering and crossing area. The site is also somewhat over-wide, with 20 ft of unstable stream bank on the left side of the channel. Treatment will include installing a log toe-slope structure along the left stream bank, and revegetating the bank with willow and sedge harvested from near the site. A small log/boulder vane will be installed at the downstream boundary of the toe slope structure to enhance scour and cover in an existing pool. Accumulated sediments from the existing pool will be excavated and removed from the site and placed outside the water influence zone of the stream. Two pieces of large wood, and 3-4 boulders (0.5 yd³ each) will be required for this site. Bank stabilization fill below the ordinary high water mark is expected to be approximately 0.2 yd³ per linear foot of bank for the log-toe-slope structures. Total fill for the site is estimated not to exceed 6 yd³.

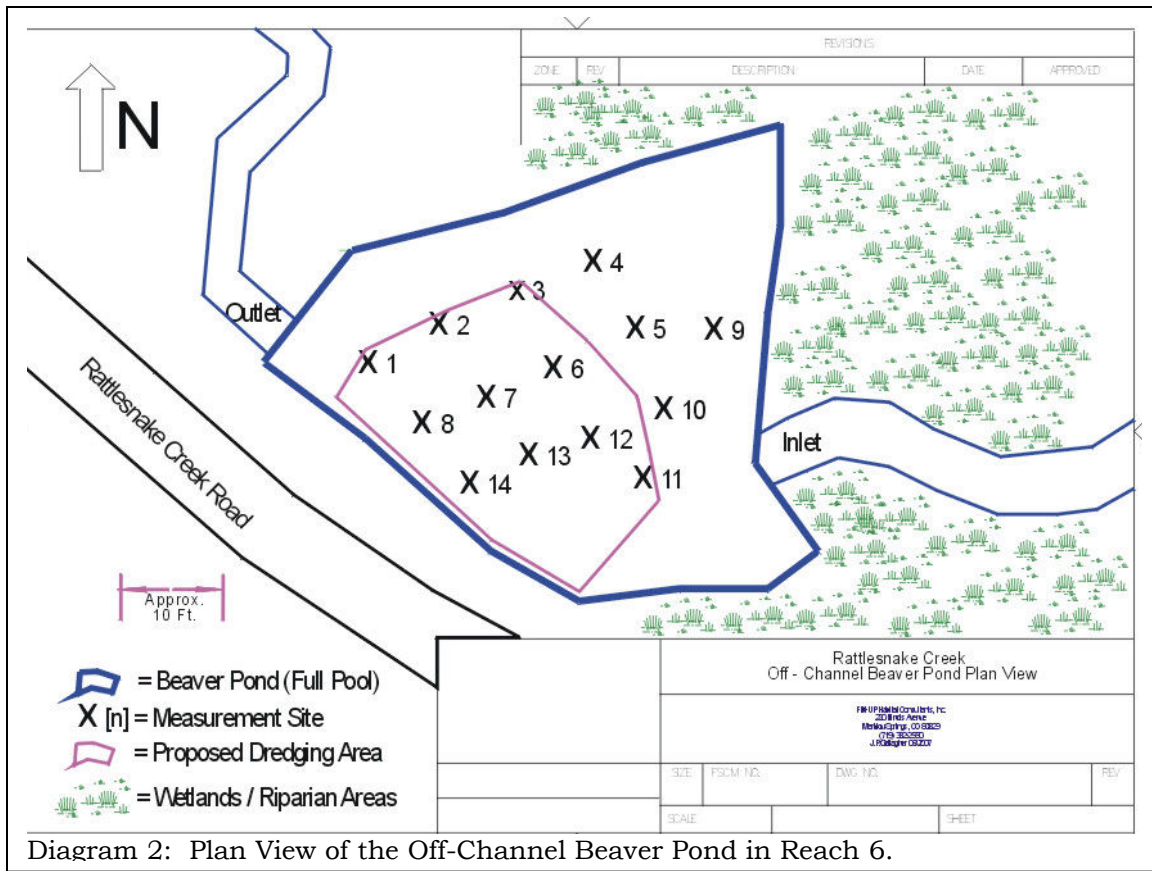
Diagram 2: Plan View of the Off-Channel Beaver Pond in Reach 6.

A sediment deposition depth profile, using a graduated wading staff, indicates that 1 to 3 feet of depositional sediment and detritus may be excavated from the western half of the pond (Diagram 2). It is expected that approximately 300 - 325 yd³ of material will be dredged from the pond and removed from the site. Average depth of the pond will be increased from 1.8 ft at full-pool stage to 2.6 ft. The maximum depth of the pond will not change, but the area of maximum

depth will increase by approximately 20%. While the surface acreage of the pond will remain the same, the volume of the pond will increase to 0.7 acre/ft.

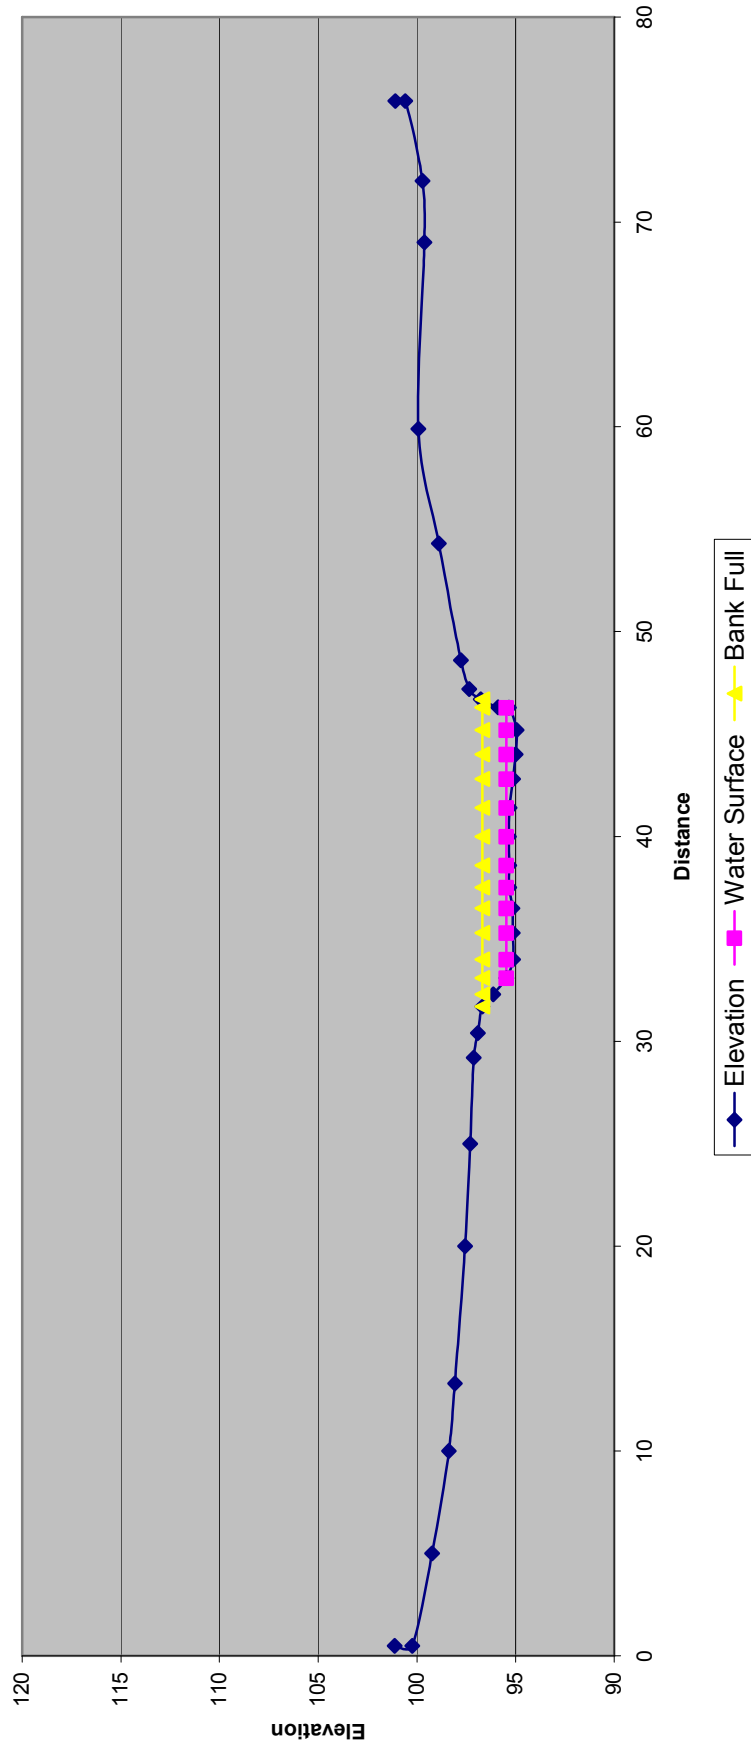
**Rattlesnake Creek X-Section #4
At Eroding Bank #6 and Riffle #24**

The other channel cross-sections indicate that there may be some lateral instability of the reach, with frequent vertical, poorly vegetated stream banks subject to considerable shear stress on the outside of the meander bends (Cross Sections #4 and #6). Cross-Section #4 (Chart 6) is a good example of lateral instability and bank failure occurring in the reach. The stream, though this cross-section, exhibits a tight meander bend, and is rapidly eroding the right bank, which is failing at several points. The width/depth ratio of the channel is currently 15.8 and appears to be gradually increasing. The point bar on the inside of the meander is stable however, and is well vegetated. The vegetation on the right bank however, consists of mostly shallow rooted upland grasses. Left untreated, the stream will continue to erode into the right bank, increasing sedimentation downstream. The photo in the chart above shows the cross-section from upstream, looking downstream at the site.

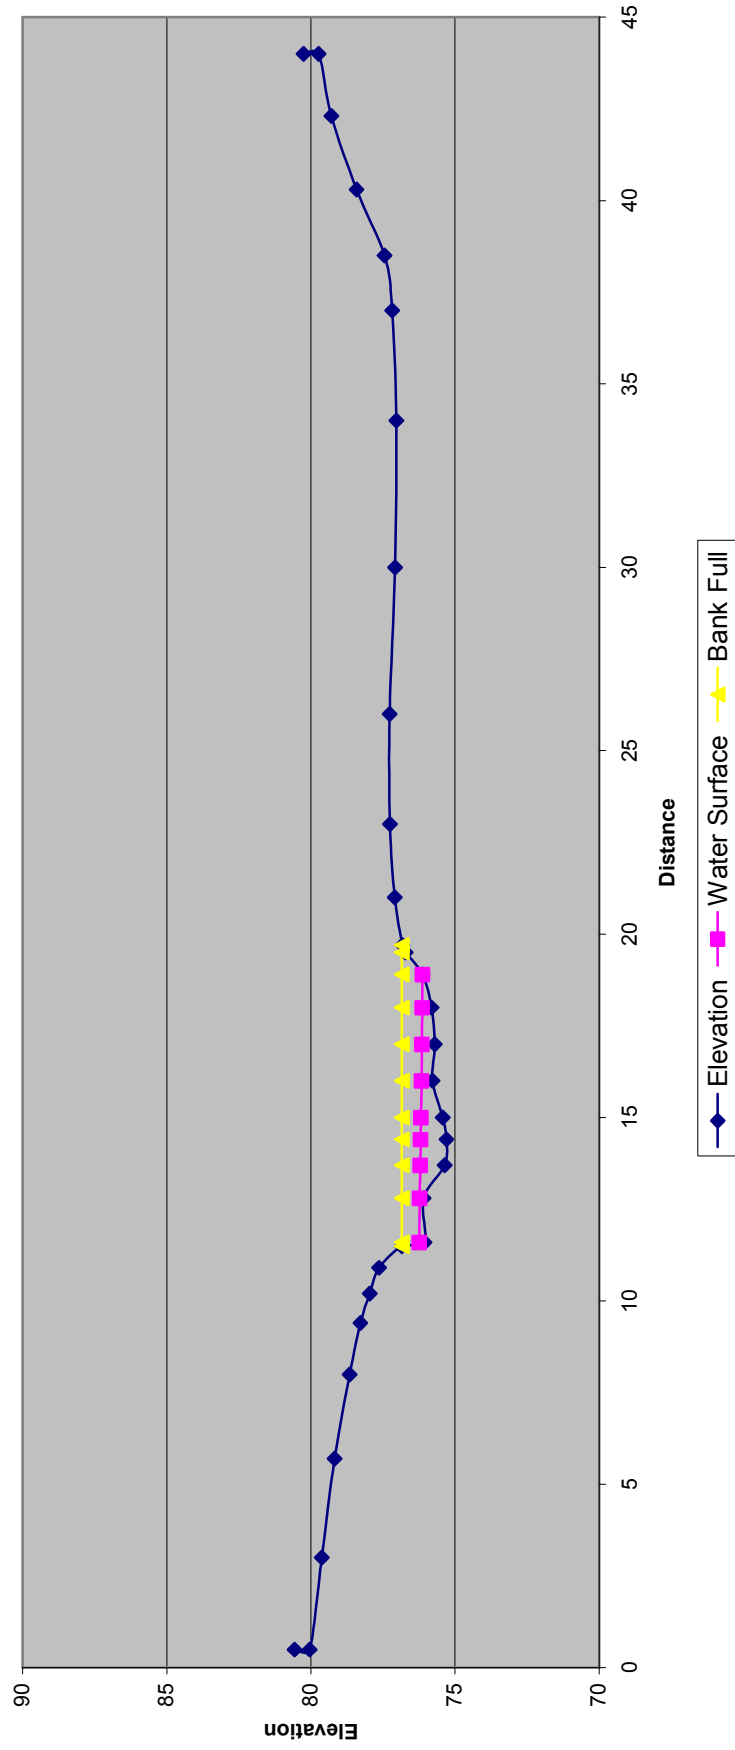
**Rattlesnake Creek X-Section #6
At Eroding Bank #1 / Rifle #7
Immediately Adjacent to the Road**

Cross-Section #6 is an example of the road/stream interactions occurring within the reach (Chart 7). As is the case with Cross-Section #4, the stream exhibits an extremely tight meander bend at the point where it is immediately adjacent to the road. The road-side stream bank vegetation is shallow rooted and very sparse, and the bank has failed at several points. Left untreated, the stream will eventually erode the bank to the point where the road will be cut-off. The photo in Chart 7 shows the cross-section from upstream of the site, looking downstream.
