Aquatic Assessment
&
Habitat Enhancement Plan
Fountain Creek - Memorial and Mansions Park
City of Manitou Springs
El Paso County - Colorado

In January 2009, FIN-UP Habitat Consultants, Inc. was contracted by the City of Manitou Springs to conduct an aquatic habitat analysis and habitat enhancement strategy for a segment of Fountain Creek within Memorial and Mansions Park, in the center of the city. The stream within the park is approximately 1,500 feet in length, consisting of a moderately entrenched channel flowing through a cottonwood and alder dominated floodplain in Memorial Park, and a severely confined channel bounded by concrete retaining walls and building foundations through Mansions Park. An aquatic assessment was conducted within the project area during the 1st week of February, 2009, and the results of this study are summarized in this document.

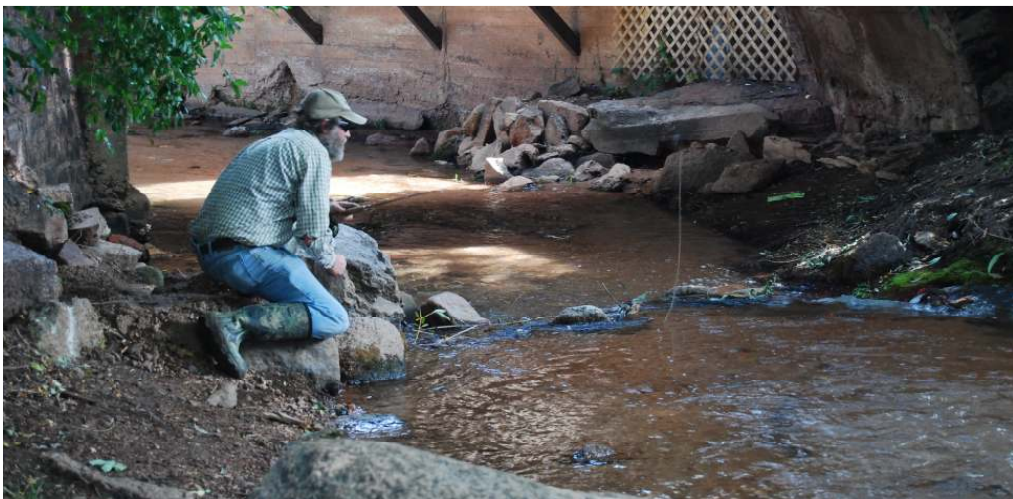
Photo 1: Pursuing brown trout in Fountain Creek, Manitou Springs, CO.

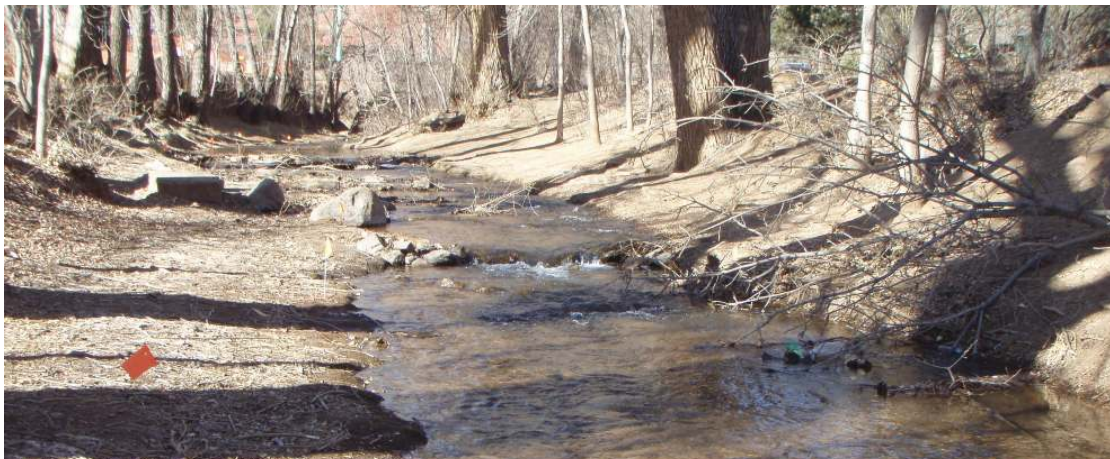
Photo 2: Cobble riffle in a B Channel within Reach 7 of Fountain Creek

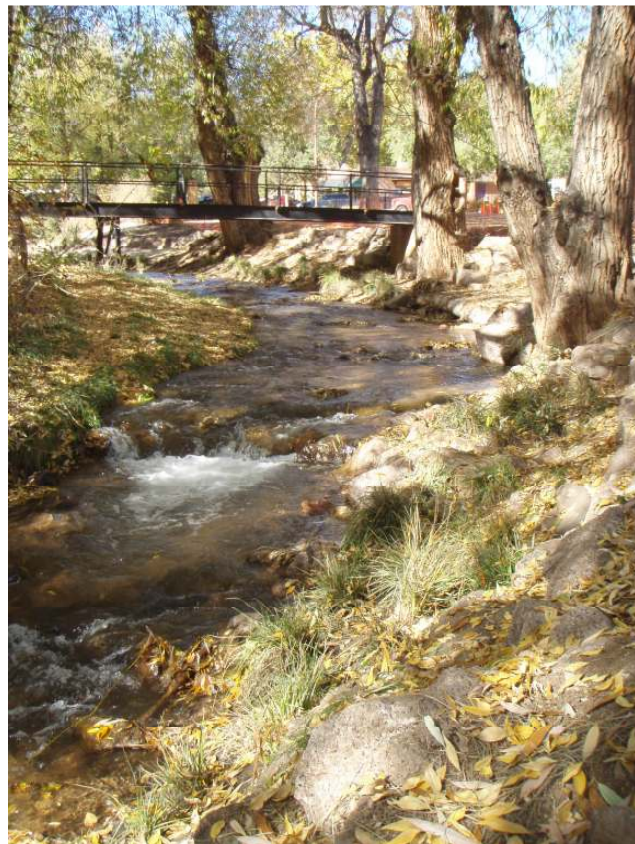
Photo 9: Restored stream bank and cross—vane. Soda Springs Park Reach 11 on Fountain Creek.

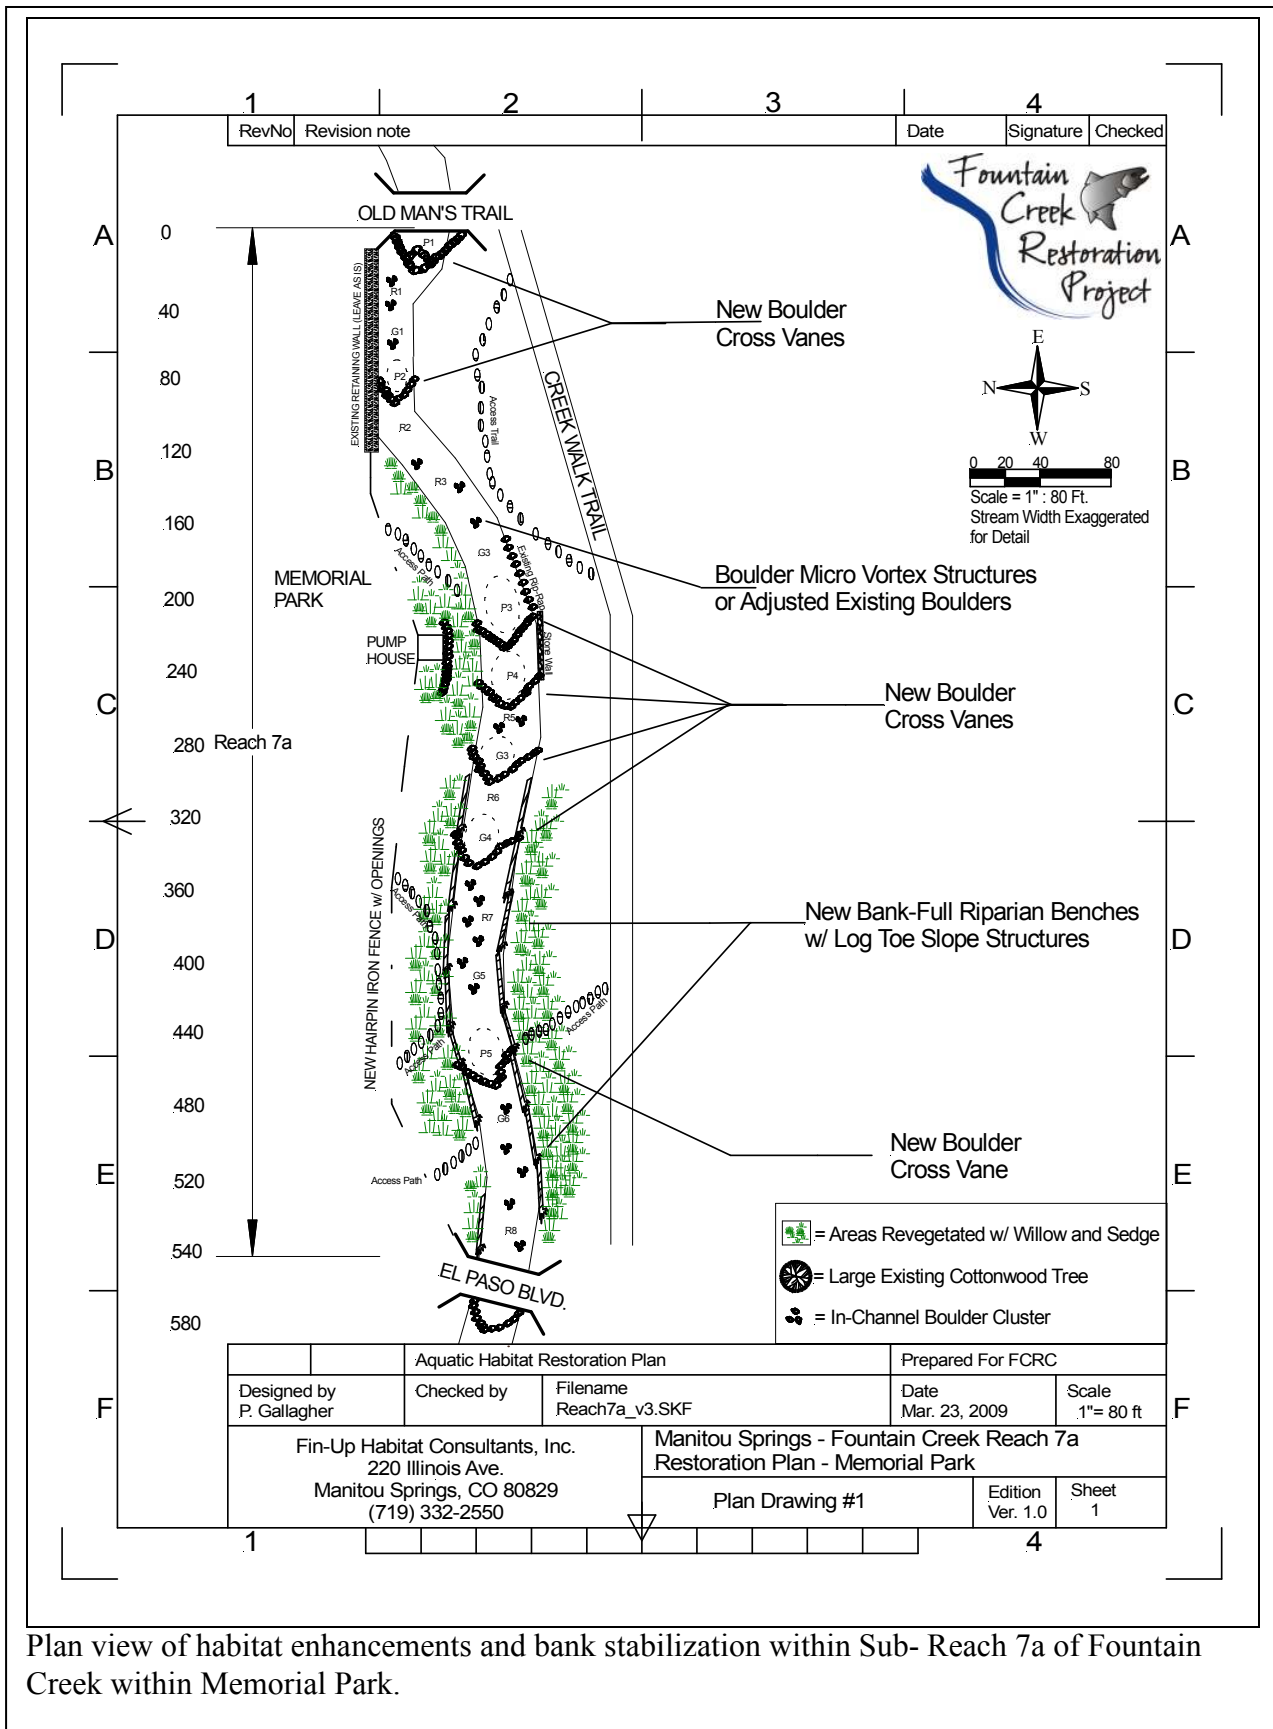
Plan view of habitat enhancements and bank stabilization within Sub- Reach 7a of Fountain Creek within Memorial Park.

Upstream of the pump-house, the stream begins to exhibit excessive over-widening, due to sedimentation, bank damage from heavy recreational use, and the construction of an un-authorized dam perpendicular to the direction of flow that has resulted in bank failure and lateral migration of the channel. This hand constructed dam will be removed from the channel, and a large boulder cross-vane will be installed at Pool 5 to significantly improve the scour and depth of the pool and downstream glide habitat. The stream channel throughout this segment will be narrowed and re-defined using large wood toe-slope structures and bank-full riparian benches on both sides of the stream to reduce the width/depth ratio of the channel and improve sediment transport within the segment. The target bank-full width of the new channel will be 22 feet. Additional sinuosity will be built into this segment by building a slight meander into the newly defined channel. A total of 300 feet of these treatments will be necessary, split approximately evenly on each side of the channel. Narrowing the channel and improving sediment transport through this segment will allow us to increase and improve pocket water habitats within the riffles by adjusting the elevations and facet slopes of existing boulders in the riffles, and by adding additional boulder micro-vortex structures in appropriate locations throughout these riffle habitats. Up to twelve of these features may be added to Riffles 7 & 8.

Stream banks in this segment exhibit the same instability and lack of vegetation as the banks in Soda Springs Park (Reach 11), and similar treatments will be used to restore and revegetate the banks. In addition to the log/boulder toe-slope treatments to narrow and define the meander in this segment, several low stone walls/terraces will be constructed to alter and vary the slope of the bare banks leading to the stream and allow for re-vegetation with native riparian and upland plant species. All stream bank re-vegetation treatments will be coordinated with the Rocky Mountain Field Institute.

A boulder cross-vane will be installed at the downstream boundary of the reach, enhancing the existing pool under the bridge at Old Man Trail. This cross vane will also provide enhanced vertical stability in the stream channel at this point, as well as protect the foundations of the historic stone bridge. Pocket water cover will be increased within Riffle 1 and Glide 1, using small rock cluster vortex structures. Pool 2 will be enhanced and expanded downstream into Glide 1 by constructing a boulder cross-vane near the top of this habitat, improving scour through the feature. Pocket water cover is currently adequate in Riffle 2, and will be increased in Riffle 3 by adjusting existing boulders in the riffle to provide better scour pockets downstream of these features. A cross-vane will be installed at Pool 3 to improve depth and extend the length of this habitat, and to reduce shear on the historic stone wall on the left side of the stream immediately upstream of this structure. Another cross-vane will be installed upstream at Pool 4 to further enhance this pool, as well as protect the pump-house perforated pipe buried on the right bank of the stream. This pipe is used to draw water from the stream for the purposes of irrigation of the park facilities, and currently requires continual maintenance due to being plugged up by fine sediment. A cross-vane will also be installed at the upstream limit of Glide 4, to covert this habitat to a functioning pool.

the left bank of Pool 3 will be re-aligned in order to provide velocity shelter for trout as well as bank armoring and protection from shear. The existing creek access trail on the left bank will be repaired, with stone steps leading down to Pool 3. Additionally, a new stone stairway will be constructed on the right bank leading to the stream, immediately downstream of the pump house.

At least one access path will be constructed from the Creek Walk trail on the south side of the stream down to the vicinity of Pool 5. Additionally, two access paths will be constructed on the north side of the stream to allow Memorial Park users to access the creek in this area. The areas immediately adjacent to the access paths will be strategically re-vegetated using woody plants that will discourage wandering off of these designed routes. To protect the stream bank restoration efforts, we strongly recommend the installation of a permanent iron hair-pin fence, with openings at each of the designated access paths, similar to the fence installed in Soda Springs Park as part of the stream restoration project in 2008. The Memorial Park fence would extend 450 feet along the north side of the creek, from the retaining wall at Riffle 2 upstream to the stone bridge at El Paso Boulevard.

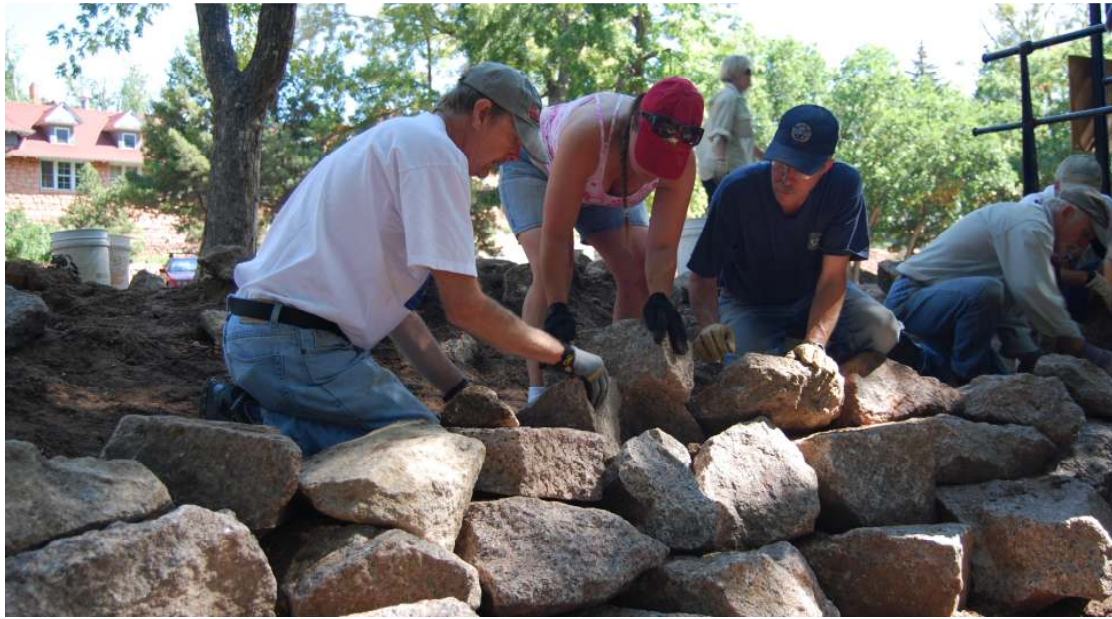
Photo 12: Volunteers constructing terrace walls for revegetation of stream banks. Similar techniques will be used in Sub Reach 7a to stabilize stream banks.

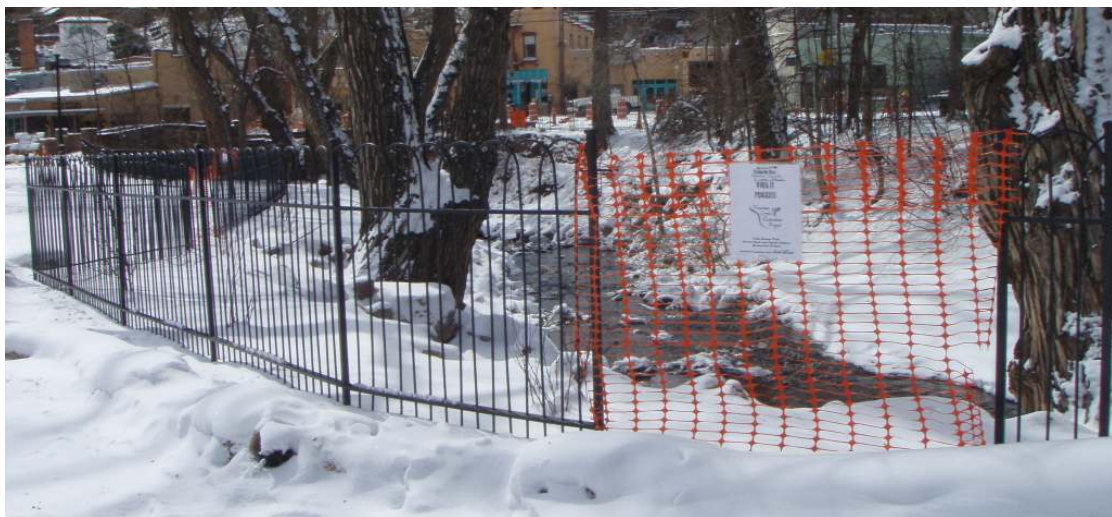
Photo 13: Iron hair-pin fence w/ path openings in Soda Springs Park (Reach 11)

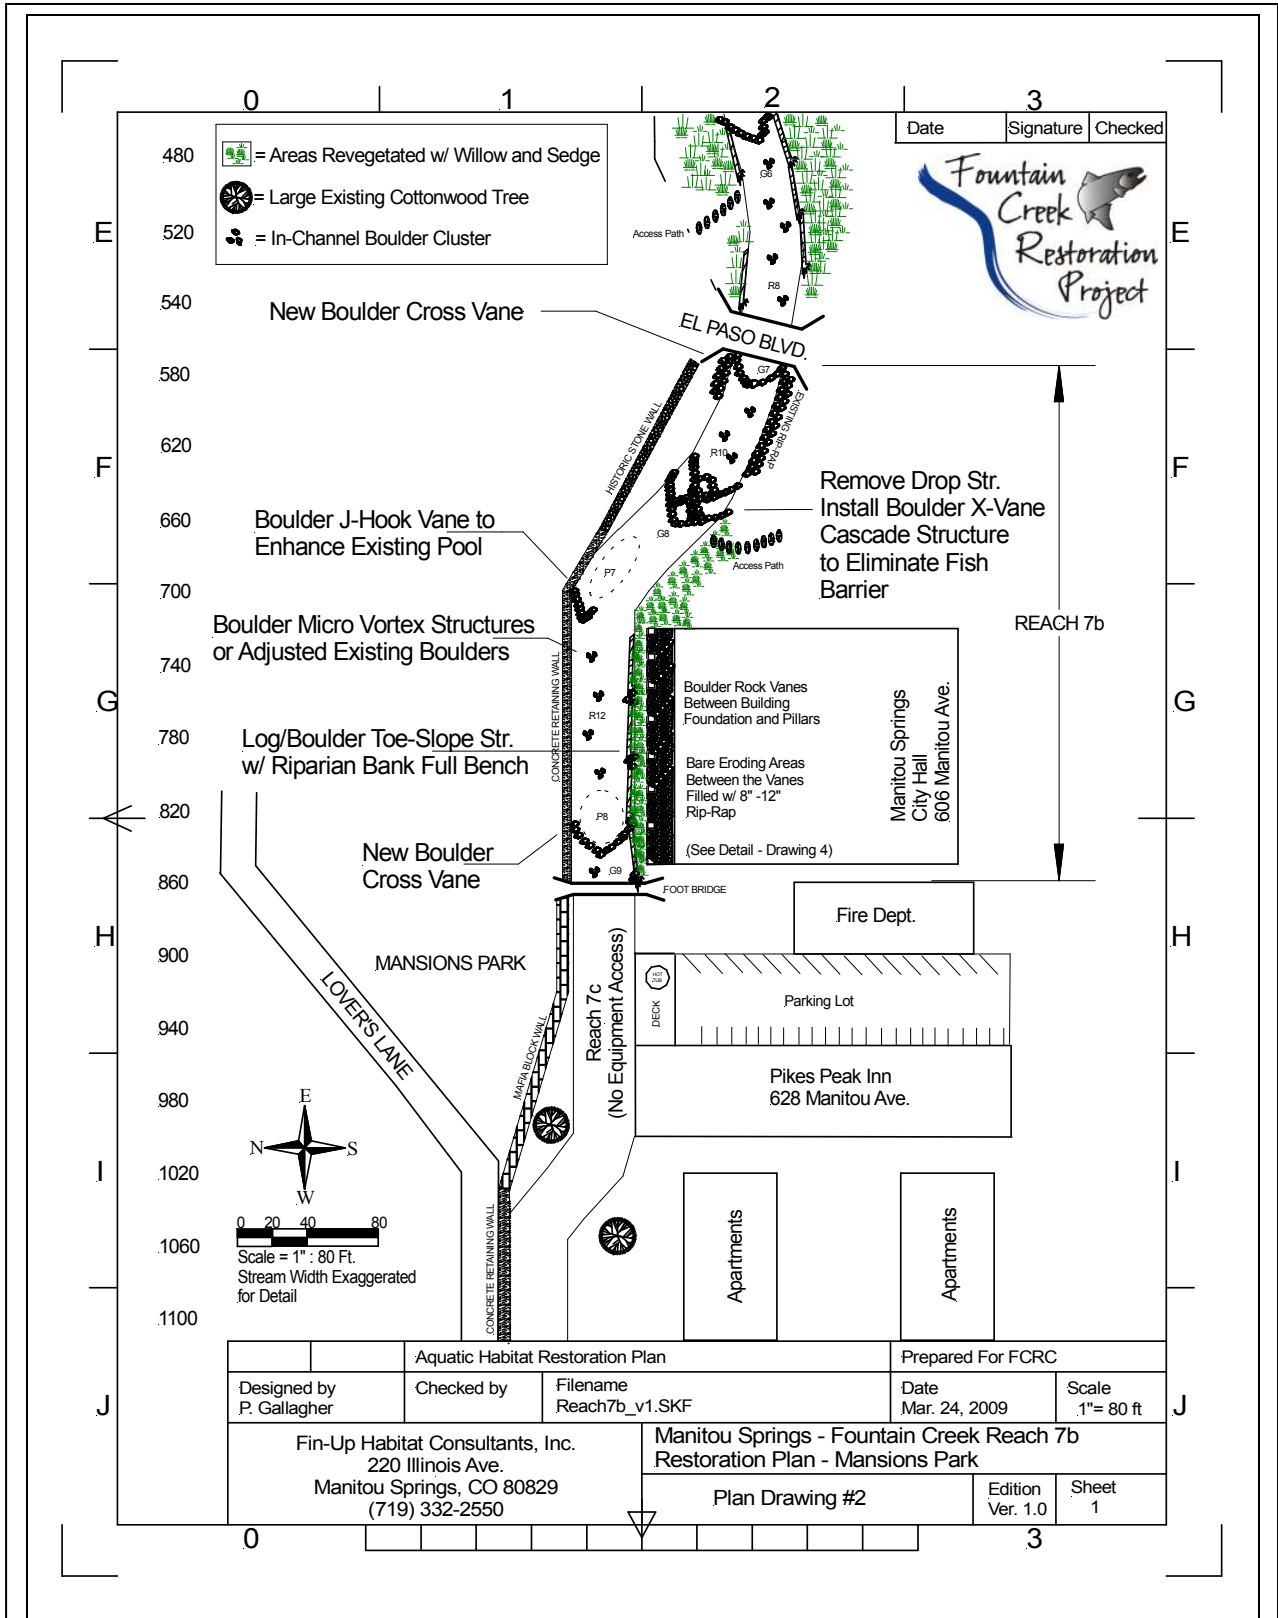
Plan view of habitat enhancements and bank stabilization within Sub- Reach 7b of Fountain Creek within Mansions Park.

Riffle 12, Pool 8, and Glide 9 are confined by a concrete retaining wall on the north bank, and by the foundation walls of Manitou Springs City Hall on the south. The City Hall building overhangs the creek by 10 feet throughout this segment (see Cross-Section 5). Periodic high flows have begun to undermine a significant section of the building foundation on the north east corner of the building, and if not quickly addressed, could result in undesirable structural changes to the building. A thin line of riparian alder and

A boulder cross-vane will be installed immediately upstream of the stone bridge at El Paso Boulevard. This cross vane will provide vertical stability in the stream channel and provide some protection the foundations of the historic stone bridge, while providing some additional pool habitat and fish viewing opportunities from the bridge. Pocket water cover will be increased within Riffle 9 & 10 by adjusting the elevation and aspect of existing boulders in these habitats. The center of the concrete “mafia block” drop structure and barrier at Riffle 11 will be removed, and replaced by a series of two boulder cross-vanes extending upstream into Glide 8 to create a step-pool cascade connecting the channel elevations between Pool 6 and Pool 7. The sections of the concrete drop structure that are embedded into the stream banks will be left in place, to provide bank stability at this point, but will be covered with top-soil and re-vegetated to camouflage these features. Pool 7 will be enhanced and expanded by constructing a boulder J-Hook vane near the top of this habitat, improving scour through the feature. A single access path, leading from the City Hall visitors parking area to Pool 7 will be constructed by volunteer crews.

willow has become established between the creek and the edge of the building, and we would like to further enhance this protective feature by installing log/boulder toe slope structures and riparian bank full benches along the entire south stream bank adjacent to the building. Behind these bank full bench features, boulder vanes may be installed underneath the building, extending at an angle of no greater than 30 degrees, from the foundation wall upstream to the concrete columns supporting the outer edge of the building. The spaces between these vanes could then be filled with smaller 8" – 12" rip-rap by the volunteer hand crews organized by the Rocky Mountain Field Institute.

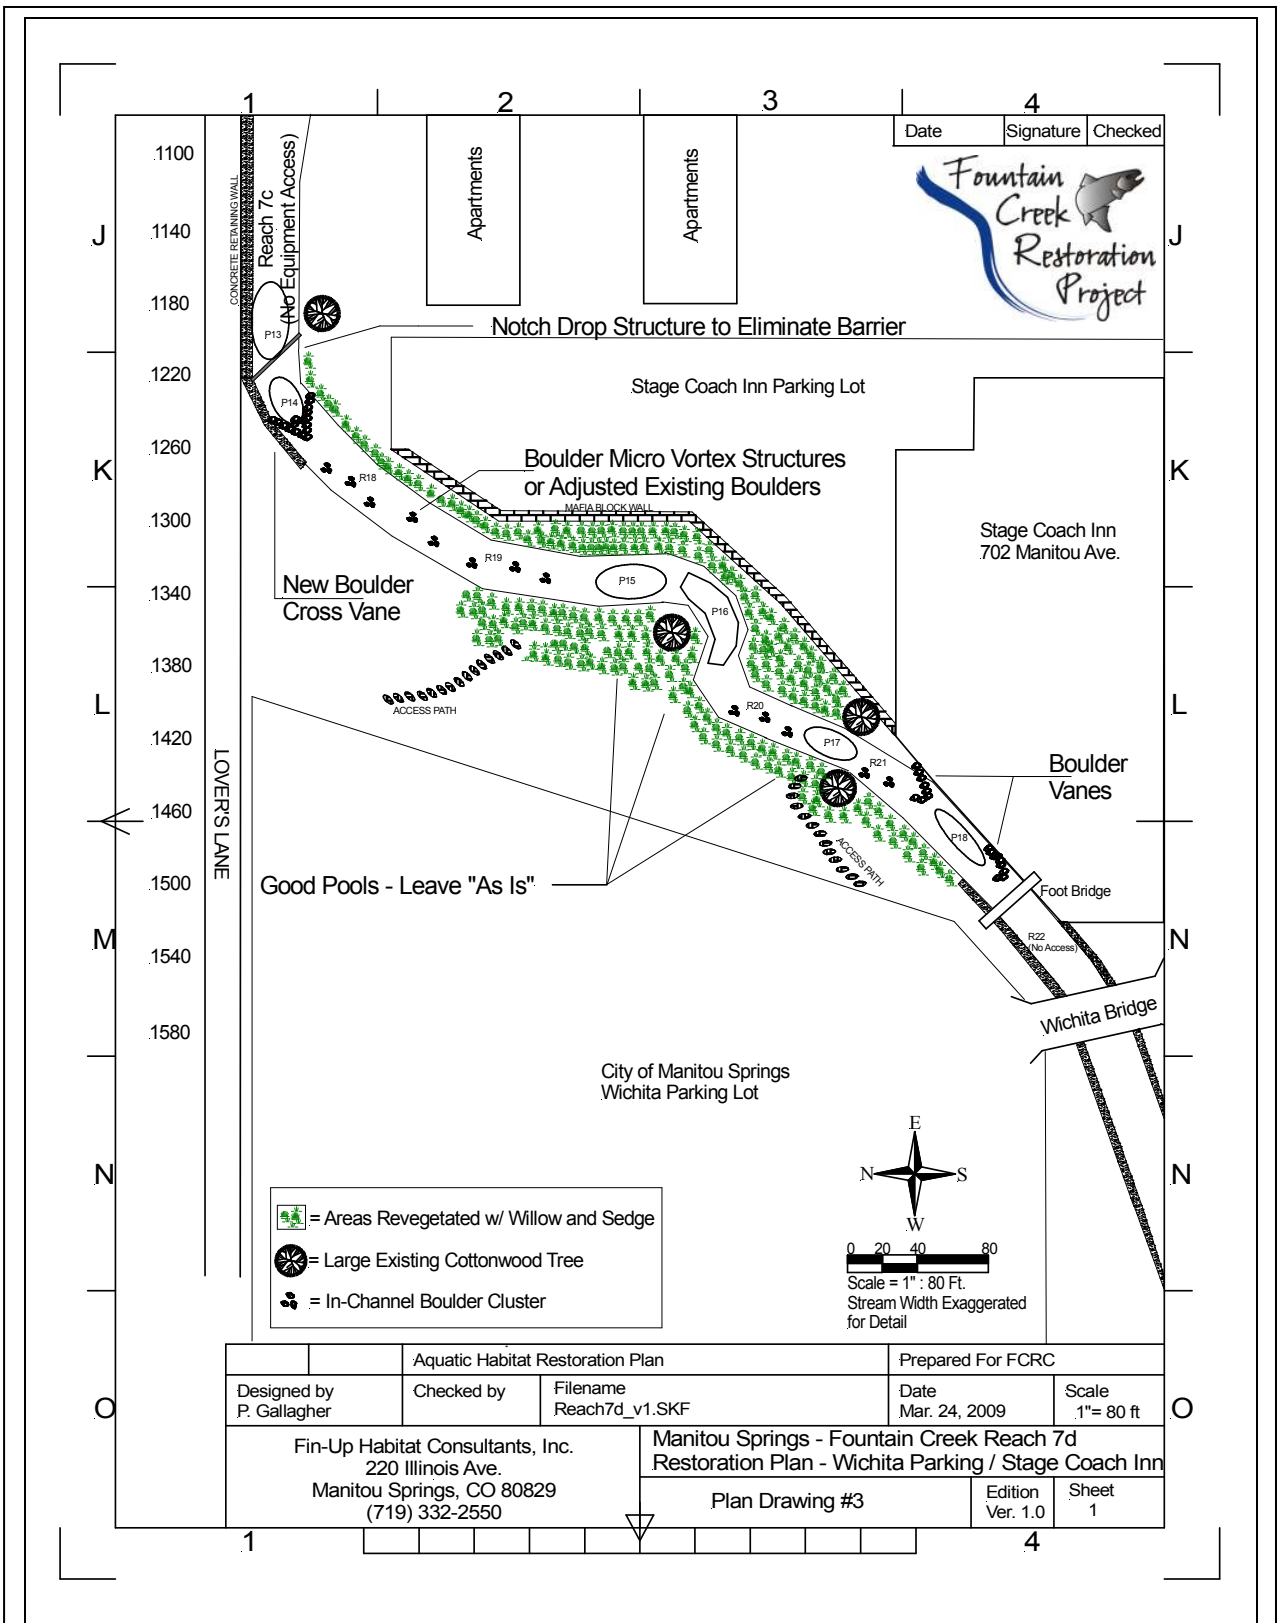
Plan view of habitat enhancements and bank stabilization within Sub- Reach 7d of Fountain Creek within Mansions Park.

While the stream banks are mostly in relatively good condition in this segment, bare and eroded areas adjacent to the right stream bank, below the Wichita Parking Area, will be re-vegetated by RMFI work crews using transplanted sedge along the stream green-line, and native upland grasses and forbs on the slopes leading up to the parking area. Up to two access paths to the stream, with stone steps, will be constructed to allow public access to the stream along this segment.

Pocket water cover in Riffles 19, 20 and 21 will be increased and enhanced using the same techniques employed downstream; adjusting existing boulders as necessary and installing up to ten boulder micro-vortex structures. Two boulder rock vanes will be installed along the foundation wall of the Stage Coach Inn, where a lateral scour pool has begun to form immediately adjacent to the foundation footings. These boulder vanes will reduce shear forces along the foundation wall during high flows, as well as provide velocity shelter and fish viewing opportunities for guests dining on the deck of the restaurant immediately above this pool.

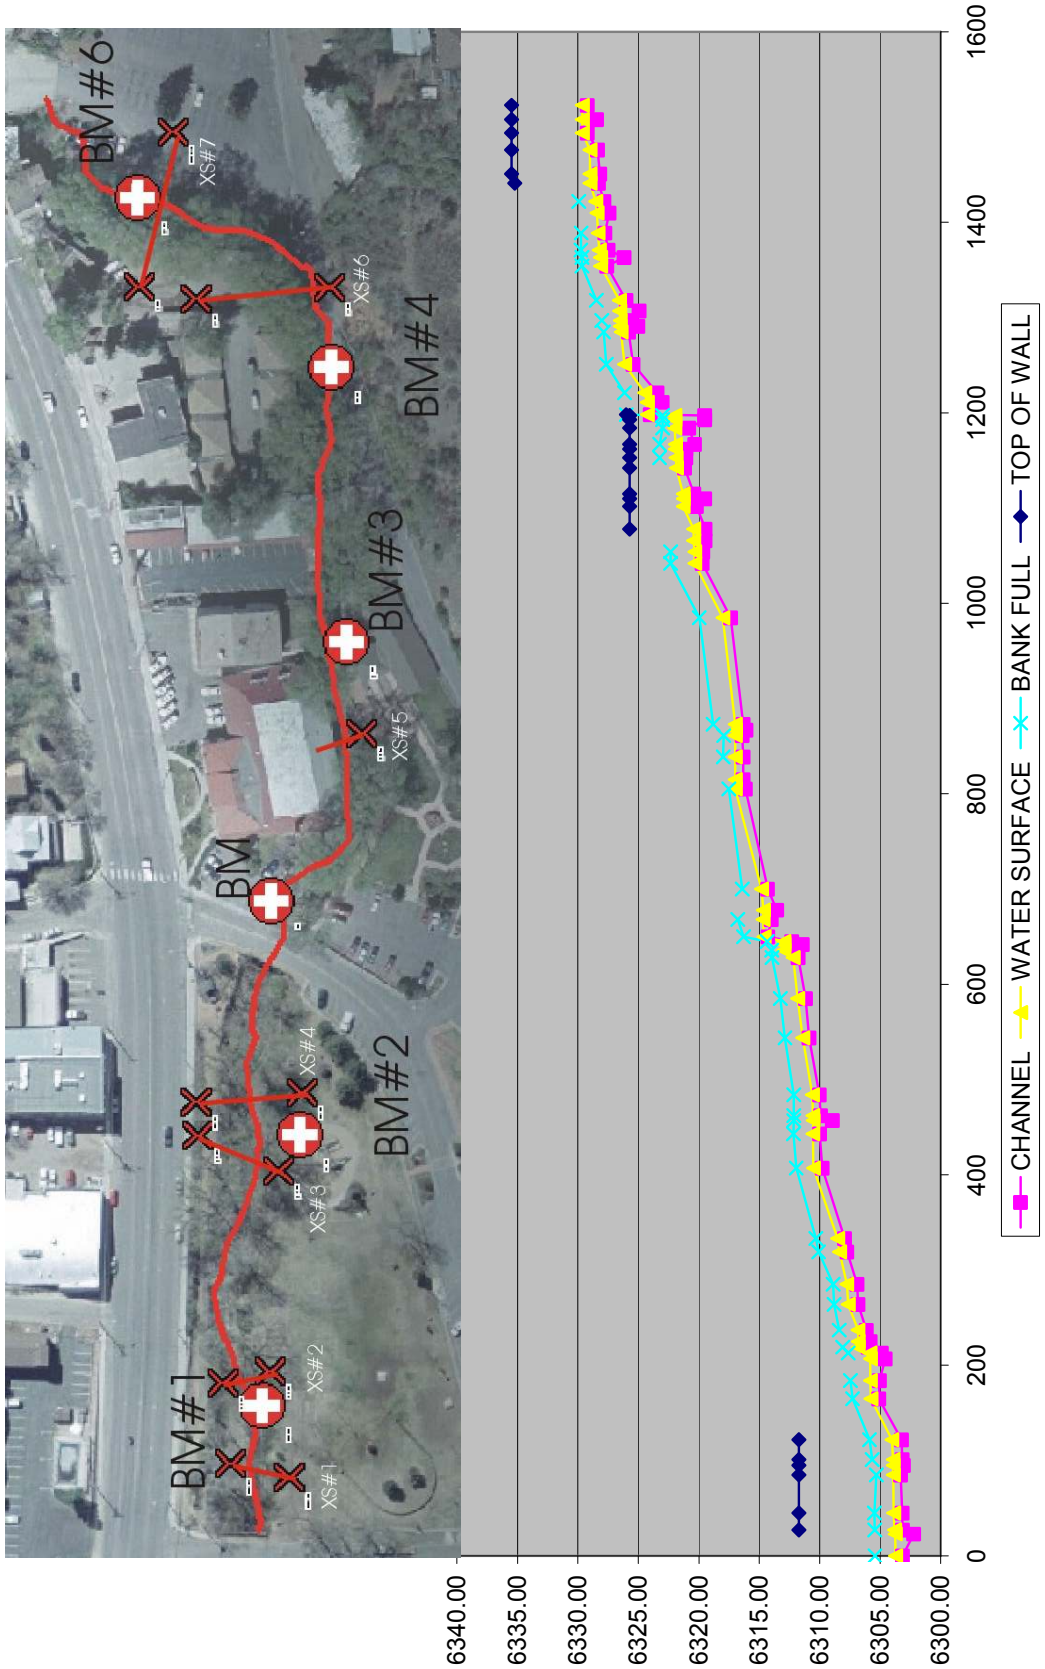
Longitudinal Profile of Reach 7

Longitudinal Profile of Fountain Creek Reach 7, including Cross Section Locations and Benchmarks - Memorial and Mansions Park in Manitou Springs, CO.

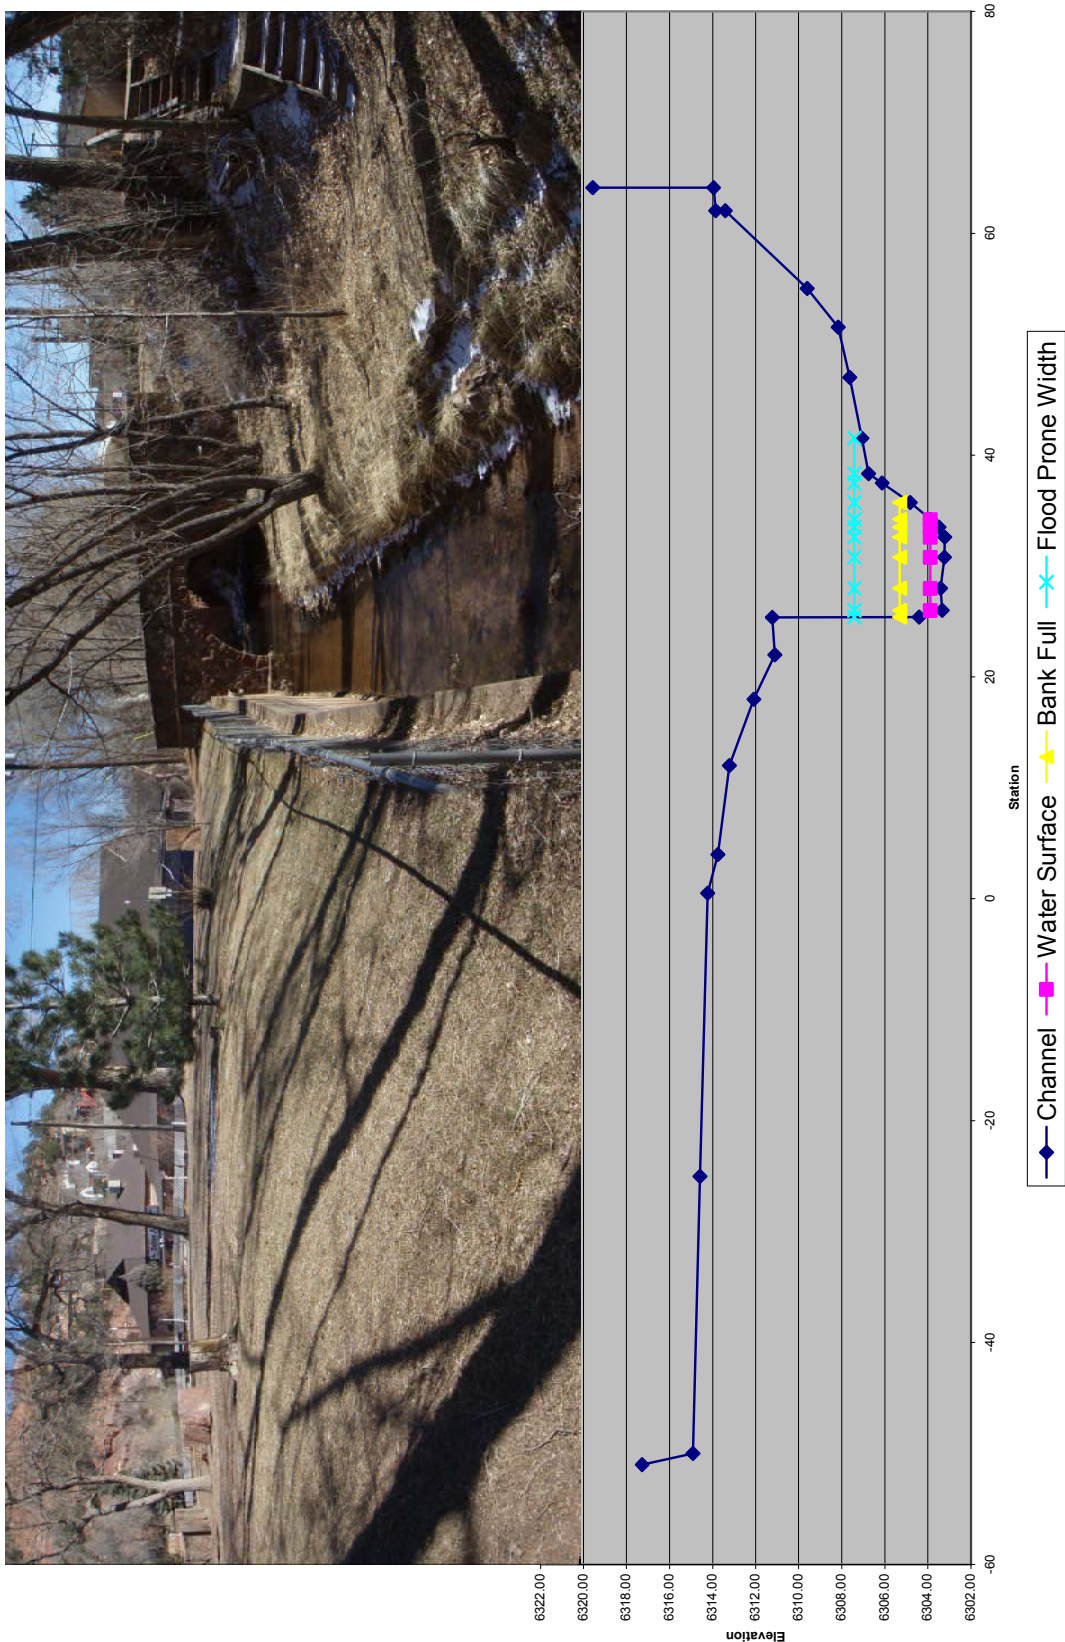
Fountain Creek Reach 7 - Cross Section #1

Cross-Section #1 on Reach 7 on Fountain Creek. The cross section is located at 0+85 ft on the Longitudinal Profile of the Reach, and transects Glide #1.

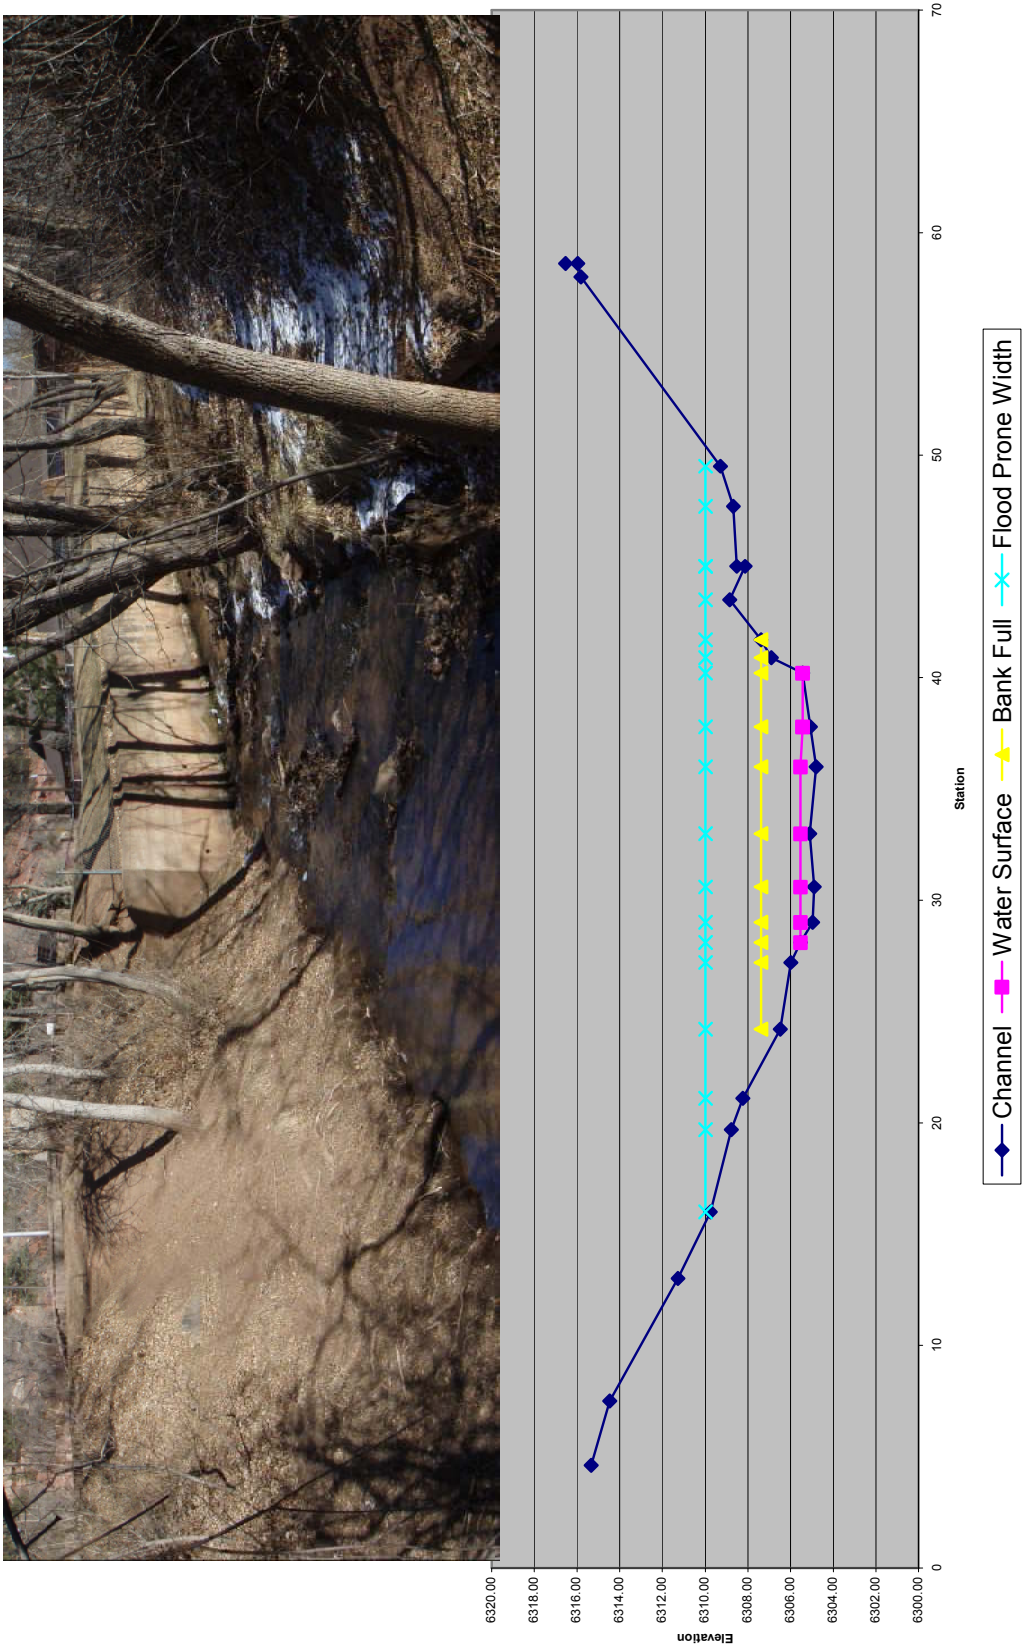
Fountain Creek Reach 7 - Cross Section #2

Cross-Section #2 on Reach 7 on Fountain Creek. The cross section is located at 0+165 ft on the Longitudinal Profile of the Reach, and transects Riffle #3.

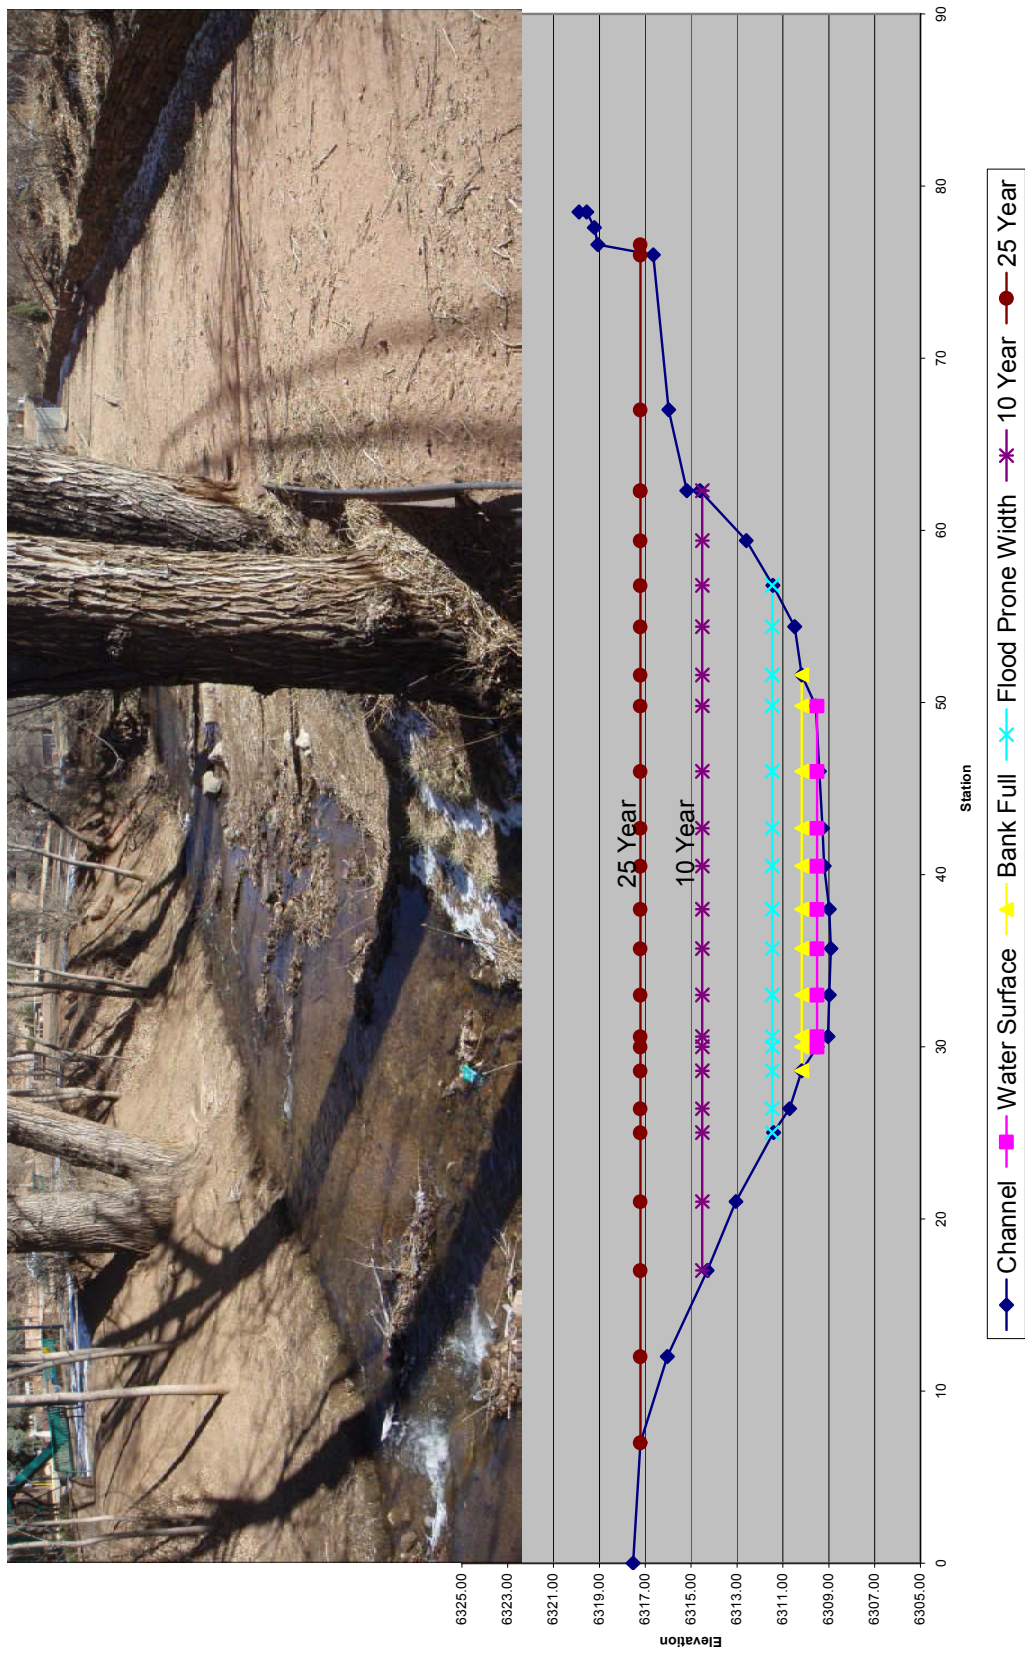
Fountain Creek Reach 7 - Cross Section #3

Cross-Section #3 on Reach 7 on Fountain Creek. The cross section is located at 0+382 ft on the Longitudinal Profile of the Reach, and transects Riffle #7. Additional hydraulic modeling to determine channel capacity was performed at this cross-section.

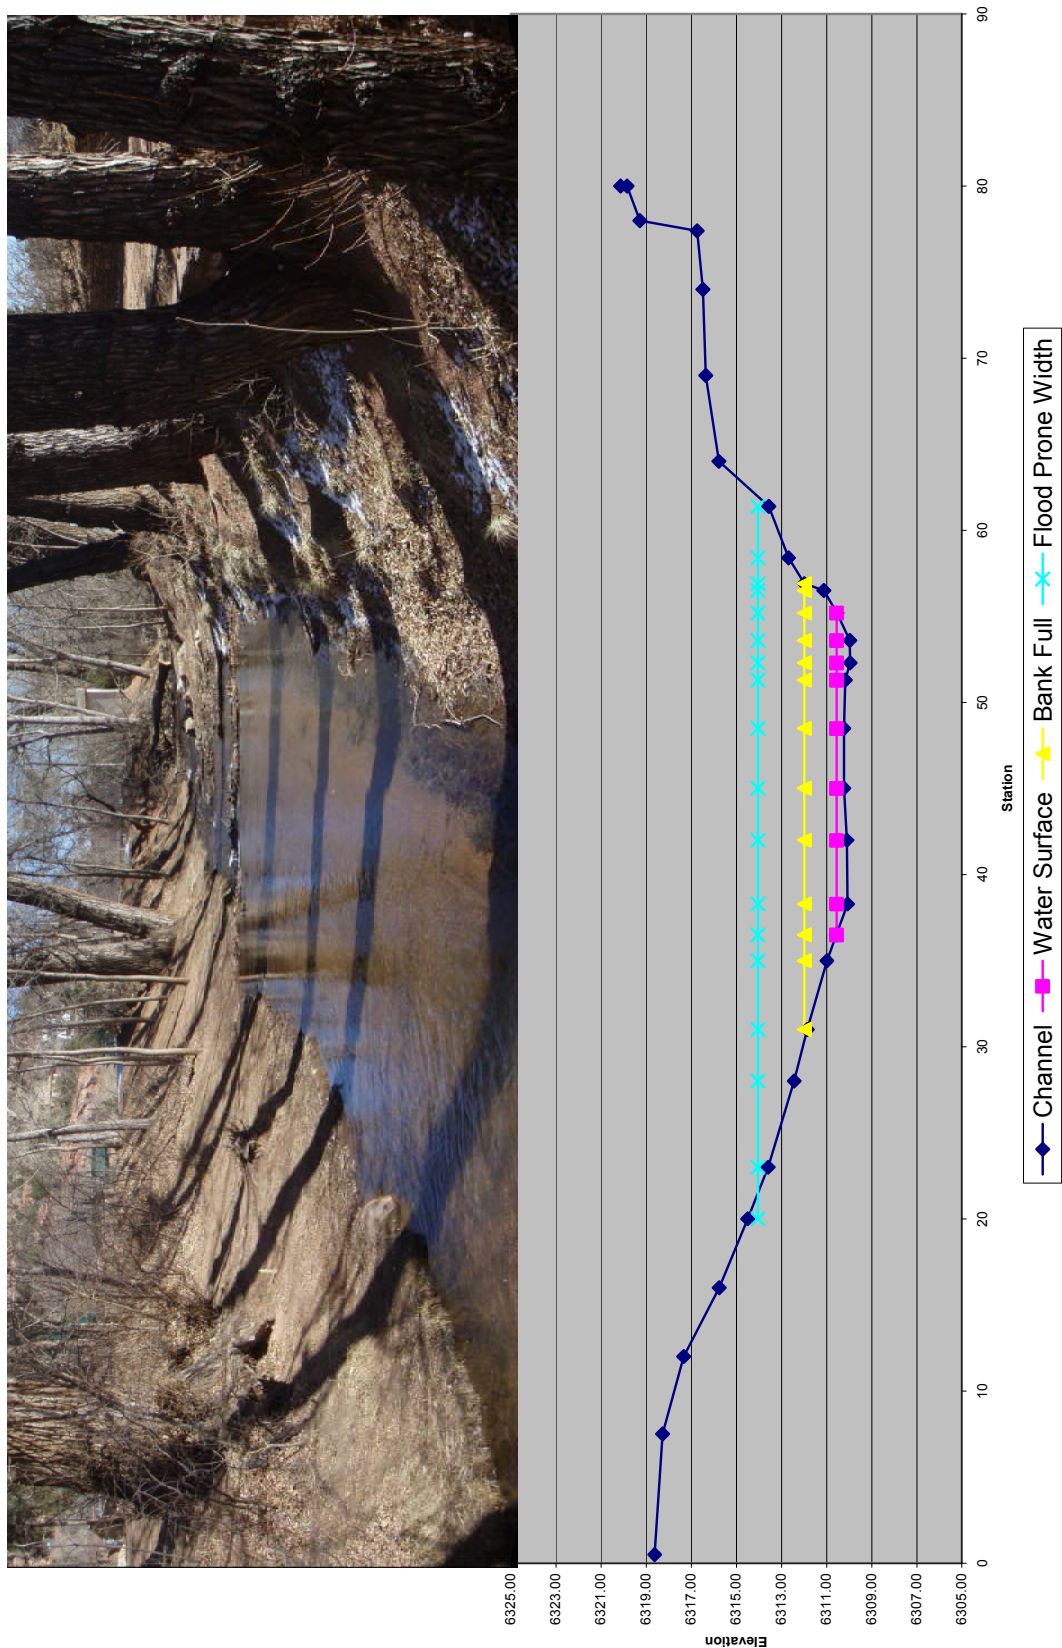
Fountain Creek Reach 7 - Cross Section #4

Cross-Section #4 on Reach 7 on Fountain Creek. The cross section is located at 0+423 ft on the Longitudinal Profile of the Reach, and transects Glide #5.

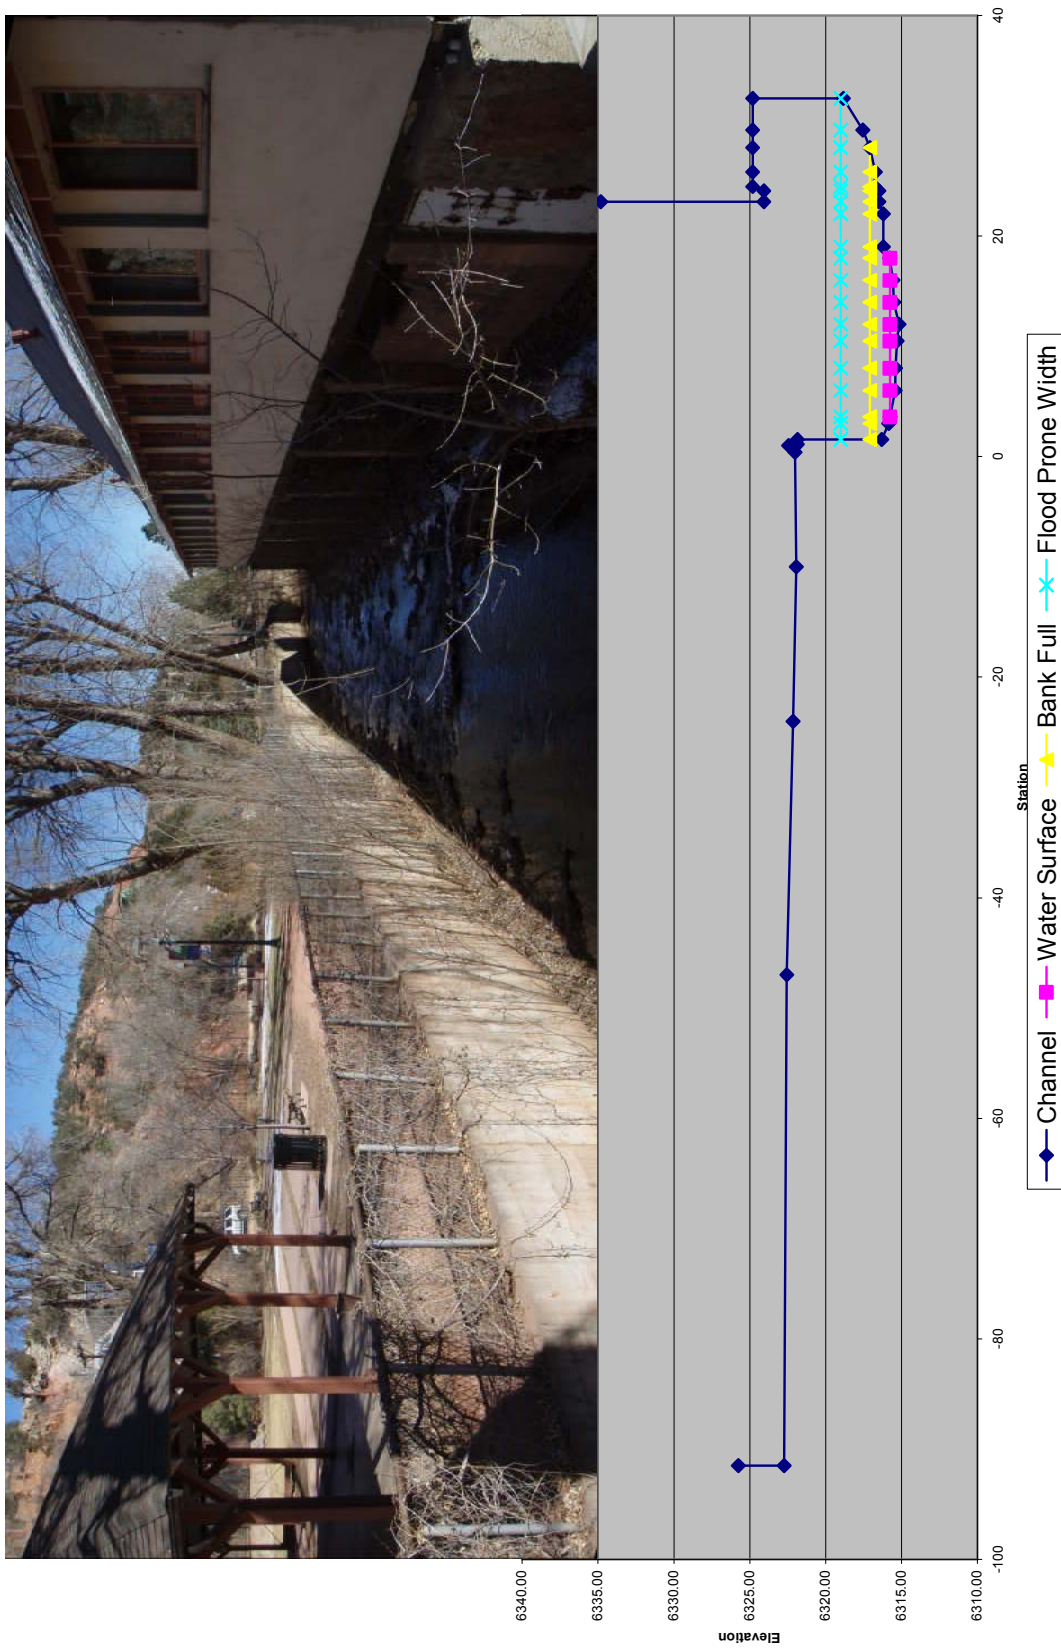
Fountain Creek Reach 7 - Cross Section #5

Cross-Section #5 on Reach 7 on Fountain Creek. The cross section is located at 0+765 ft on the Longitudinal Profile of the Reach, and transects Riffle #12.
