Aquatic Assessment
&
Habitat Enhancement Plan
Fountain Creek - Memorial and Mansions Park
City of Manitou Springs
El Paso County - Colorado

In January 2009, FIN-UP Habitat Consultants, Inc. was contracted by the City of Manitou Springs to conduct an aquatic habitat analysis and habitat enhancement strategy for a segment of Fountain Creek within Memorial and Mansions Park, in the center of the city. The stream within the park is approximately 1,500 feet in length, consisting of a moderately entrenched channel flowing through a cottonwood and alder dominated floodplain in Memorial Park, and a severely confined channel bounded by concrete retaining walls and building foundations through Mansions Park. An aquatic assessment was conducted within the project area during the 1st week of February, 2009, and the results of this study are summarized in this document.

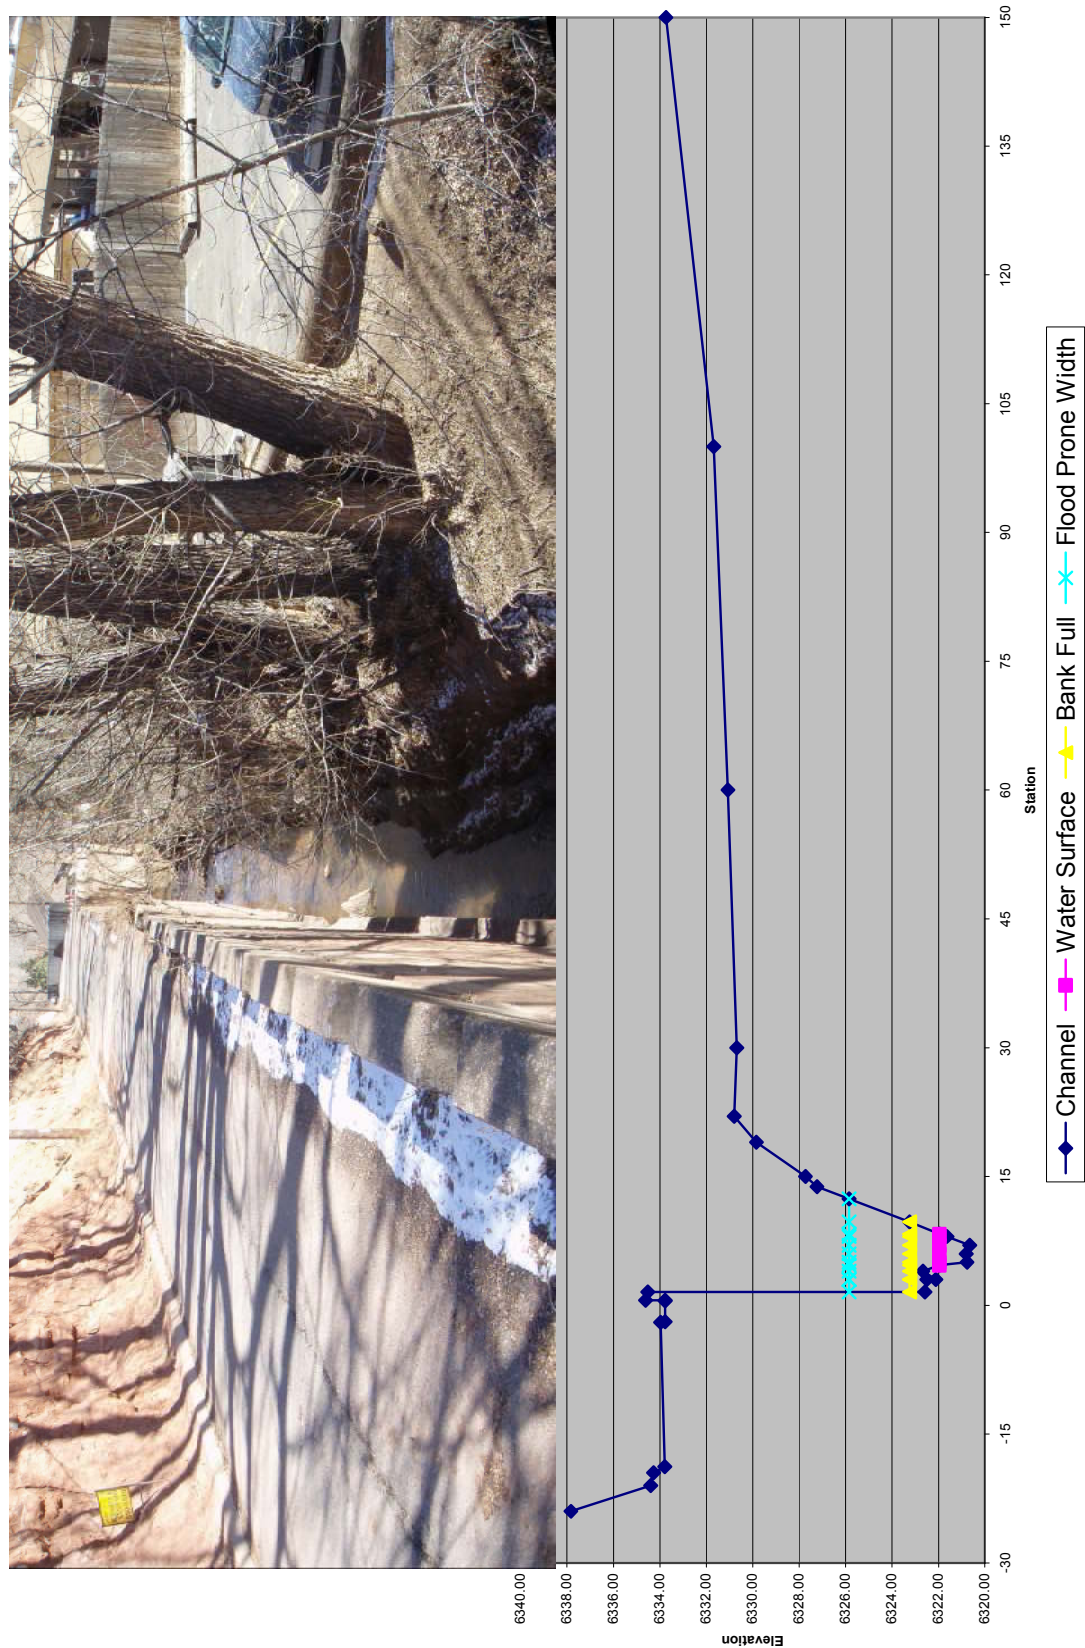
Fountain Creek Reach 7 - Cross Section #6

Cross-Section #6 on Reach 7 on Fountain Creek. The cross section is located at 0+1,164 ft on the Longitudinal Profile of the Reach, and transects Pool #12. This cross-section is located in one of the most confined segments along Fountain Creek in Manitou Springs.

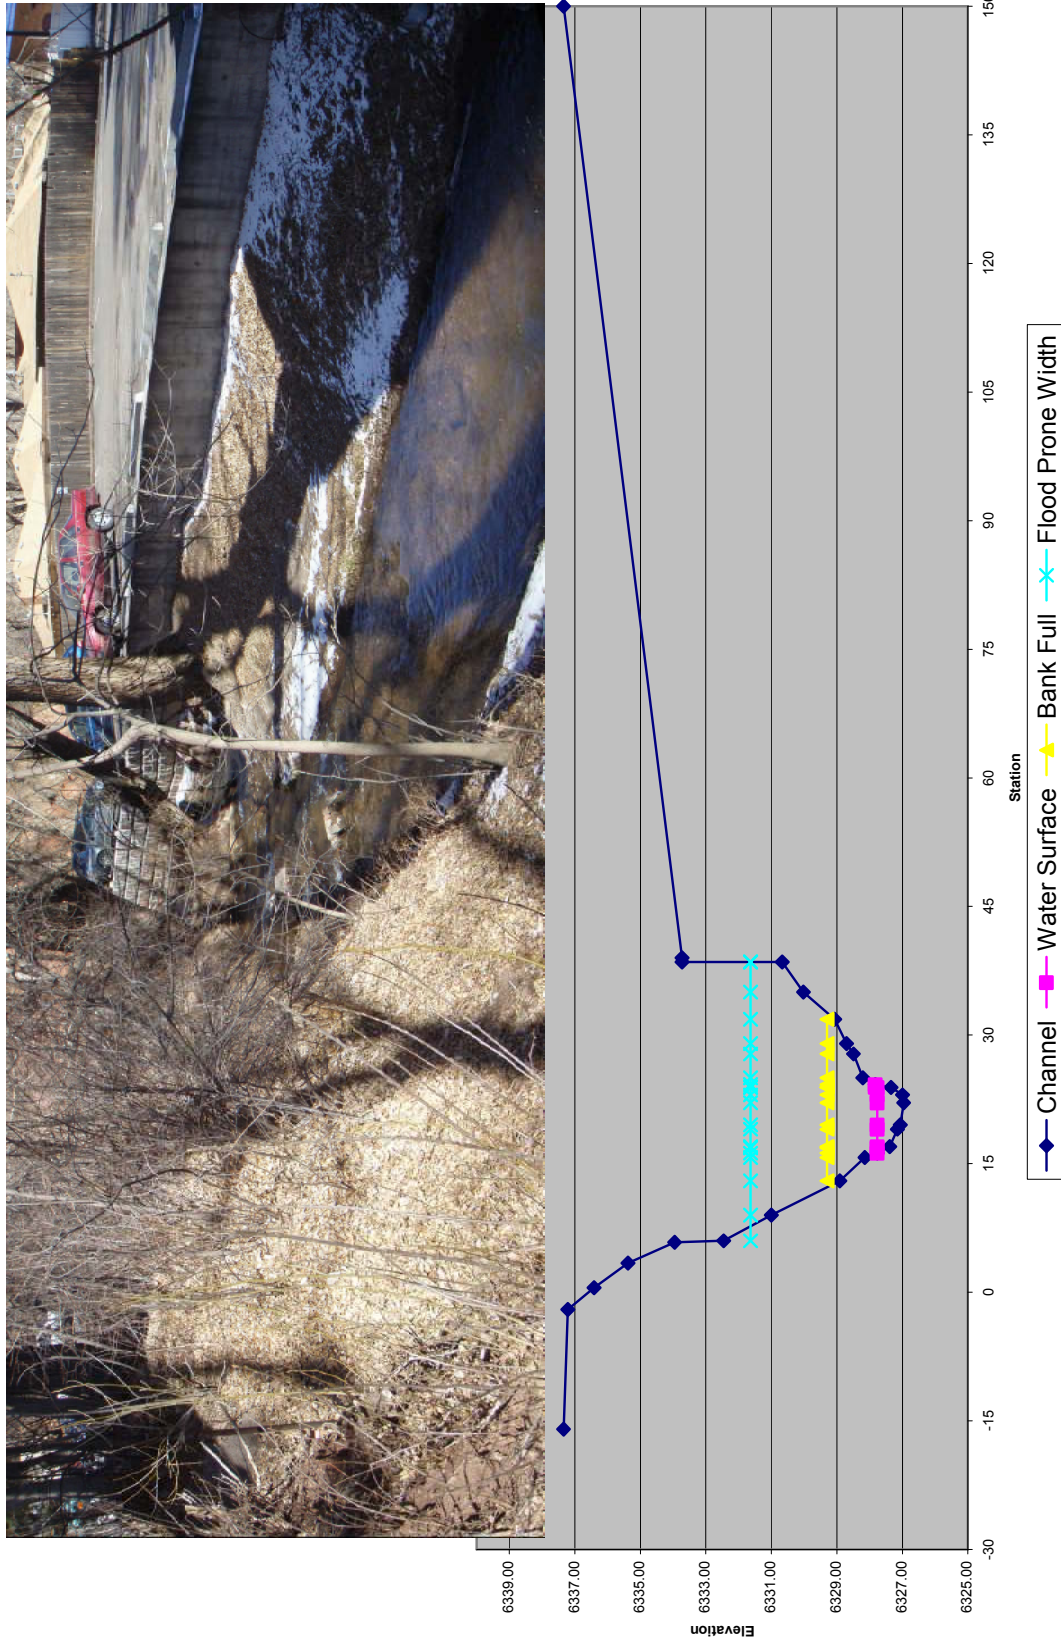
Fountain Creek Reach 7 - Cross Section #7

Cross-Section #7 on Reach 7 on Fountain Creek. The cross section is located at 0+1,344 ft on the Longitudinal Profile of the Reach, and transects Riffle #20.

Pocket water cover in Riffles 19, 20 and 21 will be increased and enhanced using the same techniques employed downstream; adjusting existing boulders as necessary and installing up to ten boulder micro-vortex structures. Two boulder rock vanes will be installed along the foundation wall of the Stage Coach Inn, where a lateral scour pool has begun to form immediately adjacent to the foundation footings. These boulder vanes will reduce shear forces along the foundation wall during high flows, as well as provide velocity shelter and fish viewing opportunities for guests dining on the deck of the restaurant immediately above this pool.
