South Platte River
Sportsman's Paradise – Reaches 20 & 21
River Assessment & Restoration Plan
May 2010

Prepared for the Coalition for the Upper South Platte
&
The Sportsman's Paradise Home Owners Association

**FIN-UP** Habitat Consultants, Inc.

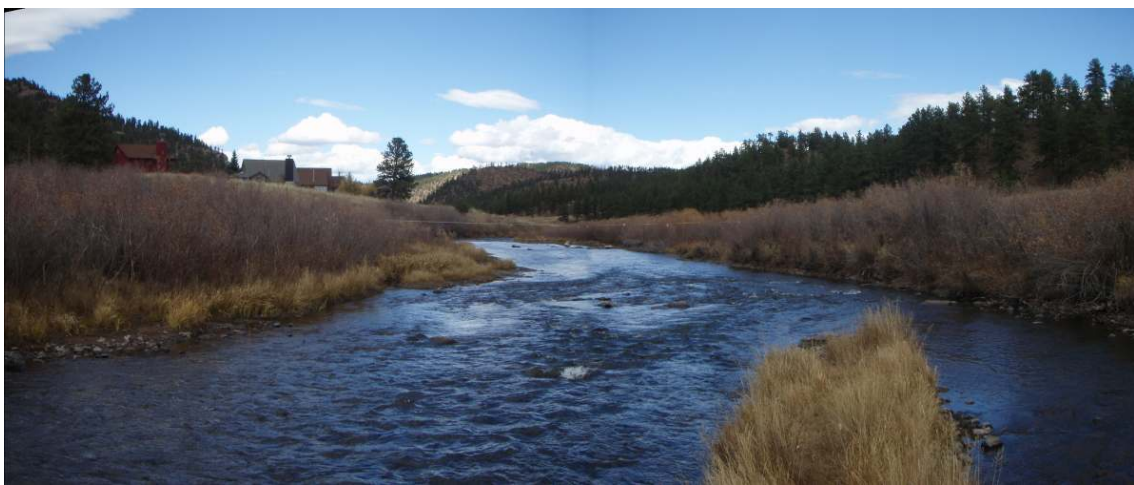
One cross-section exists in this segment. Cross Section #129 is located at 0+2,919 ft along the longitudinal axis of the river reach, transiting the tail-out of Pool #7. The wetted width at the time of the survey was 54.5 feet, and the bank-full width of the channel at this point is 73 ft. The flood prone width of the channel was determined to be 206 ft. Channel entrenchment was 2.8, and the width/depth ratio was calculated to be 33.

Photo 16: Riffle #10, Pool #7, & Cross-Section #129, from the island in Riffle #10.

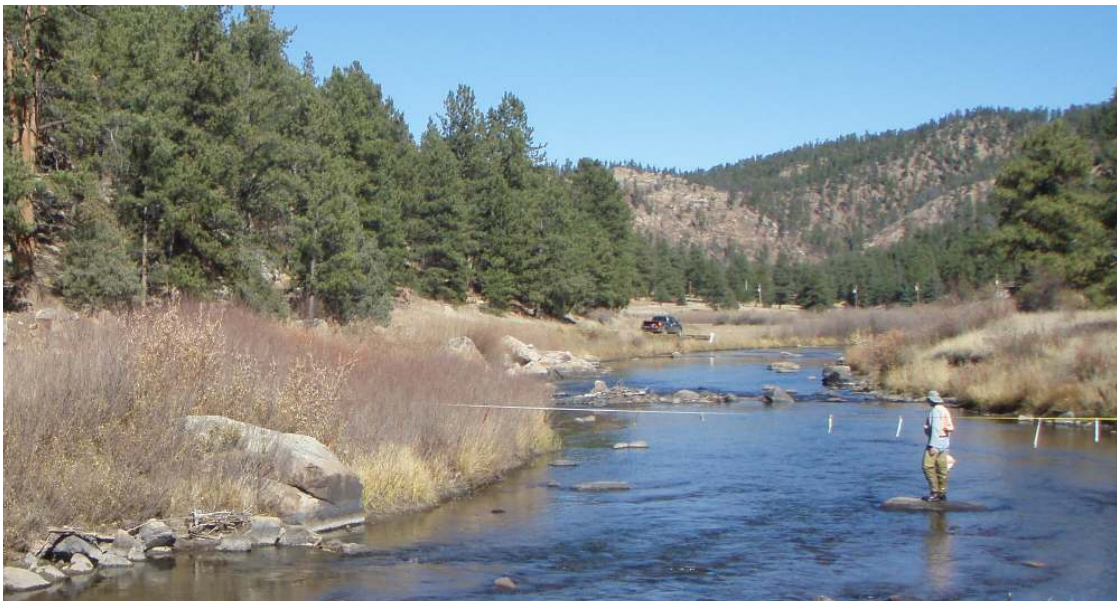
Photo 24: Looking Downstream through Riffle #14 & Pool #19 towards Structure #27. Reach 20.

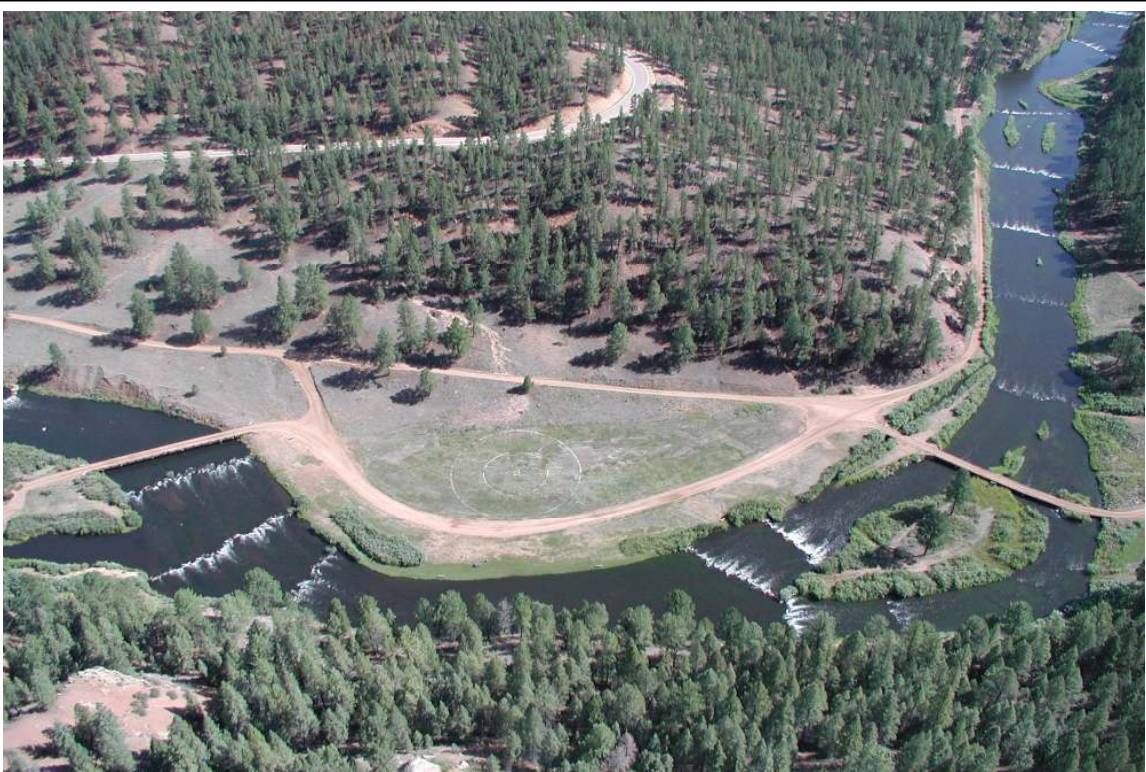
Photo 27: Example of river over-widening due to poorly configured drop structures. Wigwam Club, CO

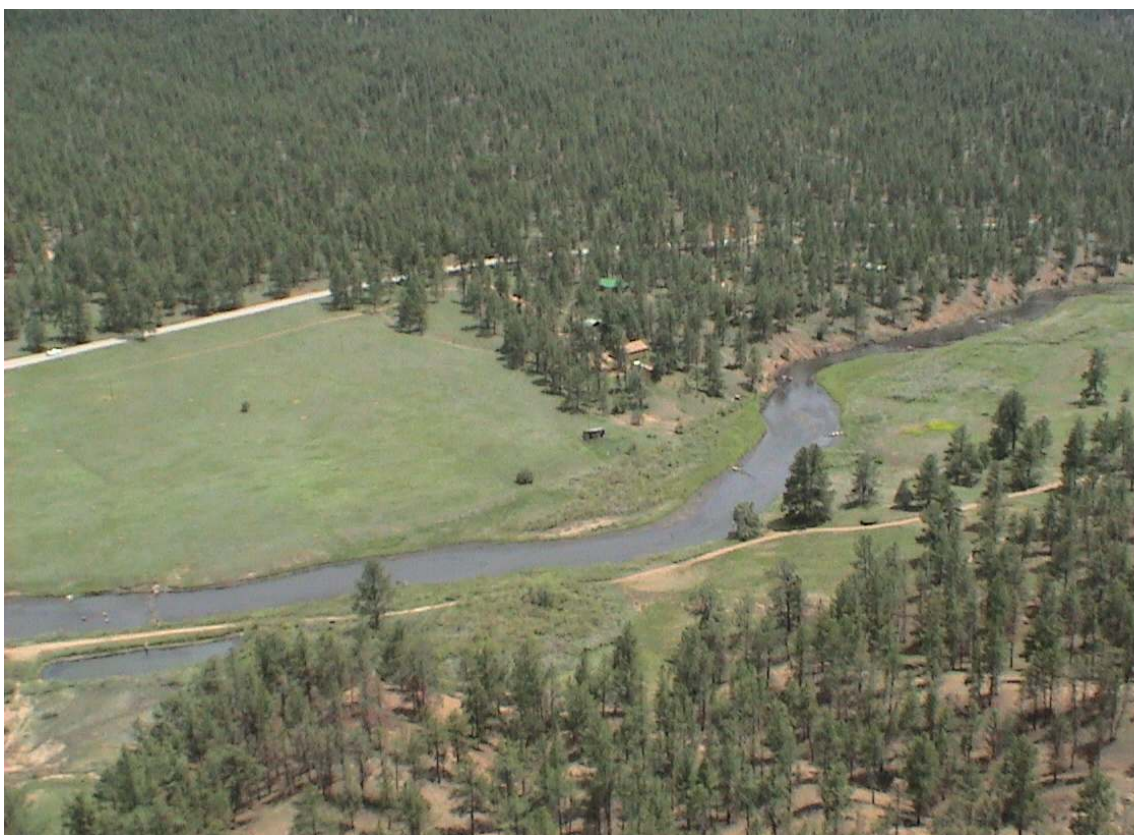
Photo 30: River over-widening due to miss-aligned boulder vanes. Swayback Ranch, CO
