**Project Area, Reach 1 Existing Condition & Restoration Treatment Maps**

**Longitudinal Profile & Cross - Sections - Reach 1**

**Longitudinal Profile  
And Channel Cross-Section Profiles  
Within Reach 1**

# Lake George Reach 1 - Longitudinal Profile

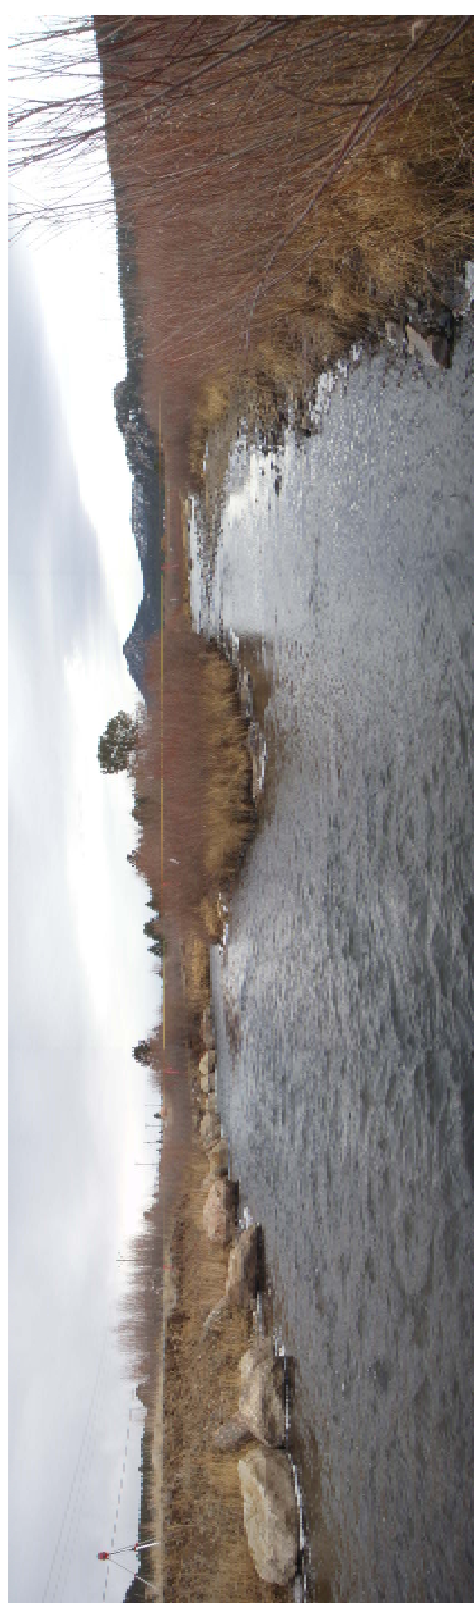
South Platte River - Lake George Reach 1  
X Section #3 @ 450 ft Along the Longitudinal Profile of the Reach

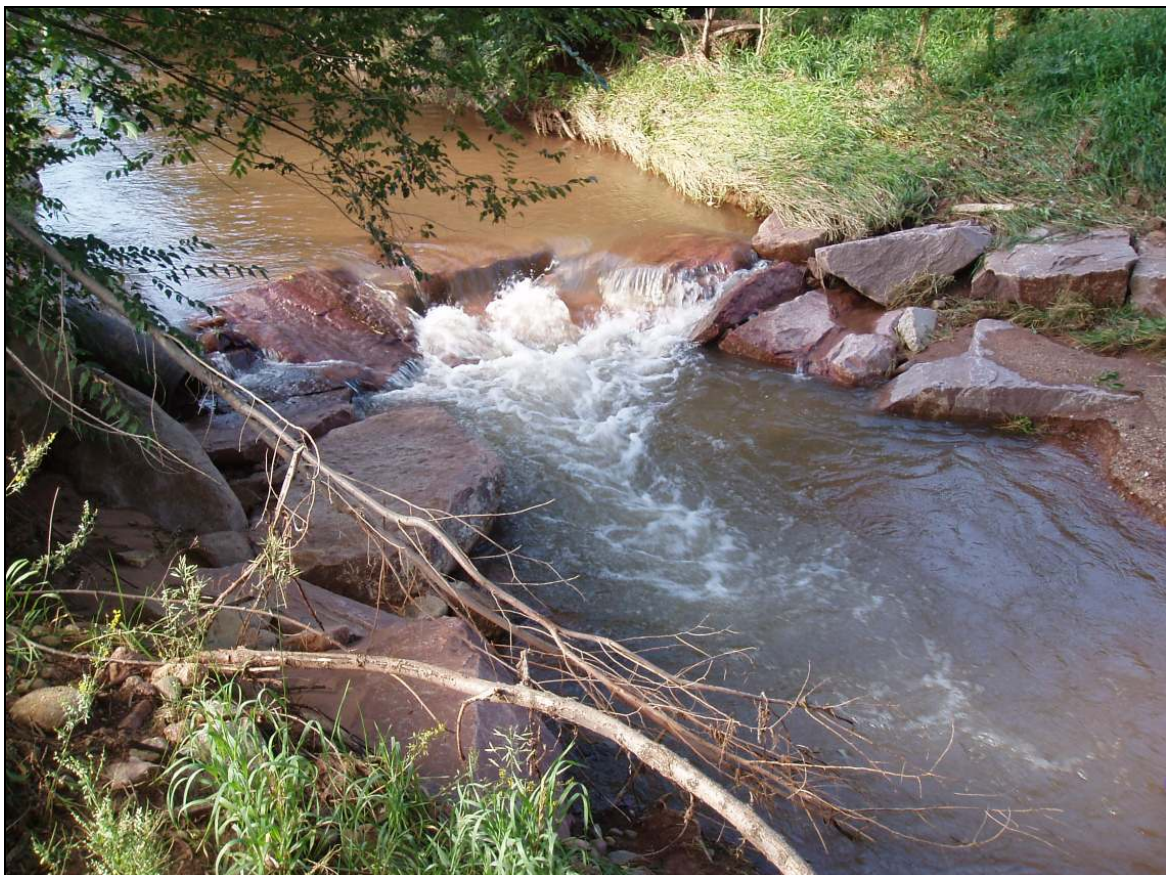
Cross Vane Structure on Fountain Creek below 21<sup>st</sup> Street Bridge, El Paso County, CO.

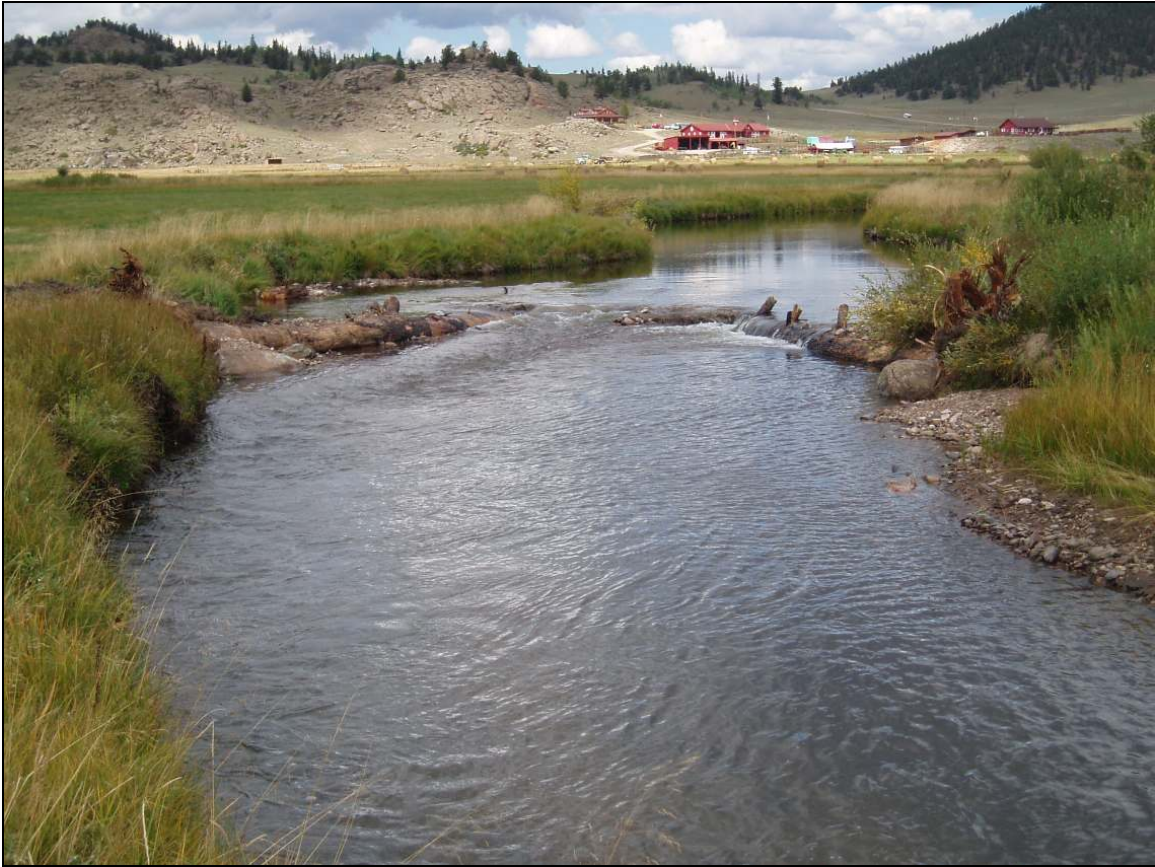
Double Log /Boulder Cross Vane Structure - Eagle Rock Ranch, Tarryall River, Park County, CO

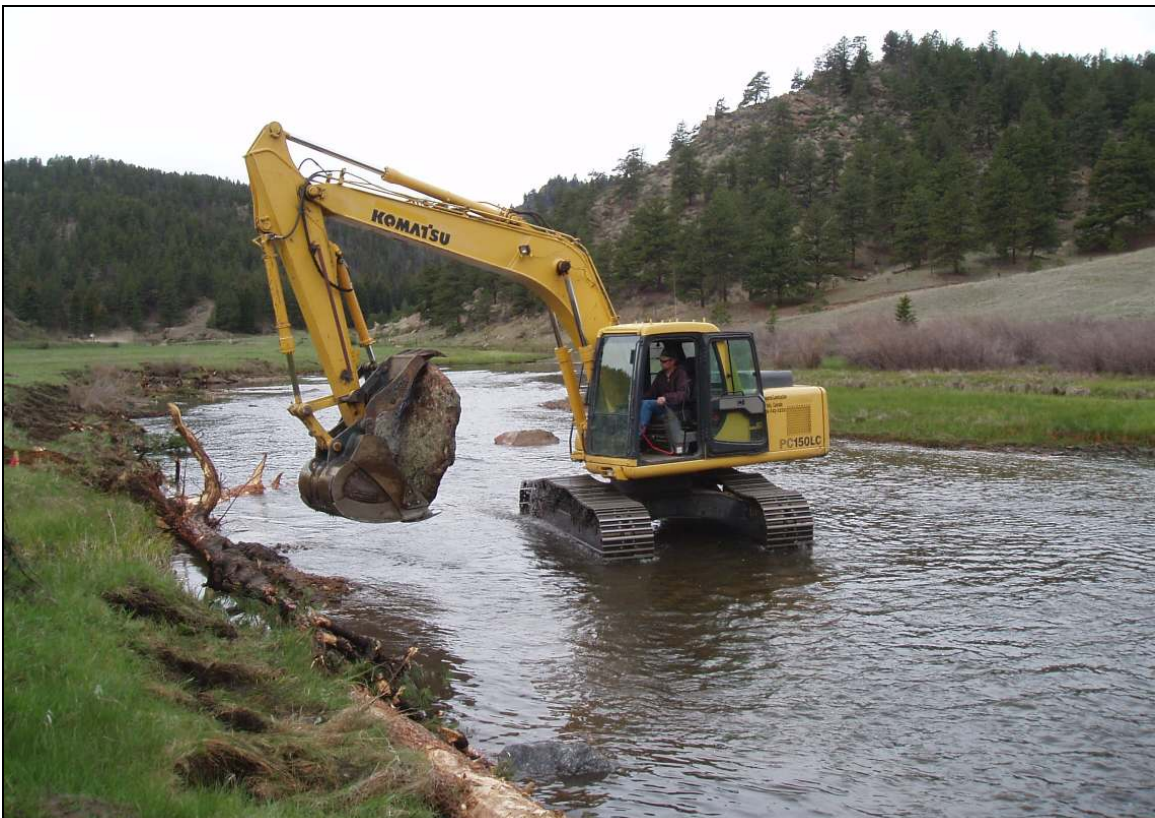
Installing Bank Full Bench & Log Toe Slope Structure - South Platte River, Camp Alexander, Park County, CO

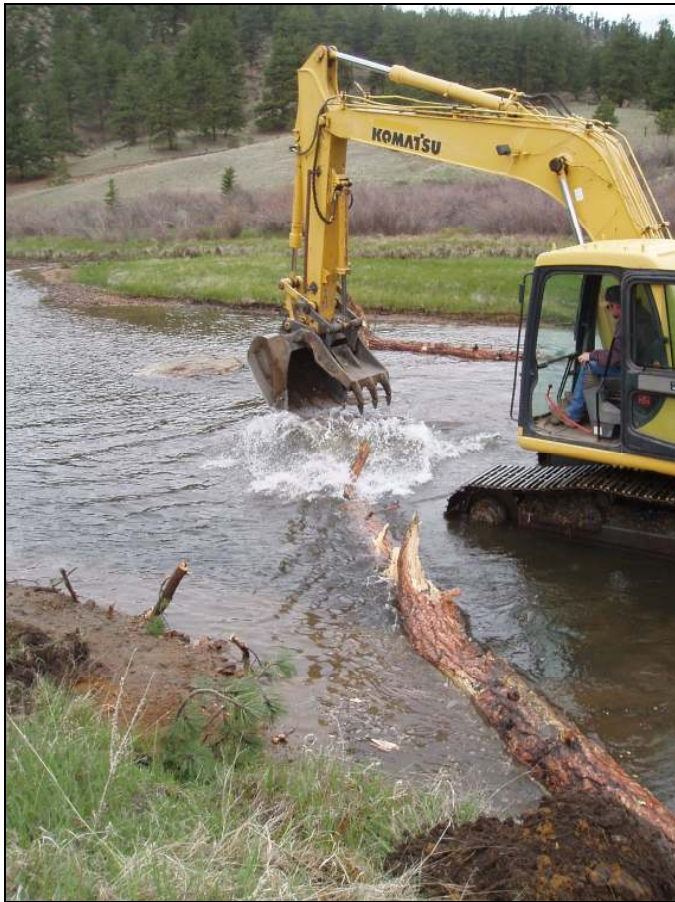
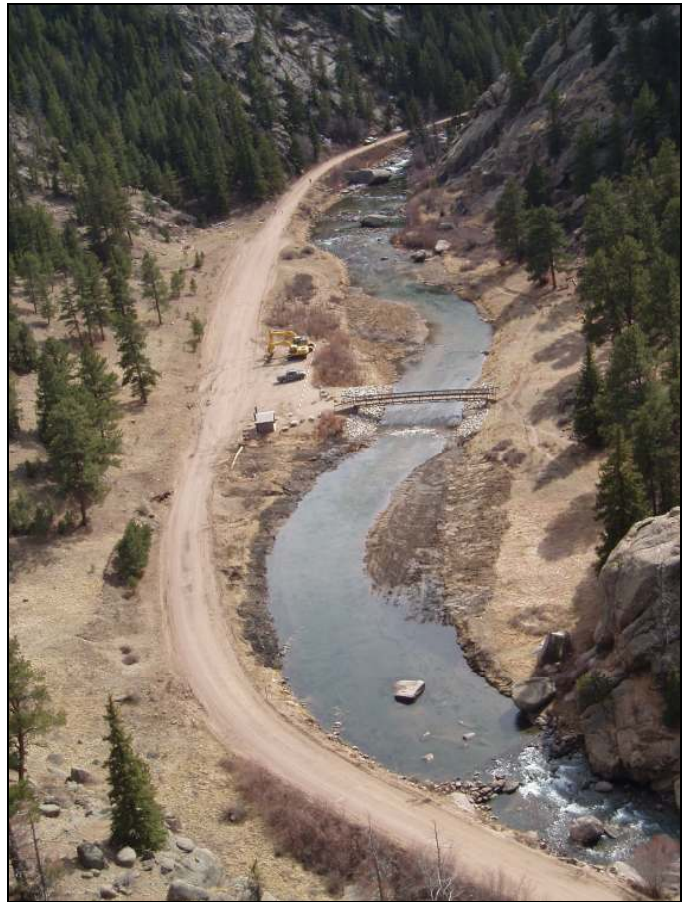
Installing a Log Vane - Camp Alexander, Elevenmile Canyon. Elevenmile Picnic Ground Channel Reconfiguration Project.

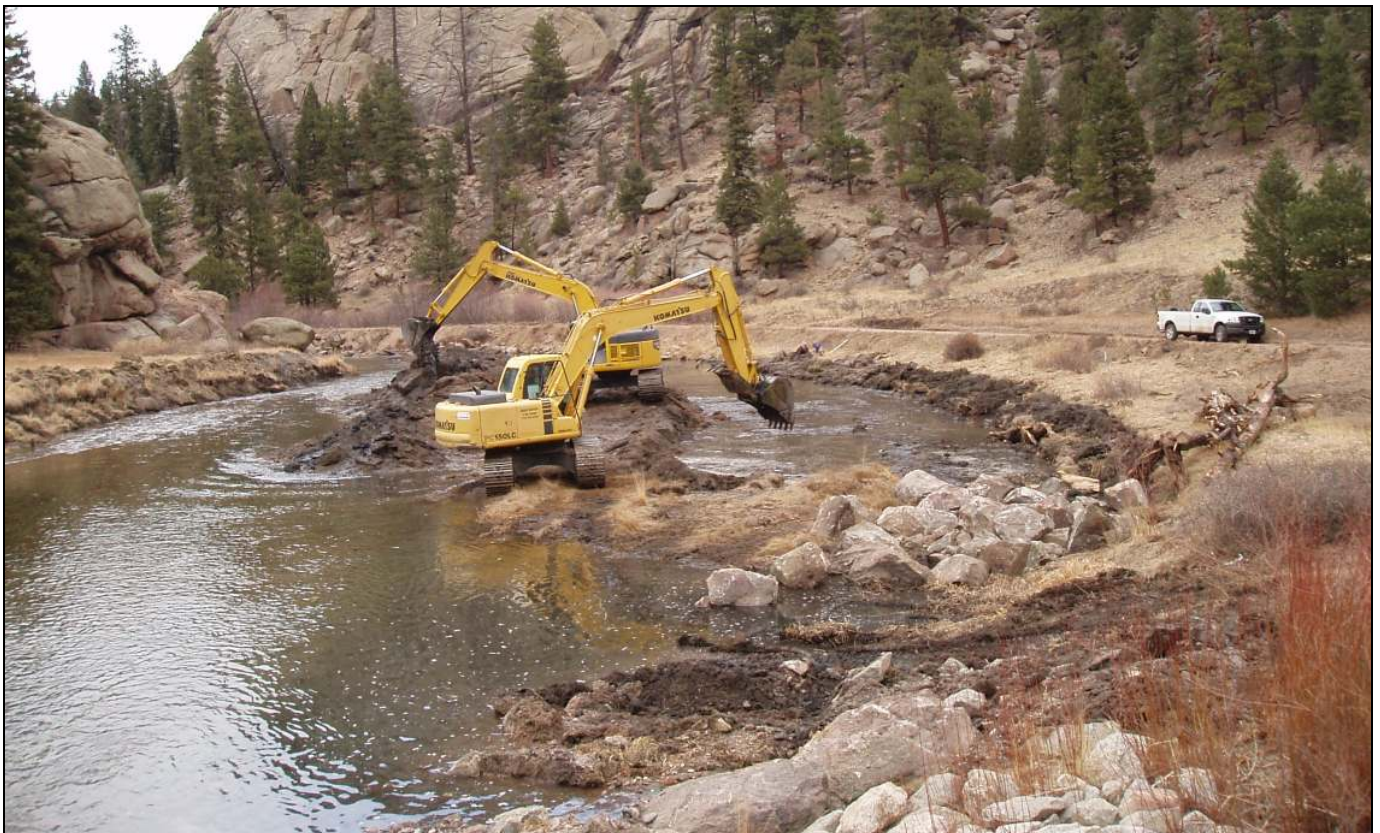
Removing the Mid-Channel Island - Elevenmile Picnic Ground Channel Reconfiguration Project - South Platte River.

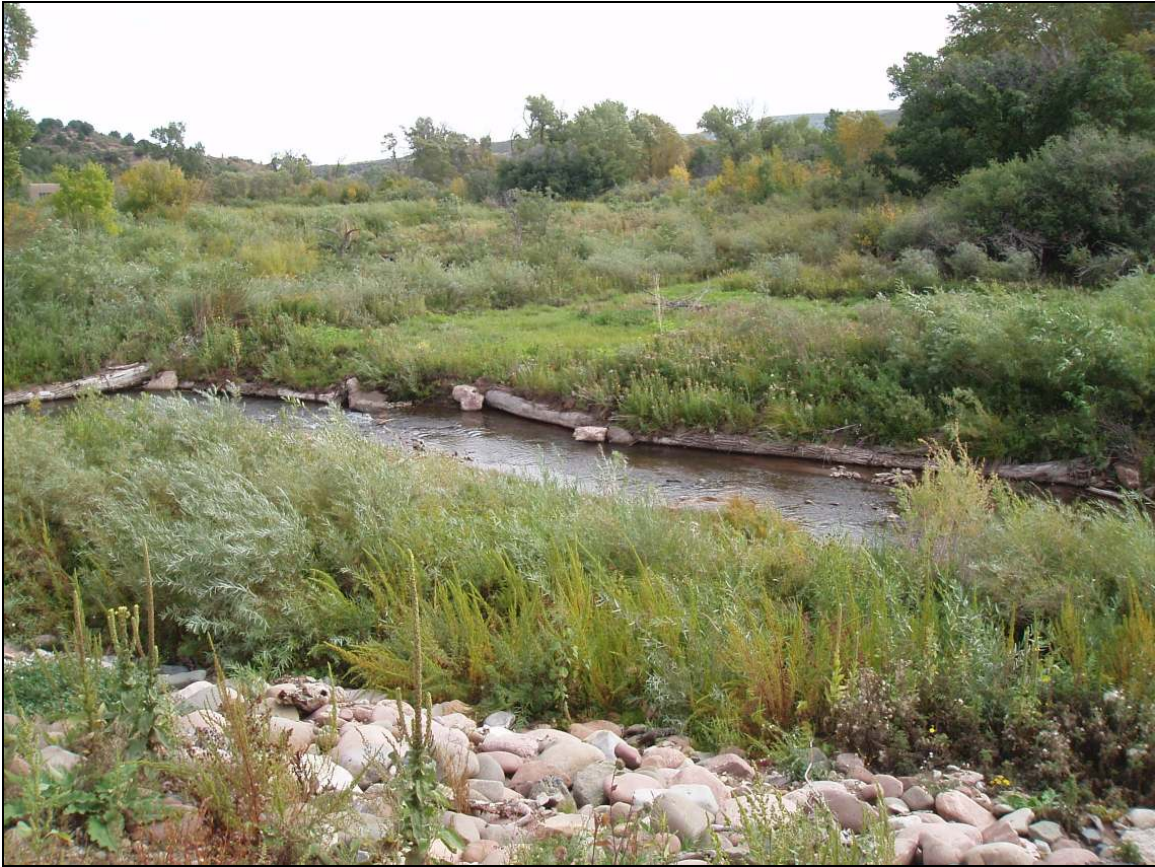
Riparian Bench / Log Toe Slope Structures, one year after construction - Cucharas River, Huerfano County, CO.

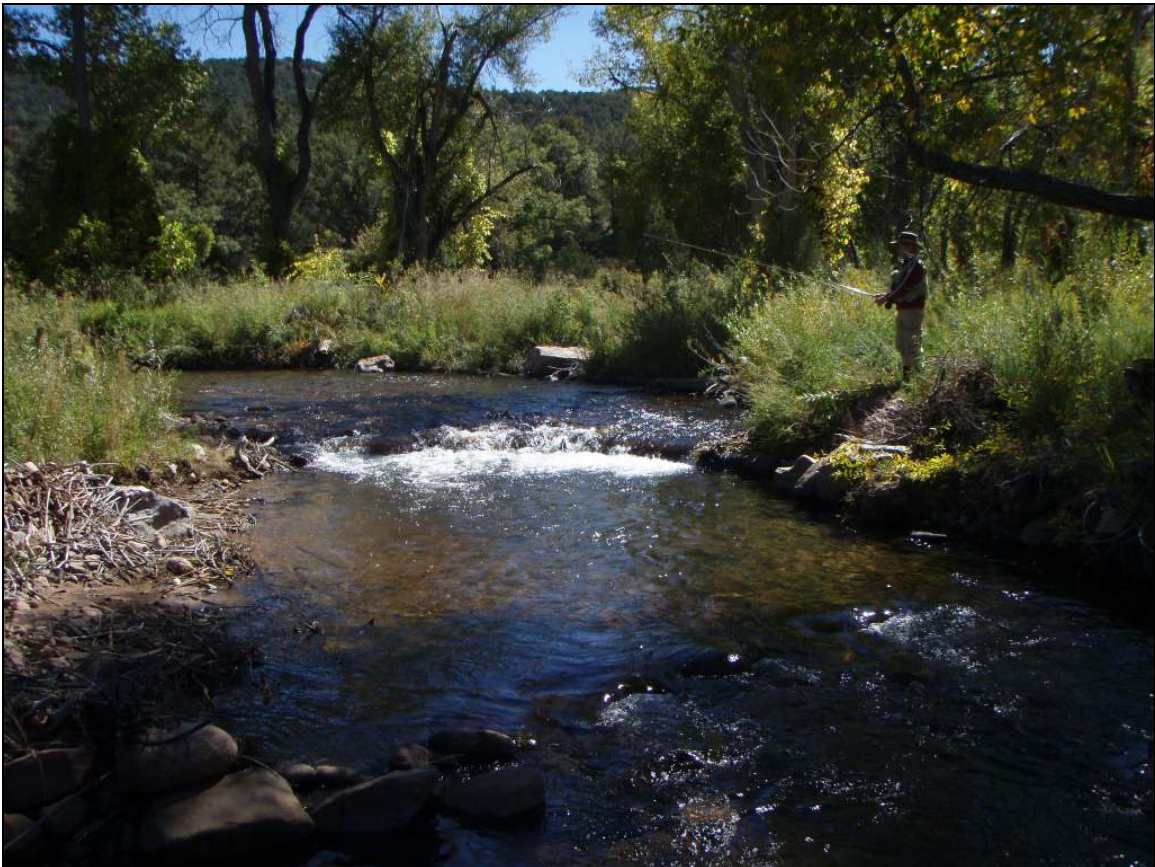
Double Log /Boulder Cross Vane with Restored Stream Bank Upstream - Beaver Creek Wildlife Area, CO.

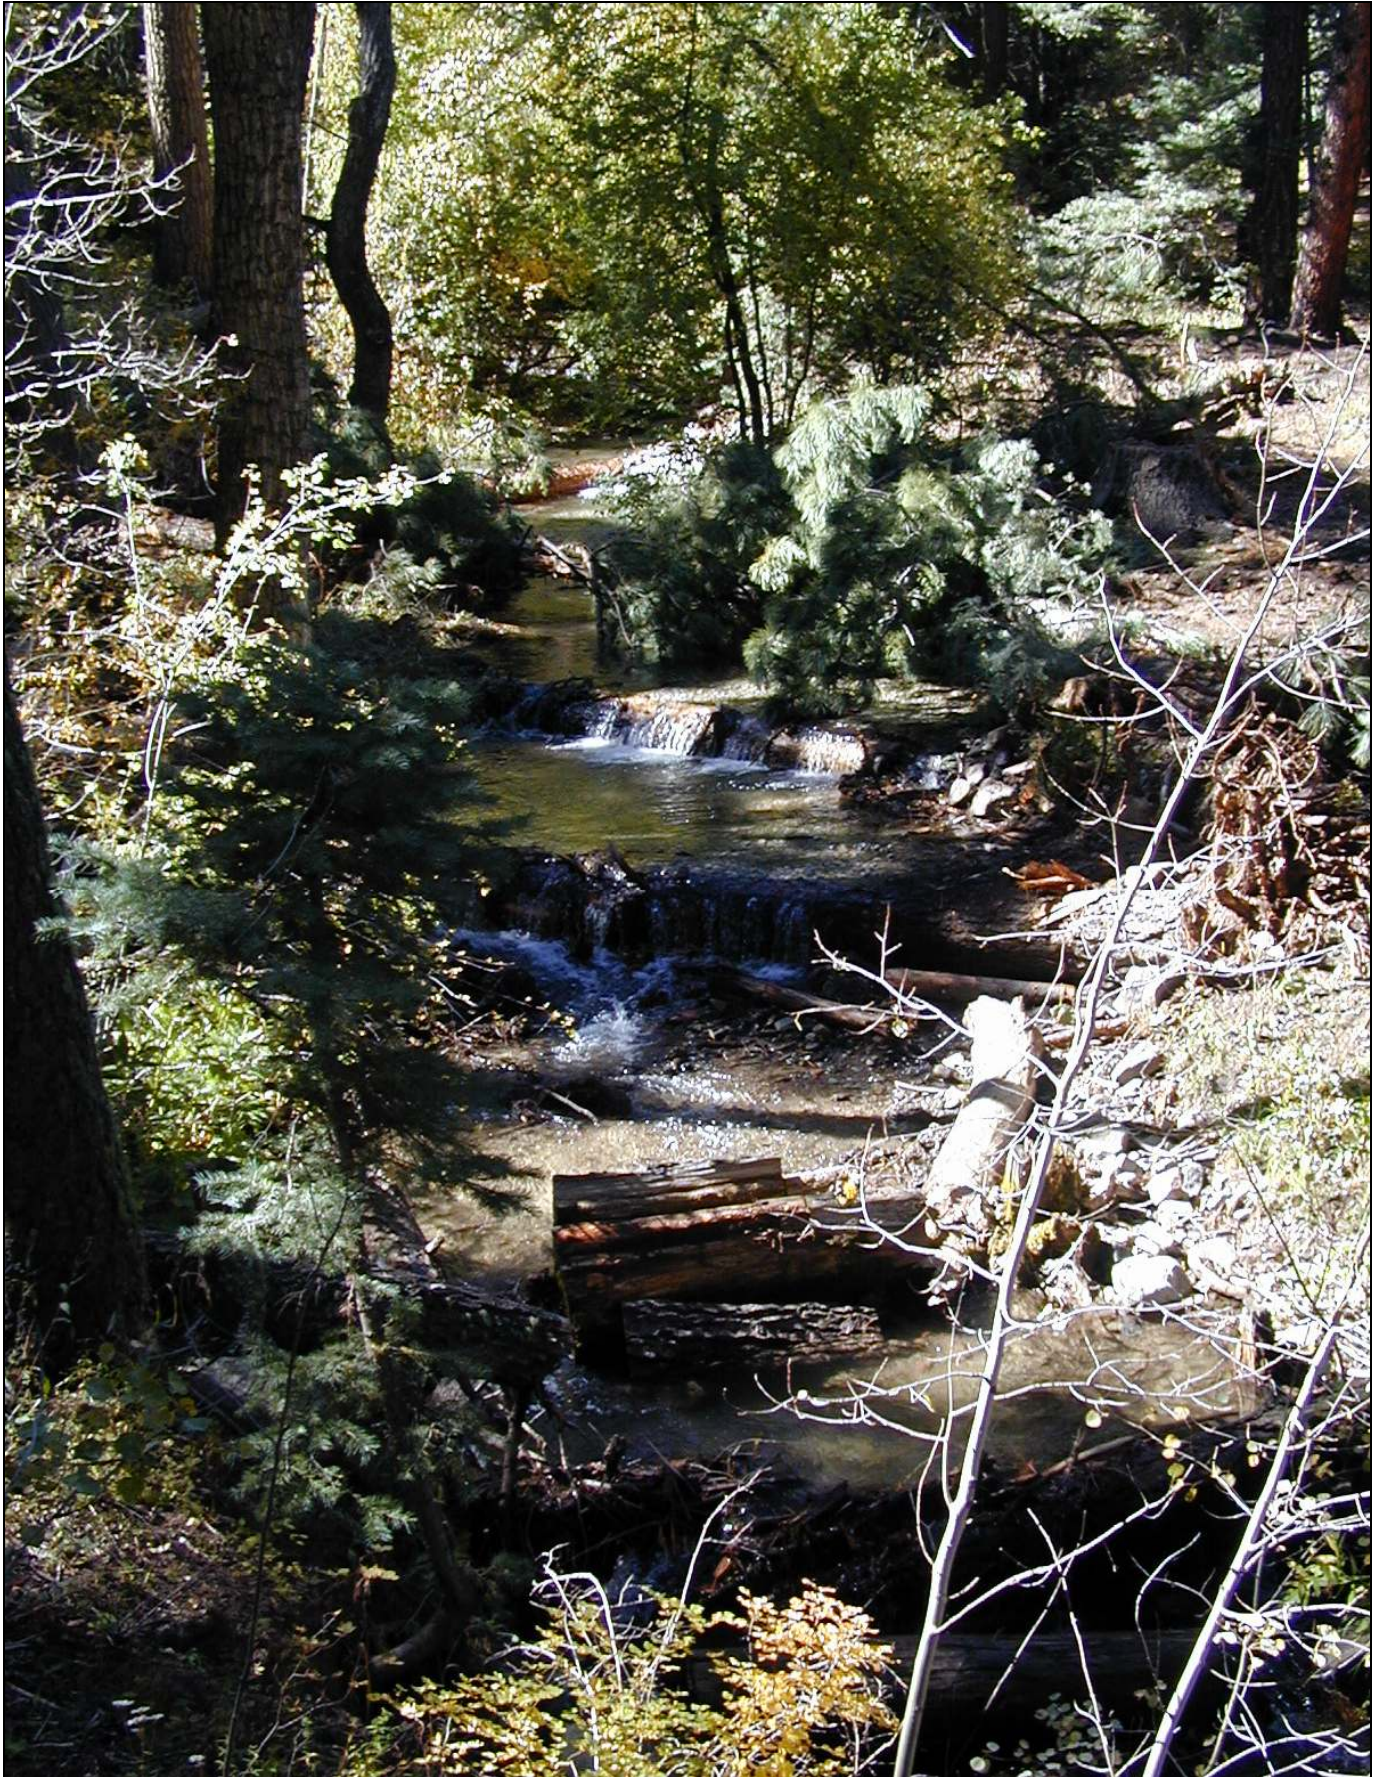
Newly Constructed Step-Pool System in a Greenback Cutthroat Stream - S. Prong of Hayden Creek, Freemont County, CO.

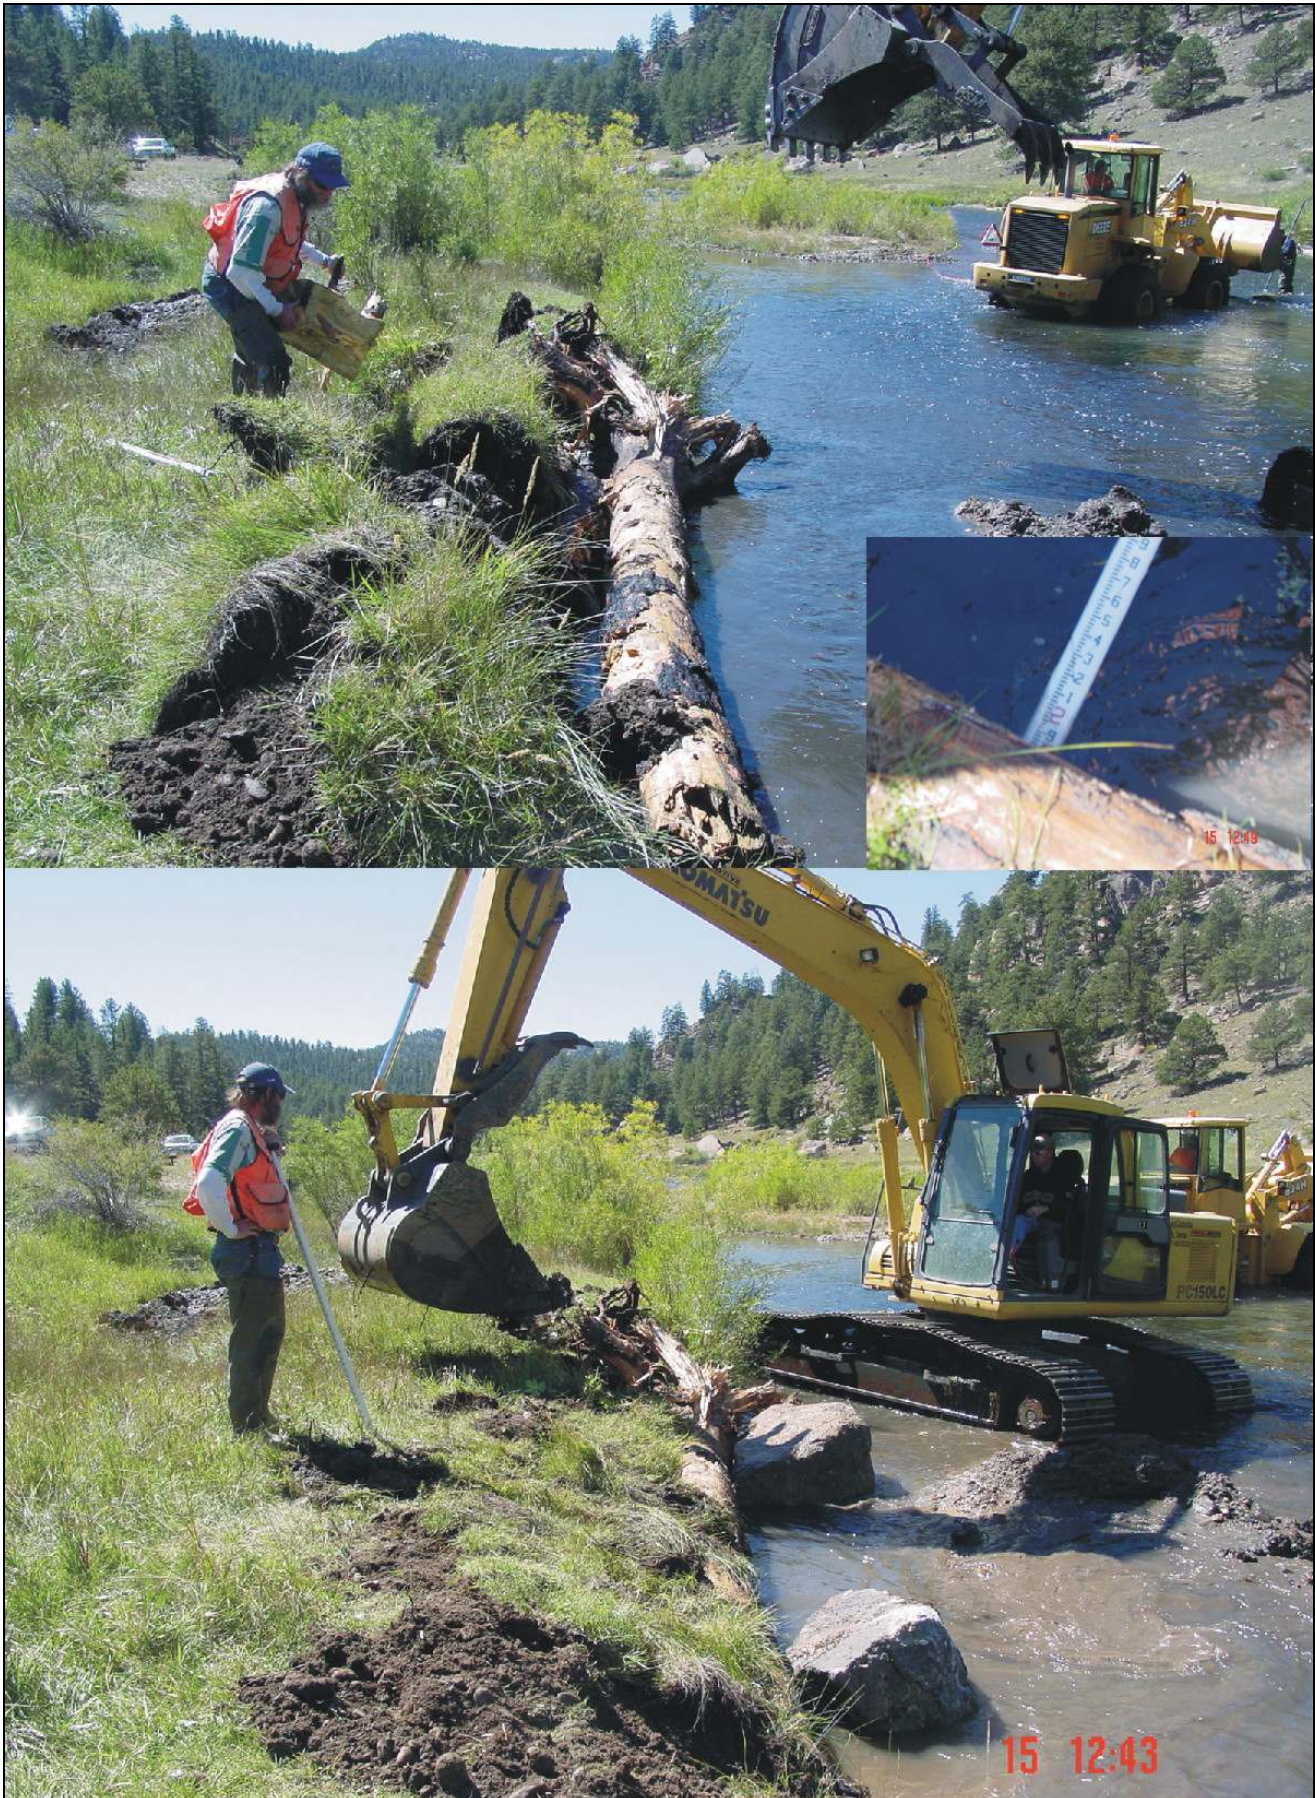
Constructing a LUNKER Stream Bank and Riparian Bench Structure - Elevenmile Canyon Trees for Trout Centennial Project.

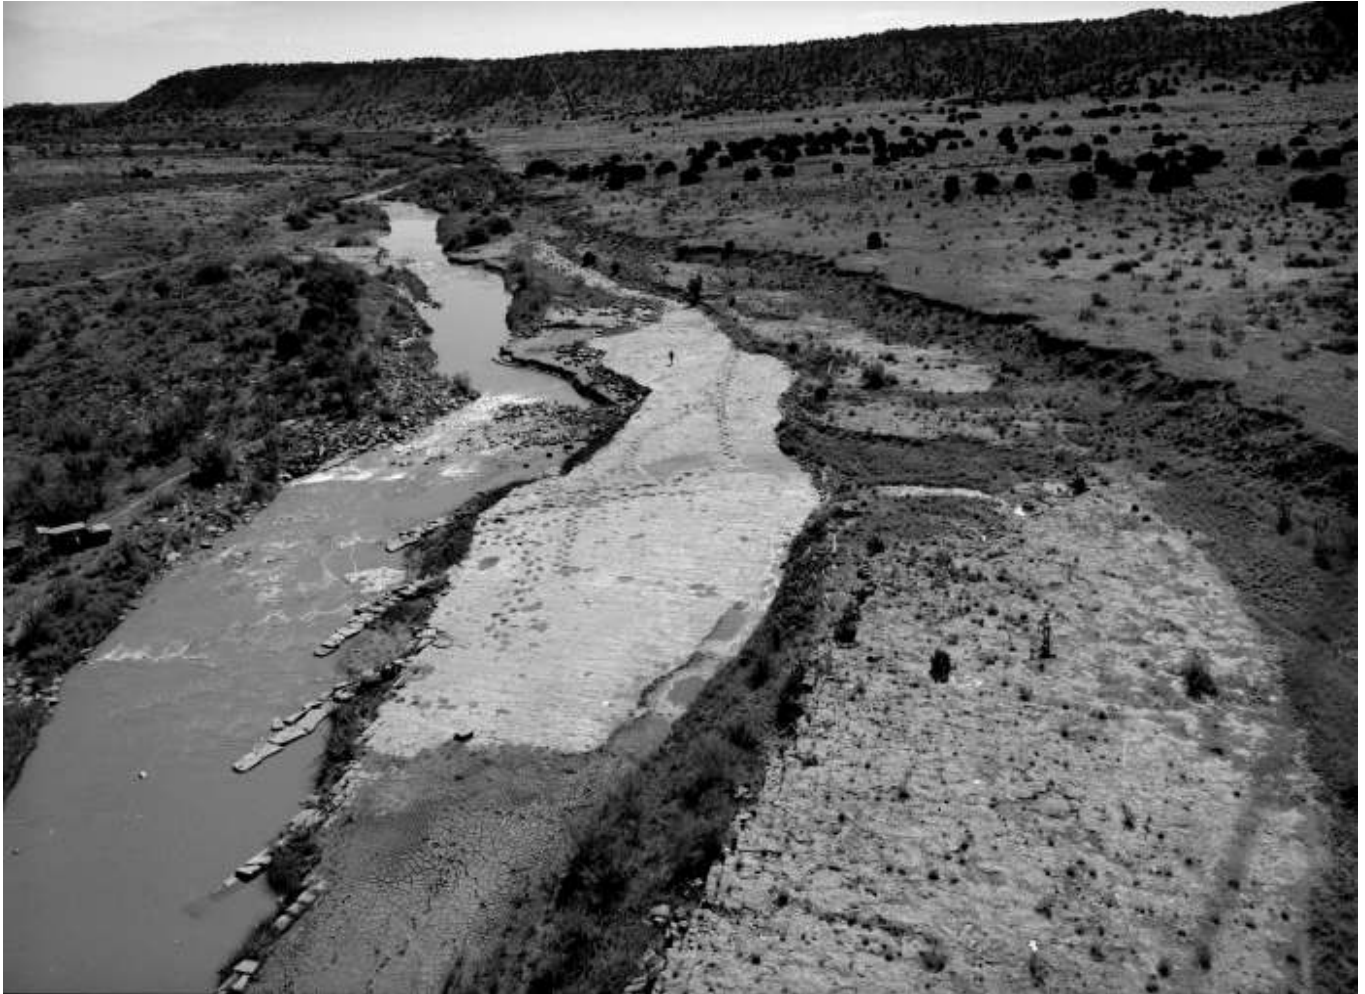
Picketwire Canyonlands, SE Colorado - Rock vanes used to protect dinosaur trackway. These structures were installed in 1998, and survived a 100 year event the following spring. Note the deposition and new willow vegetation taking hold in between the structures.
