## Habitat Improvement & Angler Access to Upper Fountain Creek Soda Springs Park, Manitou Springs, CO

Project Final Report

**FIN-UP** Habitat Consultants, Inc.

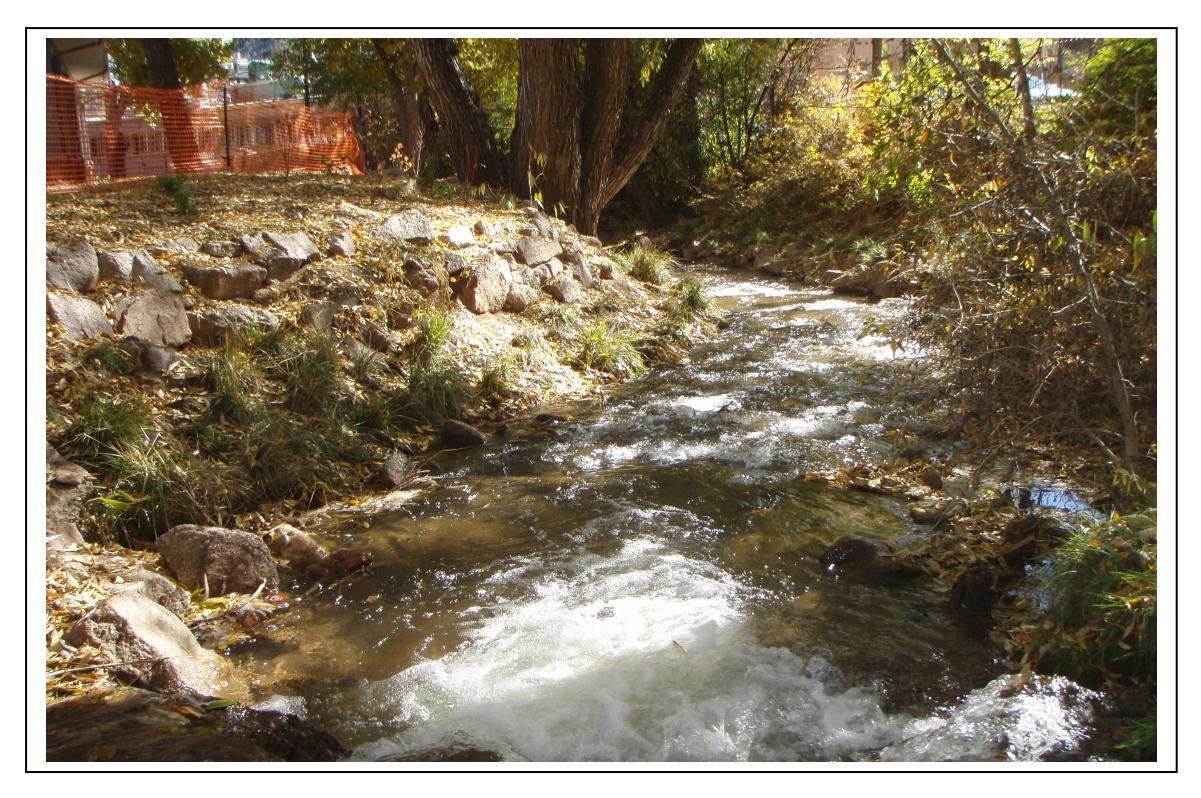
**Priority #1** identified the actively eroding stream banks in the project reach for treatment. All eroding stream banks identified in the enhancement plan were treated and re-vegetated, in accordance with the plan. A minor variation concerning the types of materials used was proposed by RMFI, and adopted by the FCRC. This change concerned the use of landscape timbers to provide stability to the eroding stream banks. RMFI pointed out that not only were the timbers expensive, but they would require some additional maintenance over time, as the timbers began to rot. RMFI proposed using small stone walls in lieu of the timbers. While this would increase the amount of time necessary to install these features, the work would be accomplished by volunteer labor, and would reduce the overall cost of the work by eliminating sever thousand dollars of timber costs.

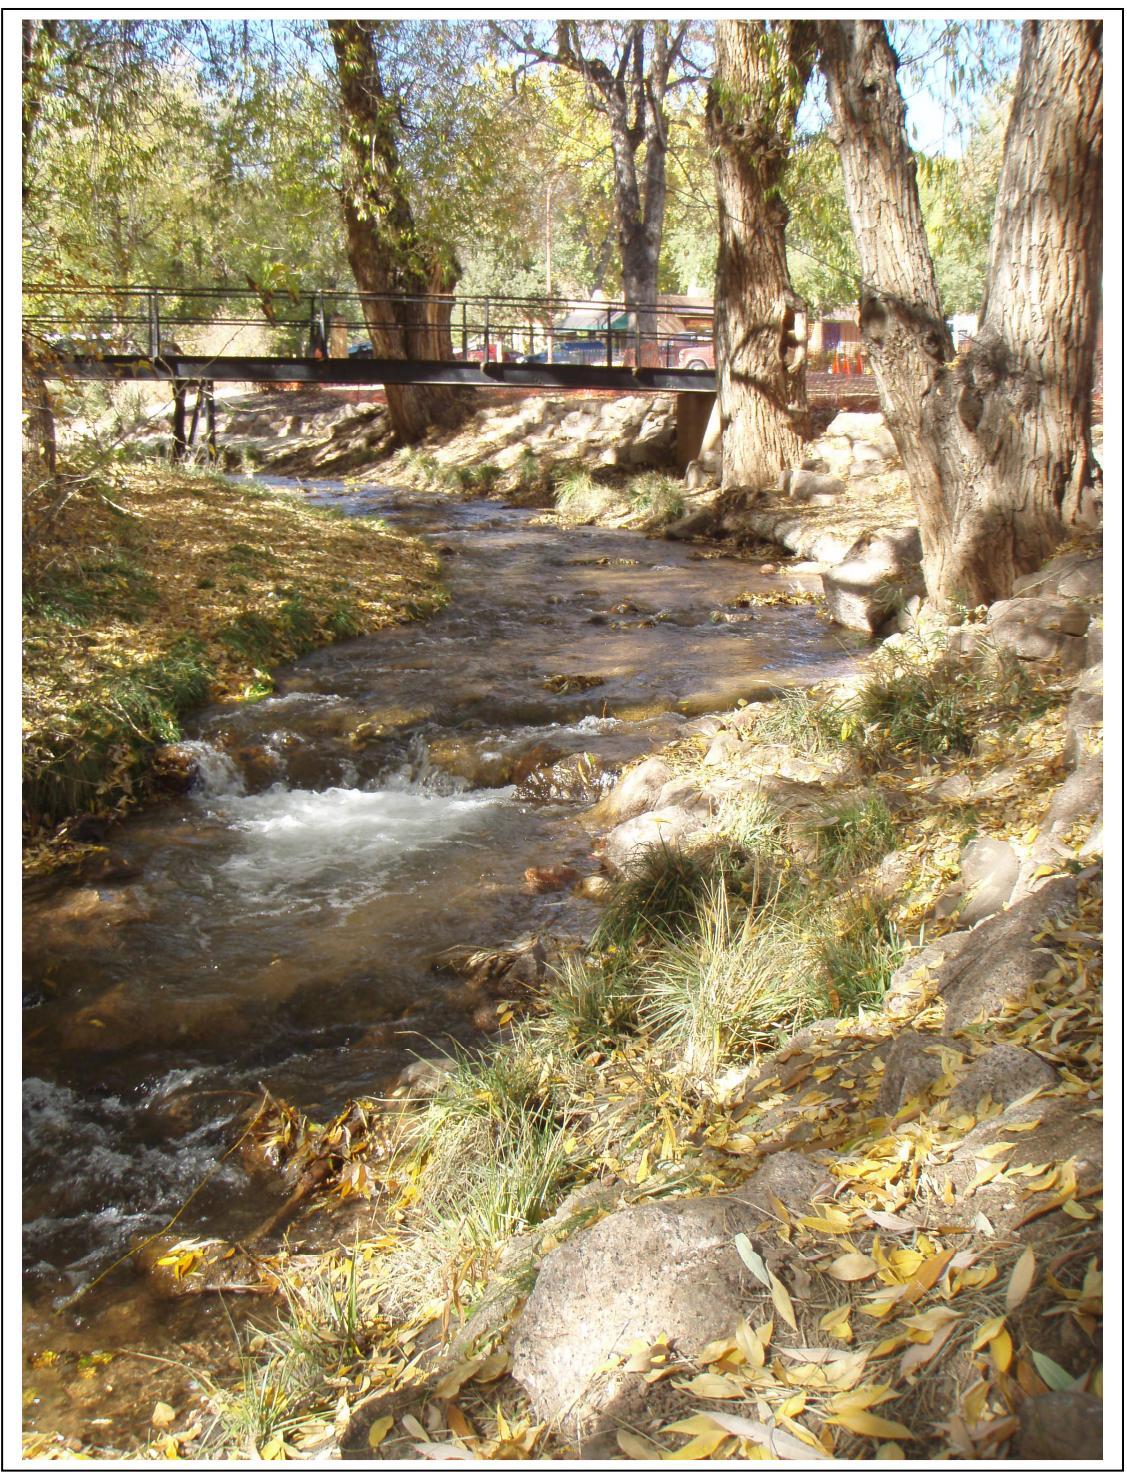
**Priority #2** included the in-channel habitat enhancements throughout the upper 2/3rds of the project reach, from the stone bridge across from the Park Pavilion upstream to the bridge at Park Avenue. In-stream habitat features were successfully installed as designed in the enhancement plan with the exception of the two cross-vane pools that were planned near the upstream boundary of the reach. In the process of installing the cross vane near the upstream boundary of the removed concrete wall, we discovered that a layer of solid

bedrock was present immediately below the existing grade of the stream channel, limiting the effectiveness of a scour feature at this point. With considerable effort, we were able to excavate enough material to create an adequate pool. It was apparent that this geologic feature extended to the project boundary, necessitating the elimination of the cross-vane upstream, due to the difficulty in excavating the channel for footings and concerns over possibly damaging the historic greenstone wall forming the right side of the channel.

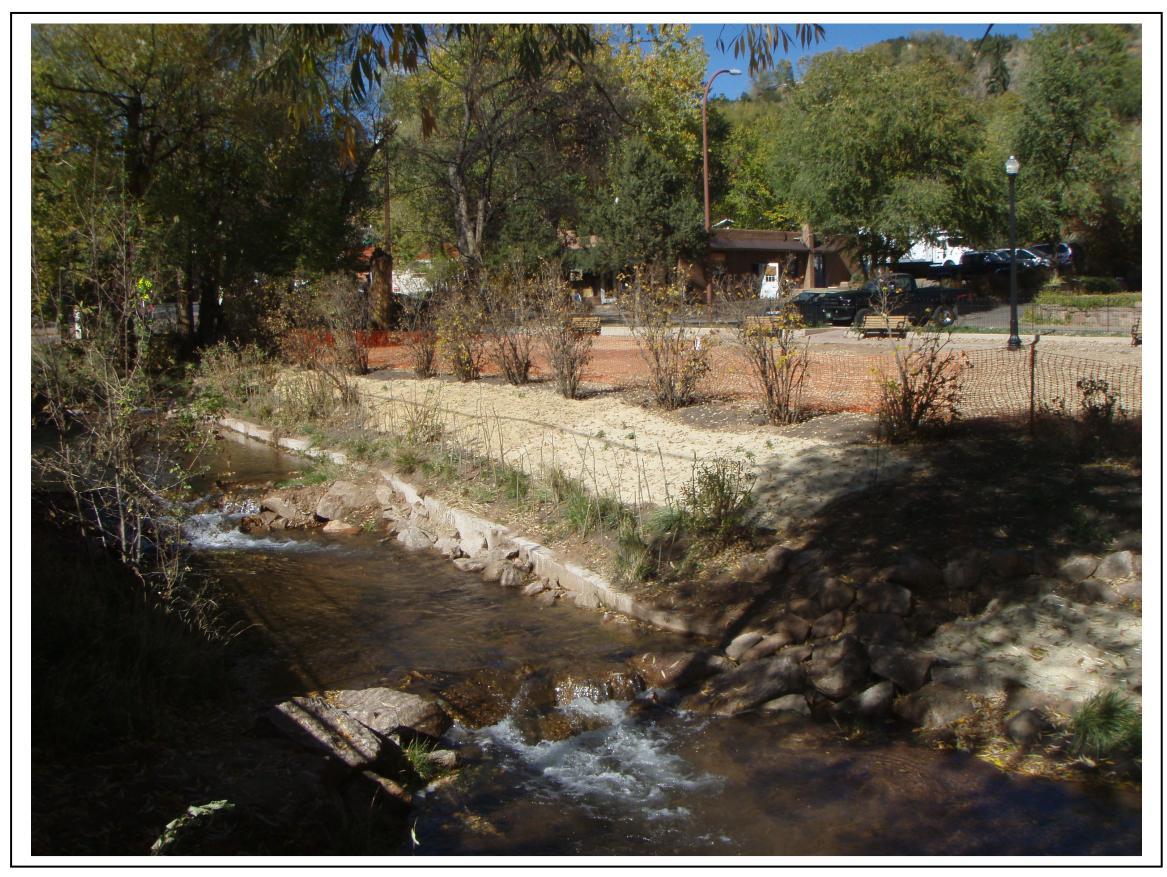
**Priority #3** treatments involved the cutting and demolition of the concrete retaining wall adjacent to the playground. Work included re-contouring and re-vegetation of the newly exposed stream bank, and construction of a boulder cross-vane to aggrade the existing stream channel elevation, hopefully covering an exposed 10 inch cast iron water main crossing the stream at this point. The initial plan called for cutting the wall around the water main and leaving this section in place to stabilize the pipe. After excavating the back side of the wall, it became apparent that this would not be possible, and a decision was made to cut the entire length of the wall, just below the bank full elevation of the channel, and use the remaining wall as a toe-slope foundation for the restored stream bank. Fortunately, the wall foundation is perforated, allowing for good saturation of the soil behind the footing and allowing for adequate sub-irrigation of the willow and riparian sedge planted along the bank full bench adjacent to the stream. The mid channel island that had formed upstream of the utility crossing was removed, with the willow preserved for transplantation along the new stream bank.

A boulder cross vane constructed below the utility crossing effectively eliminated the fish barrier created by the old log drop structure protecting the water main. This structure was set at an elevation sufficiently high enough to allow sediment to accumulate behind the structure and bury the exposed pipe. A slight increase in channel elevation could be accomplished here without significant increase in flood risk due to the increase in channel cross-sectional area resulting from the removal the concrete retaining wall from the right stream bank.

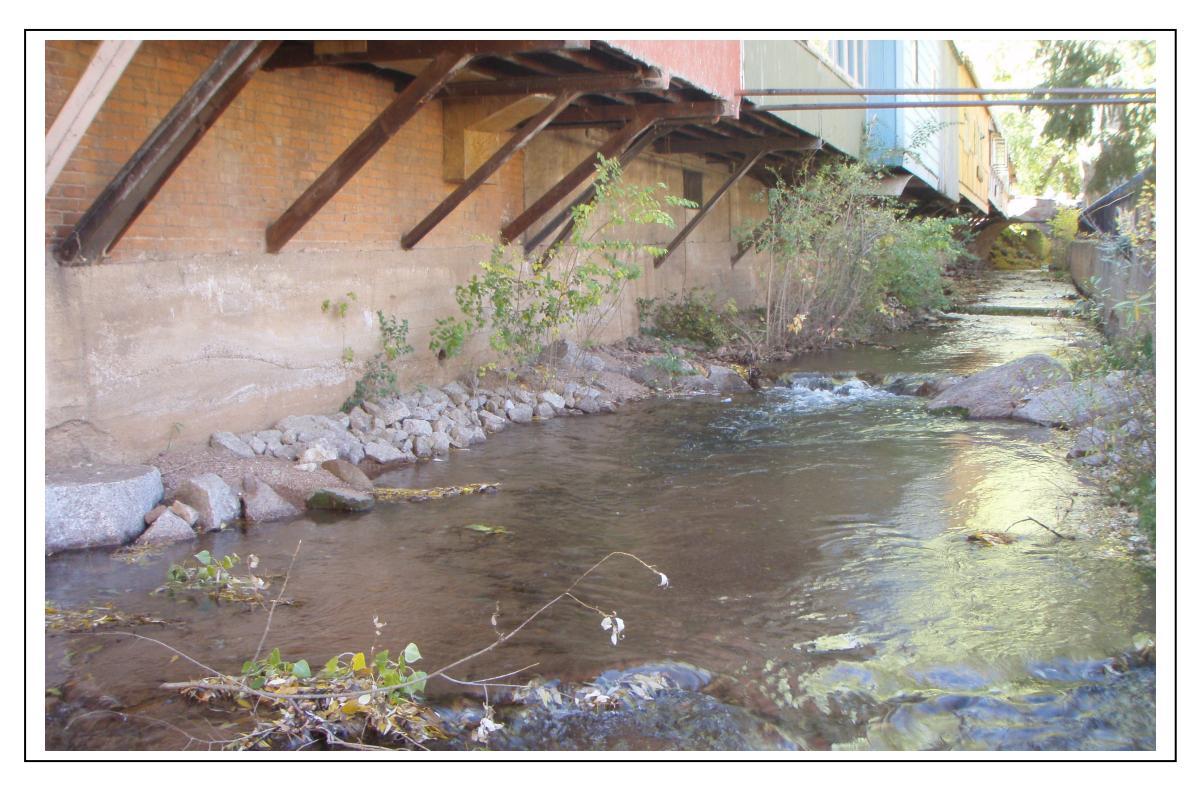
**Priority #4** treatments, involving the installation of in-channel habitat features in the retaining wall confined segment of the project reach downstream of the stone bridge proved to be every bit as challenging as predicted in the enhancement plan. Work in this segment was accomplished using a small Komatsu PC45 excavator, operated by a remarkably skilled operator. The equipment was "walked" under the stone bridge, at one point with less than 1 inch of clearance, and work was commenced at the downstream end of the segment, working back upstream.

Two minor modifications were necessary to the original design in this segment. A small rock vane was added downstream of the first cross-vane plunge pool in the project. The vane provides additional protection to the foundation of the building forming left side of

the channel, deflecting the stream away from an eroding section of the foundation. A second minor change involved the substitution of a series of boulder vanes for a planned cross-vane, due to the lack of clearance necessary underneath the buildings to install the originally planned structure. It was agreed that installing vanes upstream and downstream of the inaccessible segment would provide the sought after velocity shelter and object cover, while providing additional protection to the building foundations on the left side of the channel. A deep sigh of relief was expressed by all when the excavator emerged back on the upstream side of the stone bridge, signaling the completion of this phase of the project.
